Teton Dam Failure

failure, damage, lessons

Teton Dam

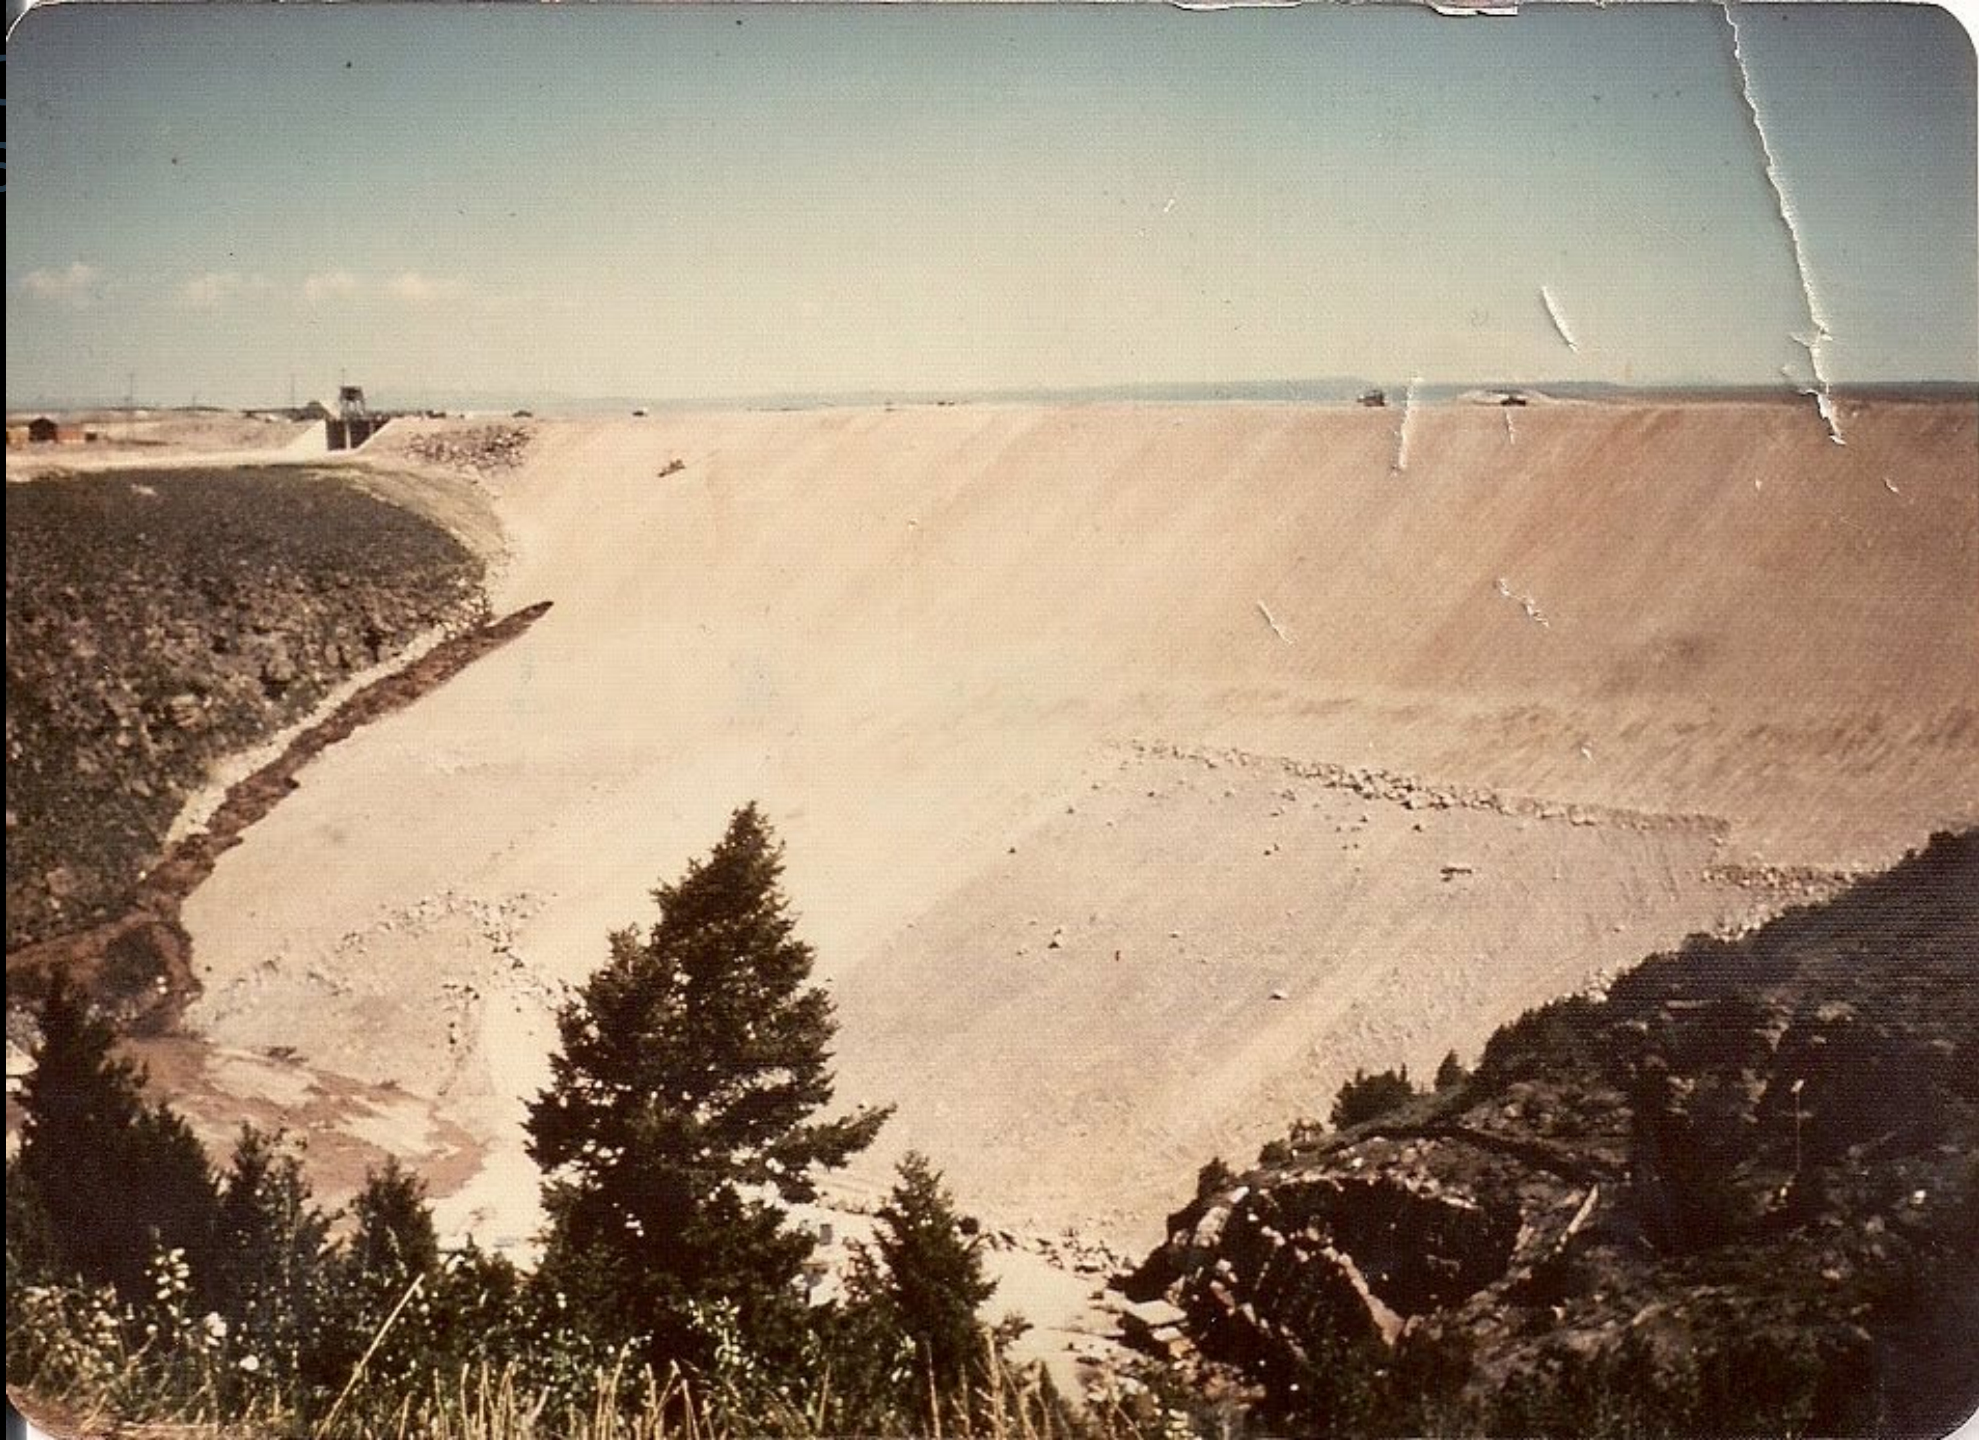
10:15 – 10:45 AM

- Wet spot on the embankment forms and rapidly begins to flow and erode embankment materials.
- Loud noise heard by several people
- Two bulldozers begin to push materials into the hole in the embankment
- PCE notifies 2 county sheriff's offices, advises of flooding, says prepare to evacuate.

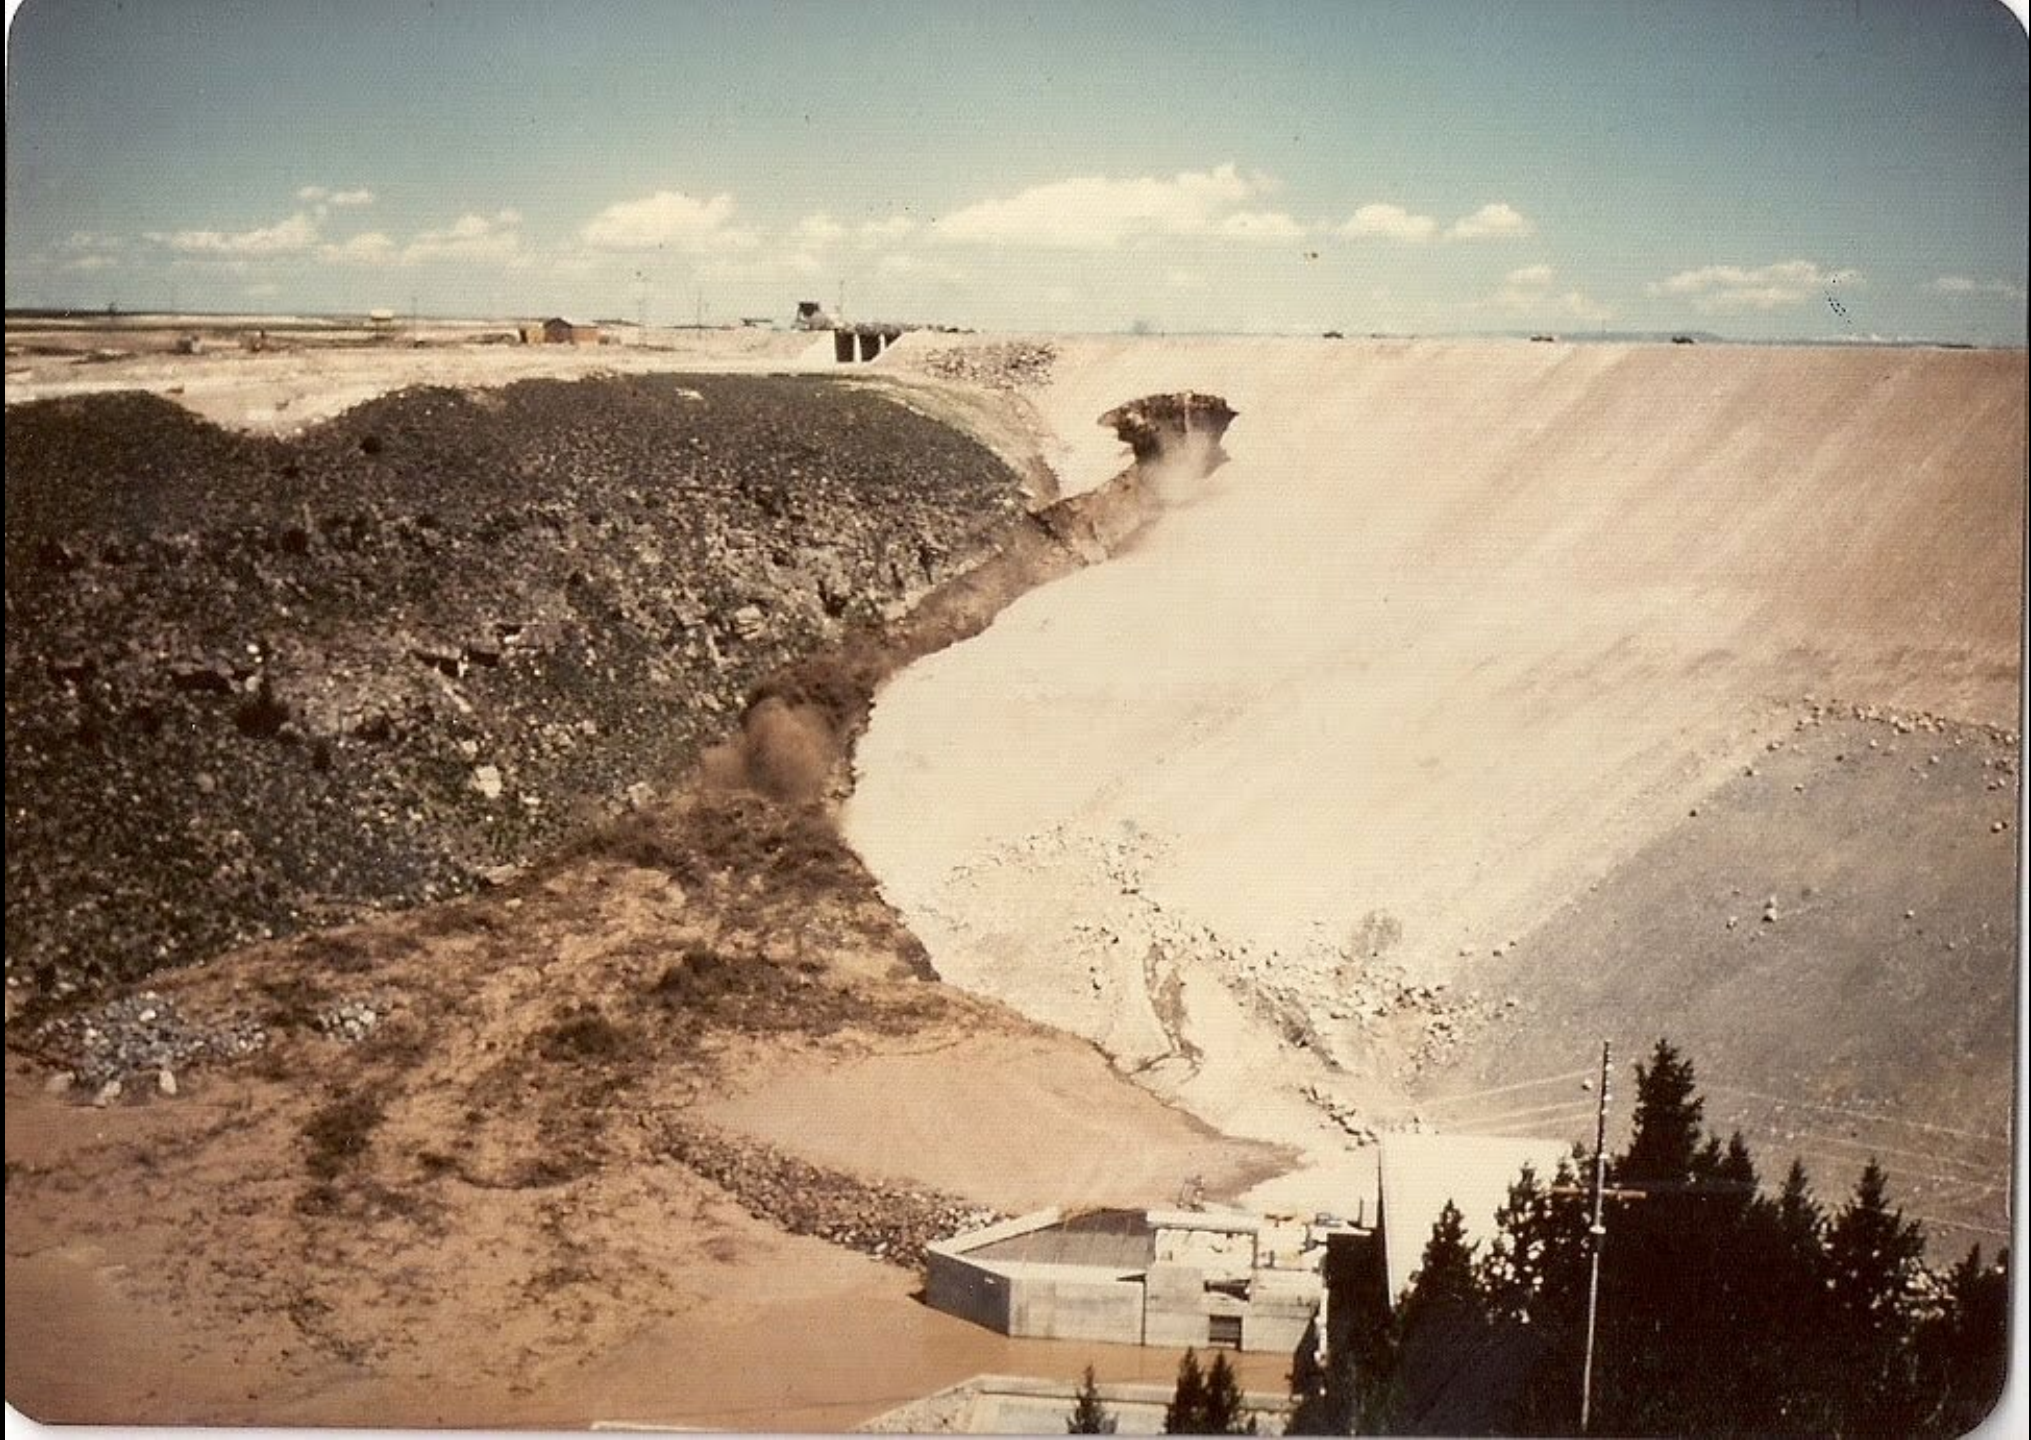
AFTER VAINLY TRYING TO FILL BREAK
IN EMBANKMENT OF TETON DAM, TWO
"CAT" OPERATORS BACK TOWARD
SAFETY AS THEIR BULLDOZERS SLIDE
INTO THE WIDENING GAP

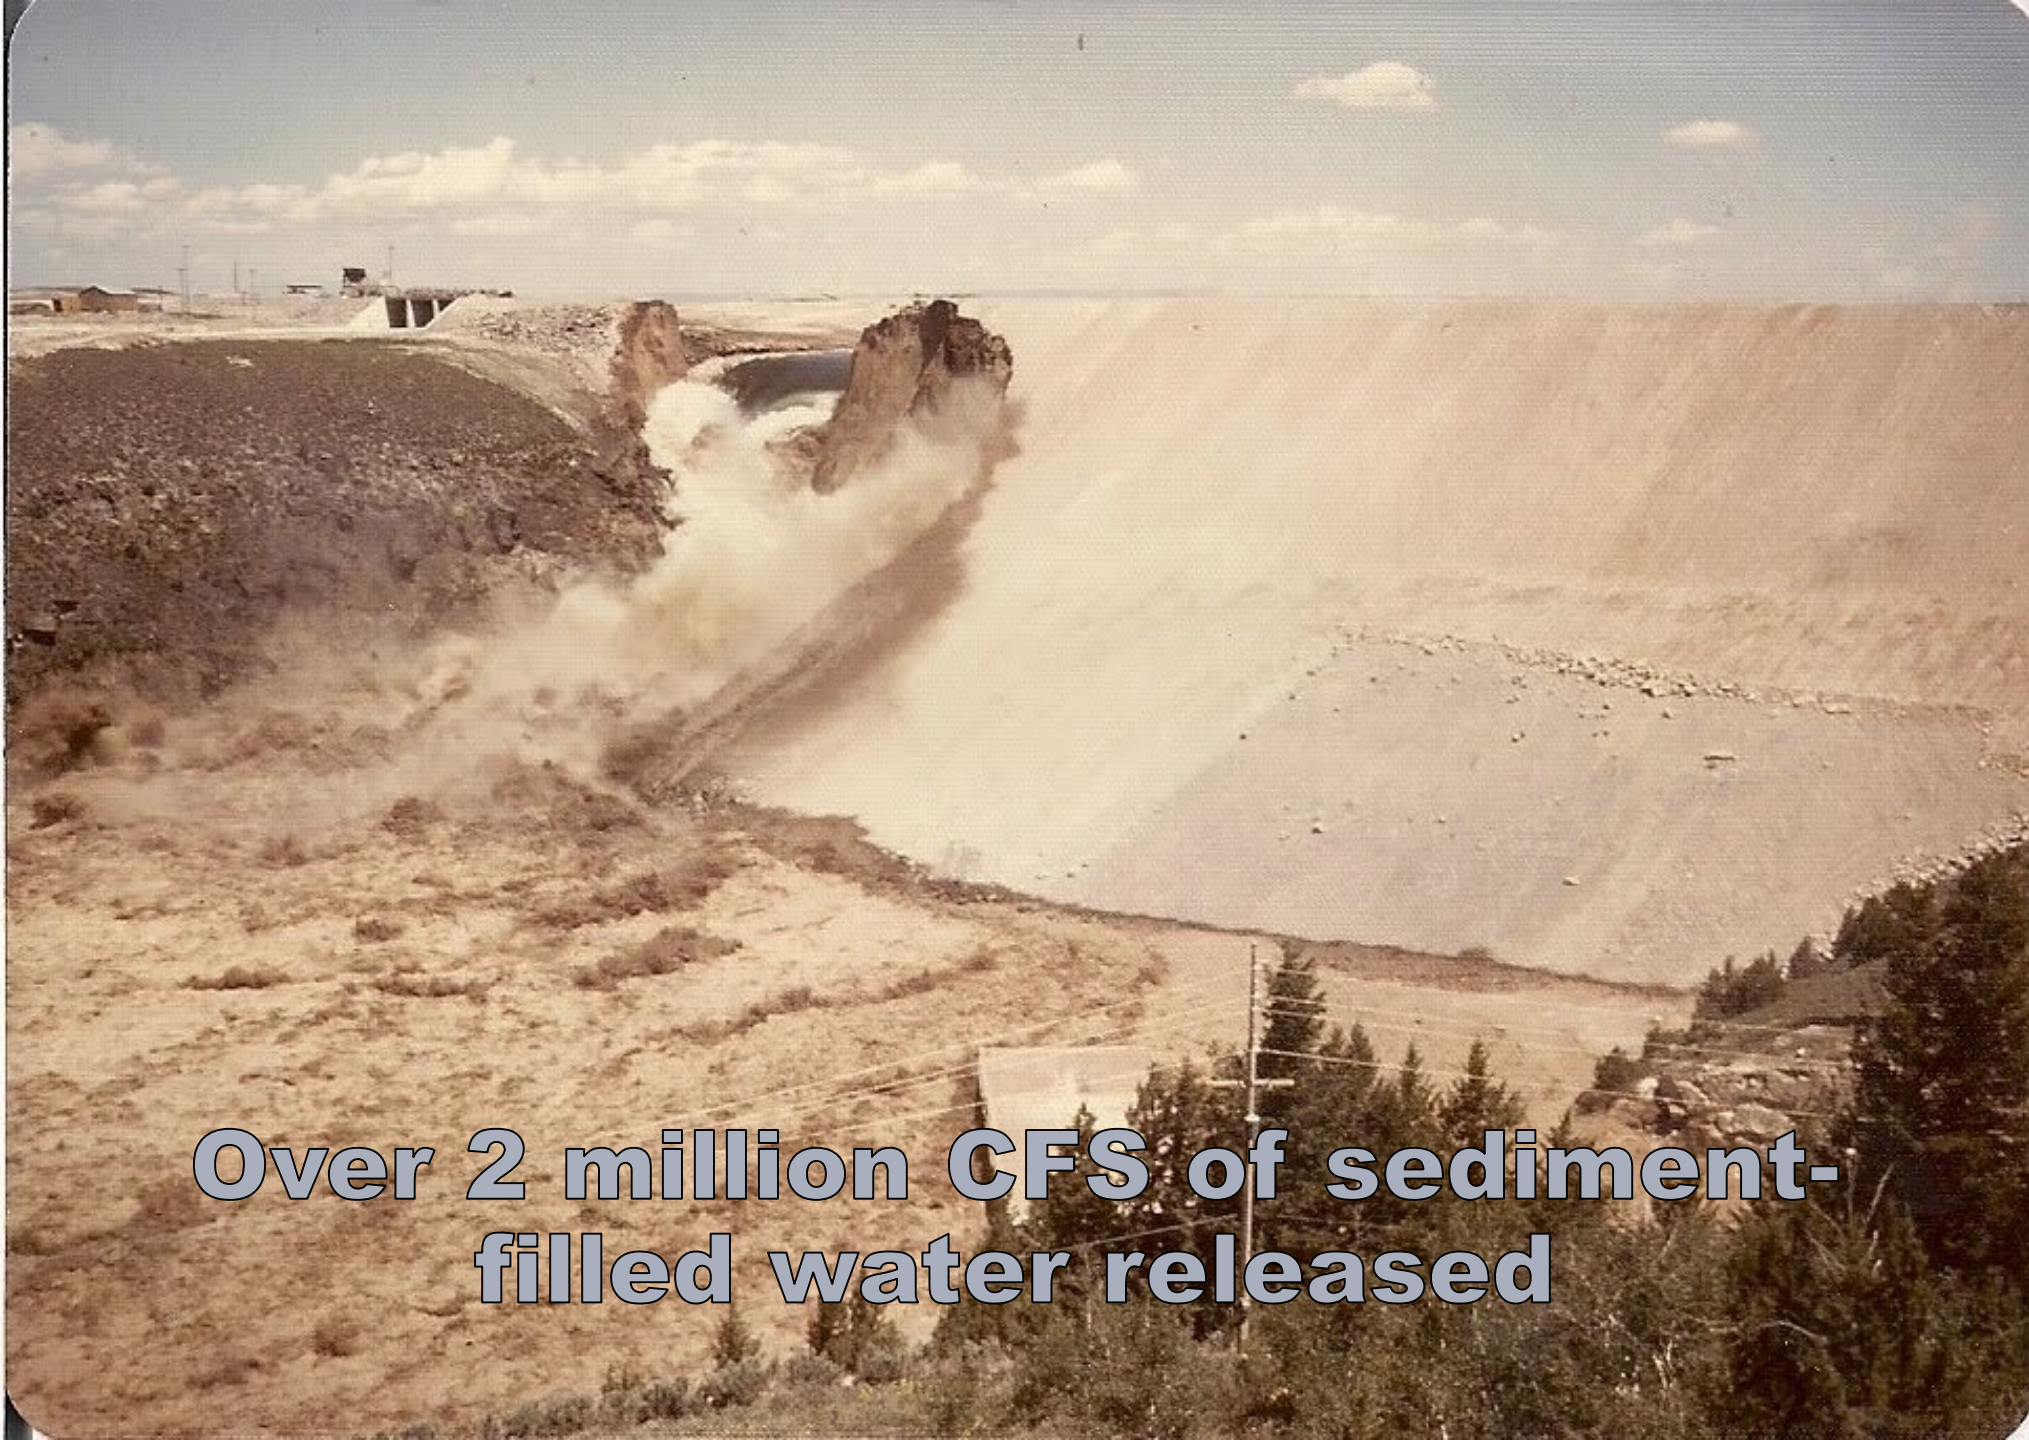
11:55 AM

**Dam Crest collapses and falls
into river**

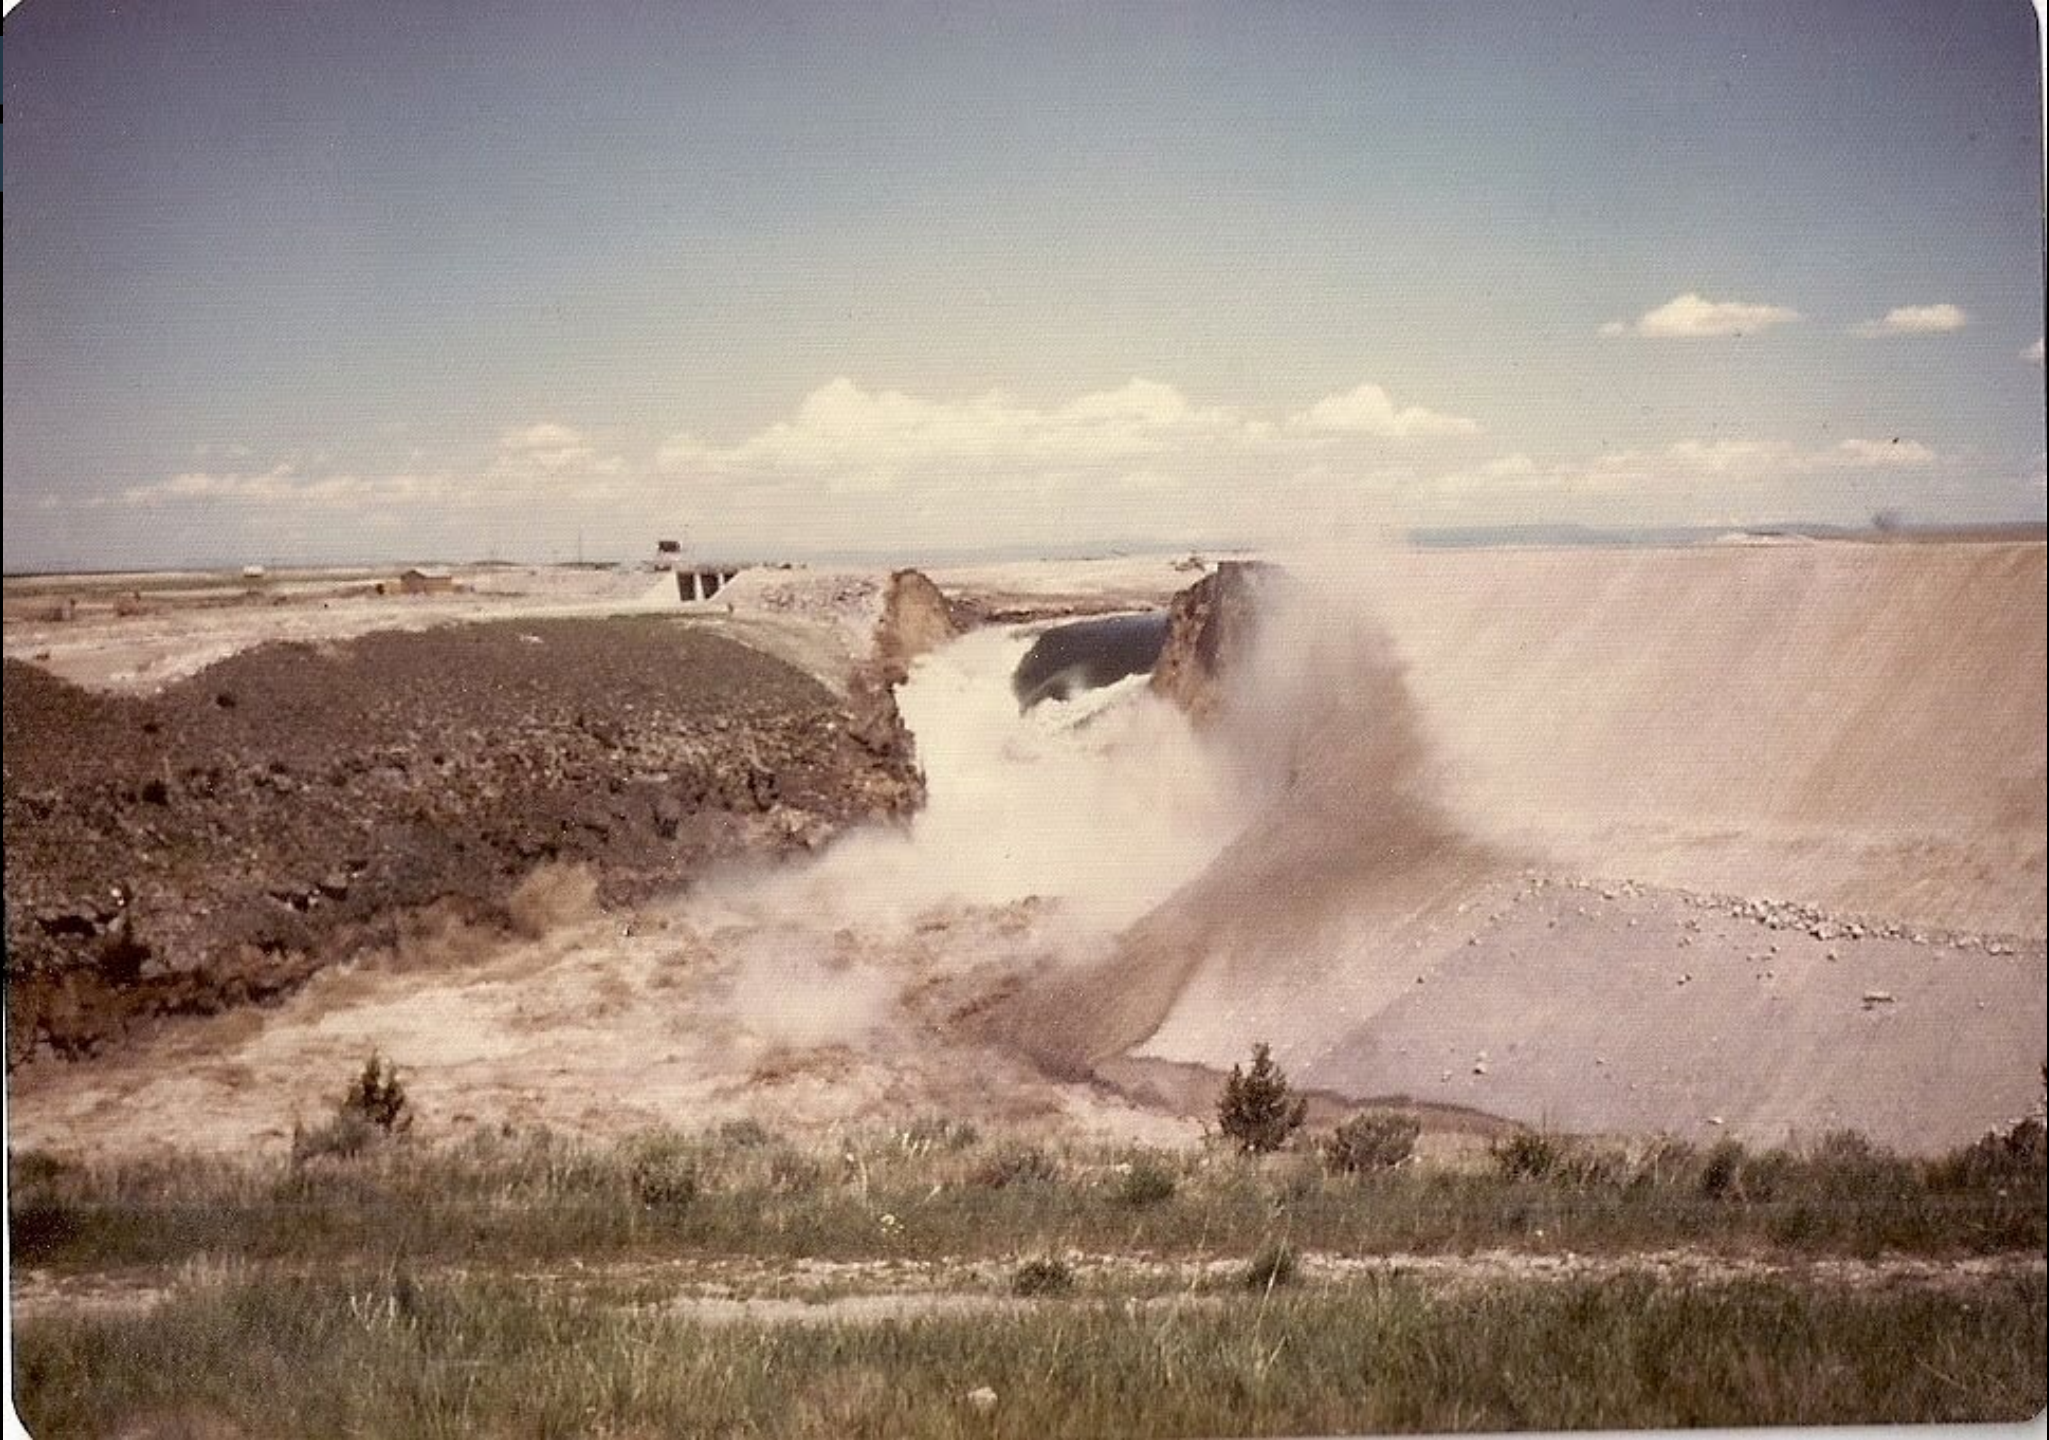
Over 2 million CFS of sediment-filled water released

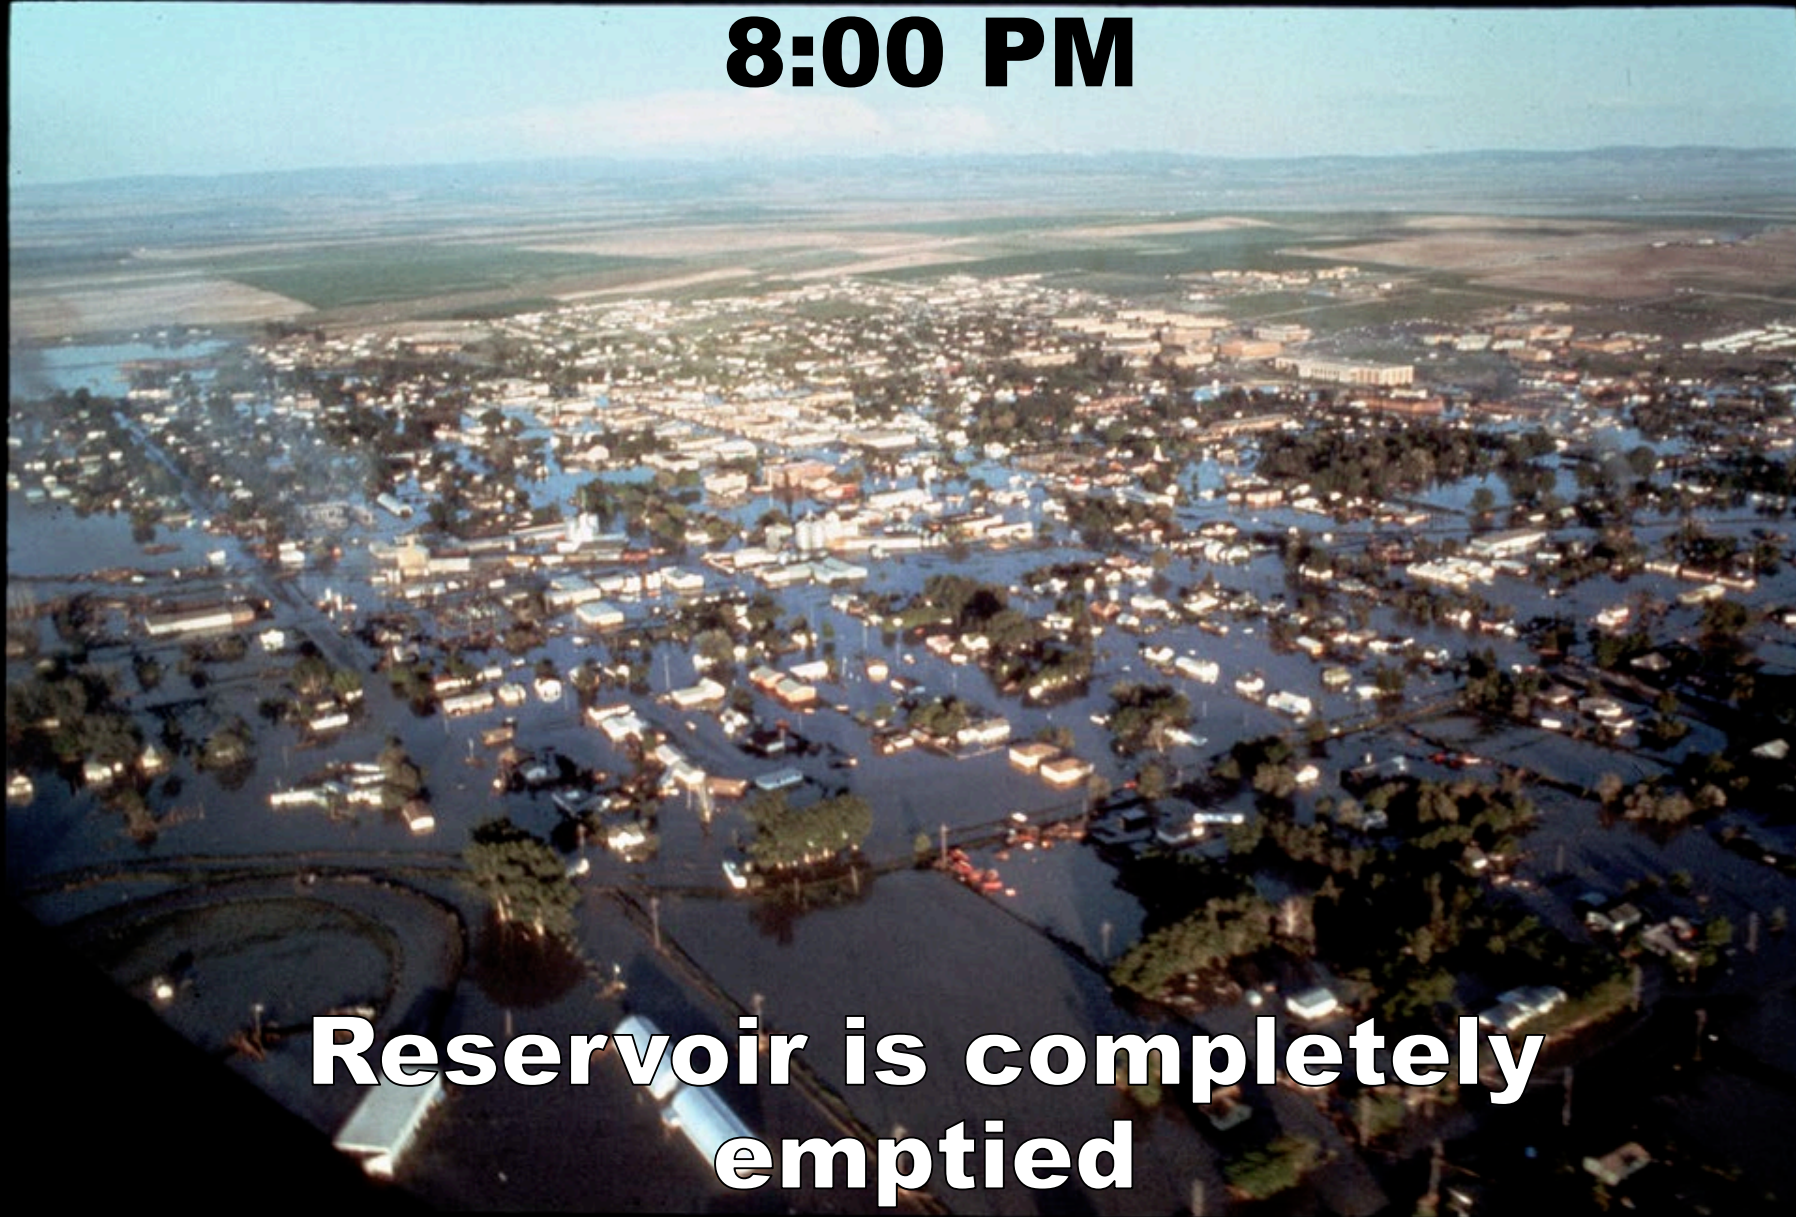
8:00 PM

Reservoir is completely emptied

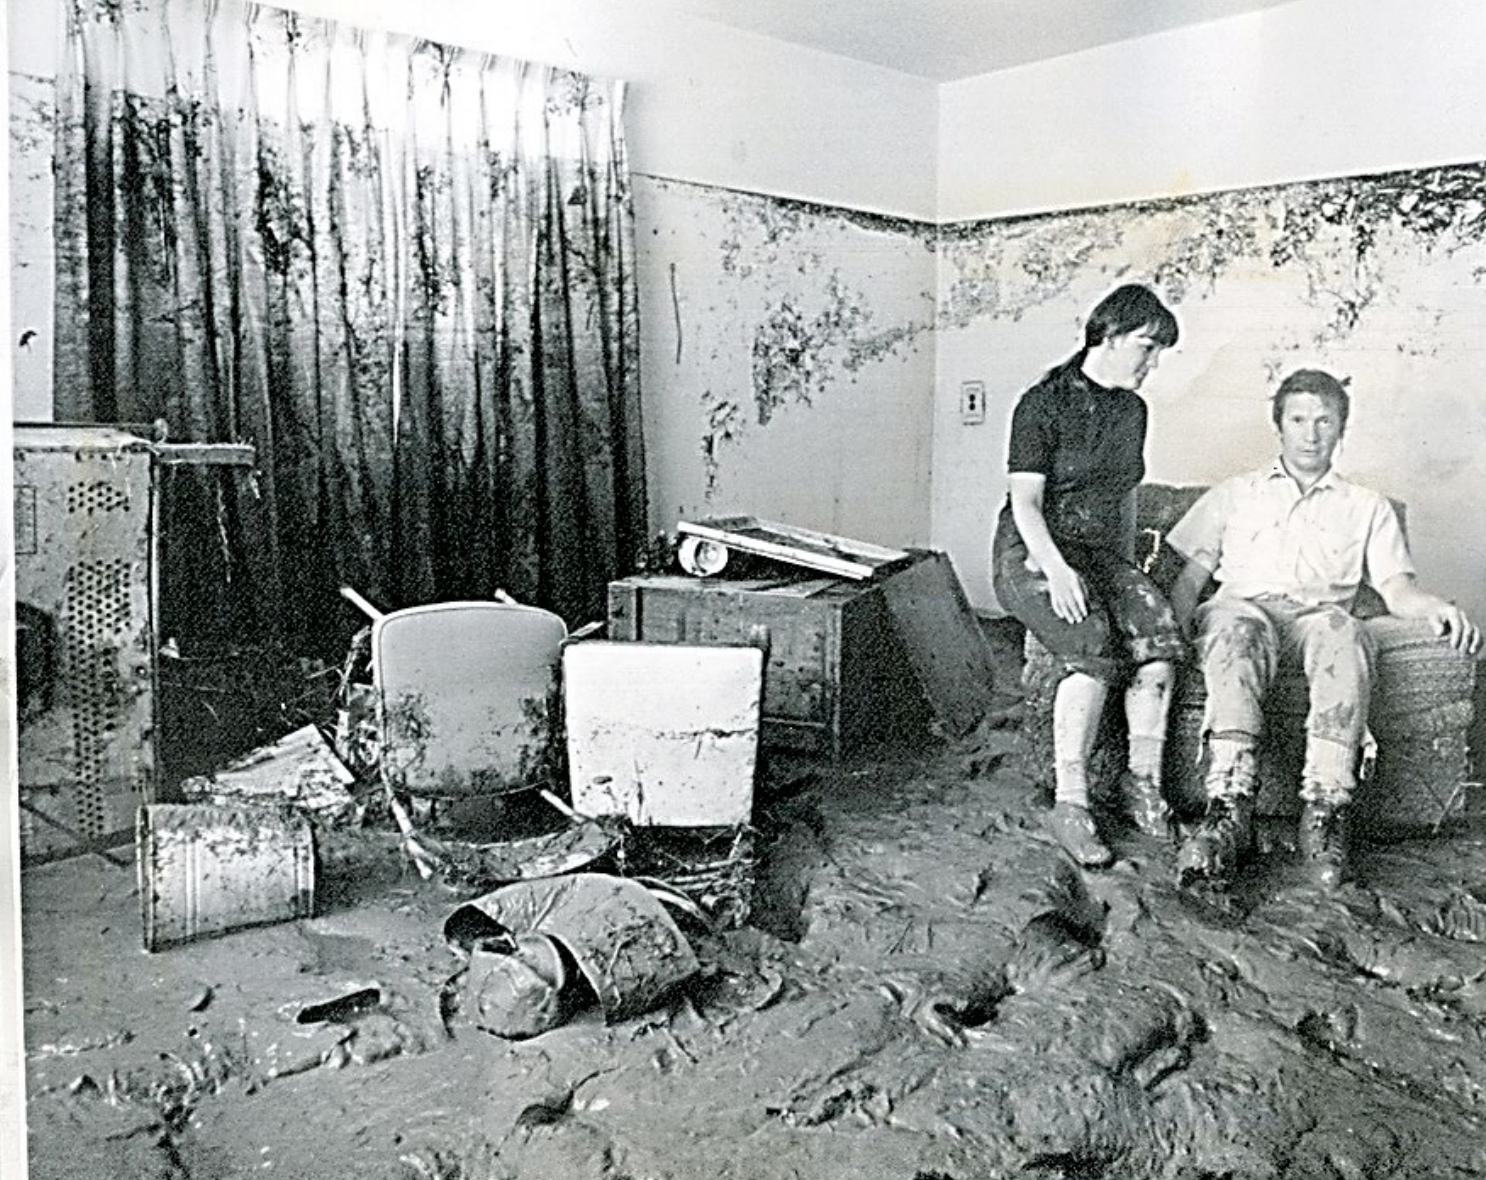
(SK1)-REXBURG, Idaho, June 6--DISMAY IN FLOODED HOME--Mr. and Mrs. Lauren Williams sit in the flooded Rexburg home of Mrs. Williams' mother, Thelma Williams, and view the damage caused by waters released by a collapsed dam. The floor is covered by mud and furnishings are ruined. The line showing the depth reached by the now-receded water is visible on the wall and drapes. (AP WIREPHOTO)(See AP Story)(JB1337Tribune) 1976
