# Montana Association of Dam and Canal Systems

## *2024 Rock Lake Operator Repair and Monitoring System Improvements*

Karl Kingery, P.E., CFM  
Water Resources Engineer

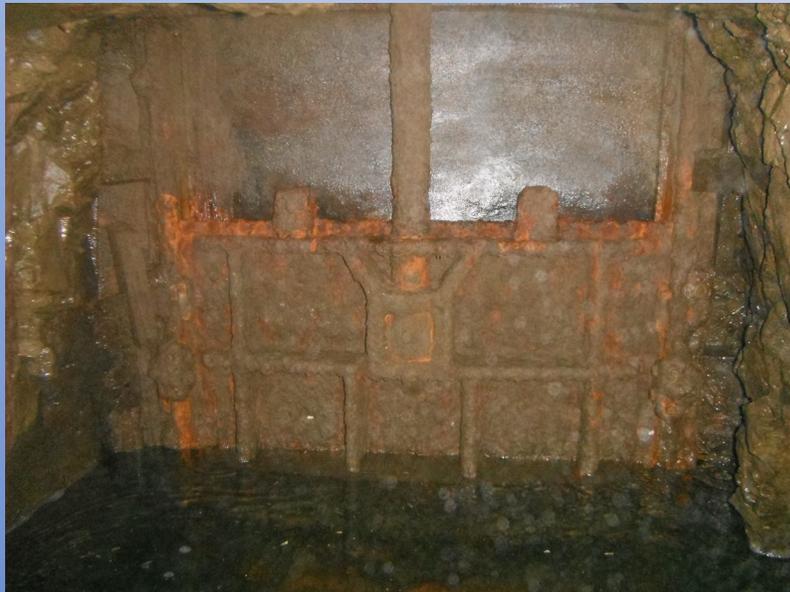
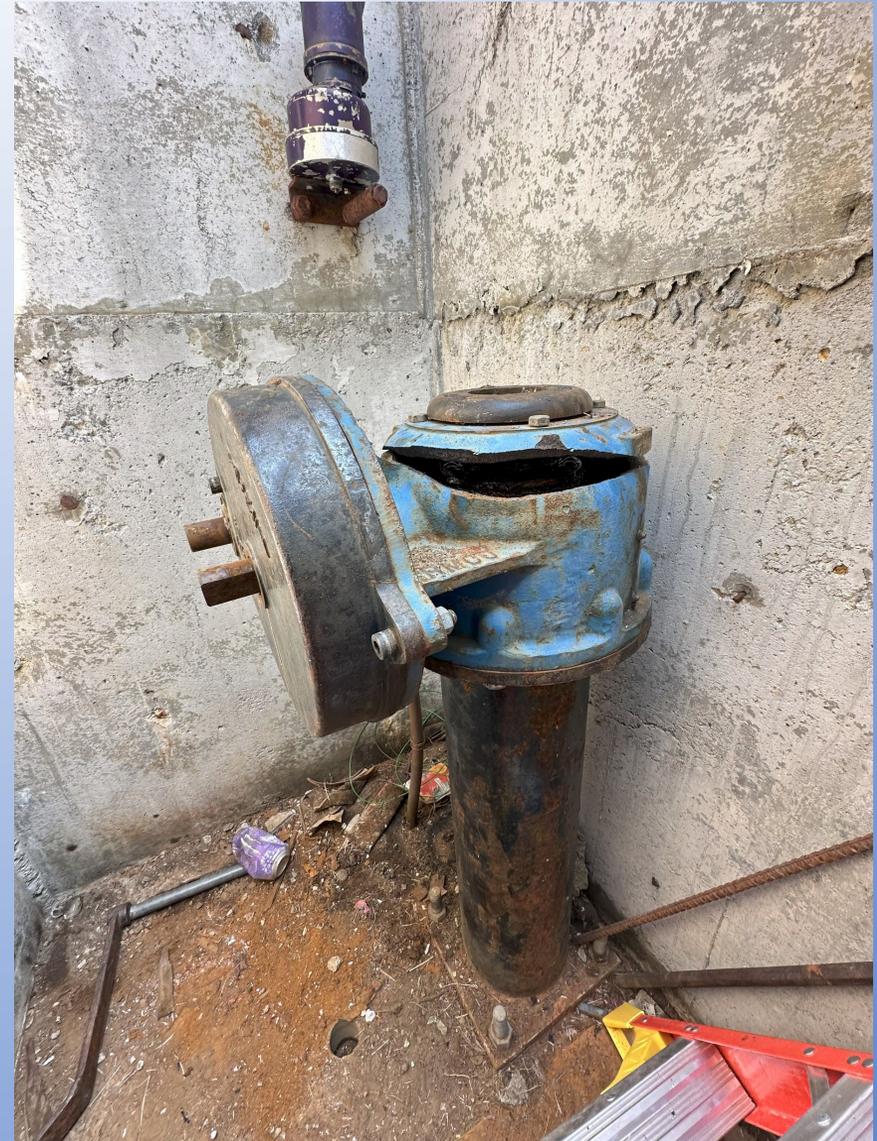
July 17, 2024

Existing Gearbox Failed During Initial Operation of the Year, with Full Reservoir Pool on Original Gate.

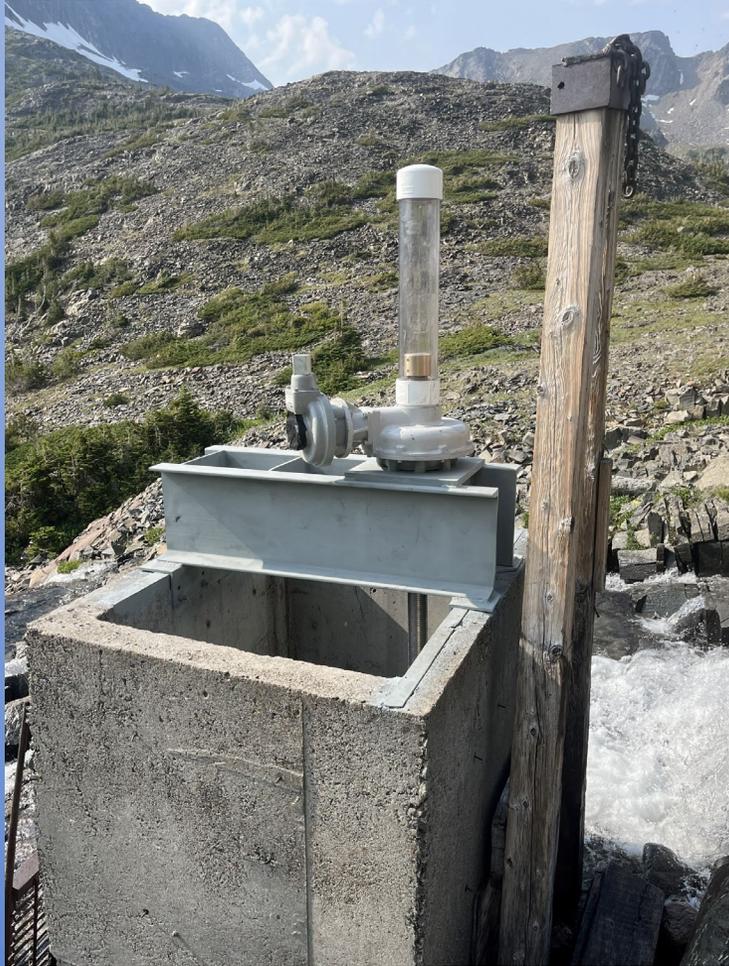
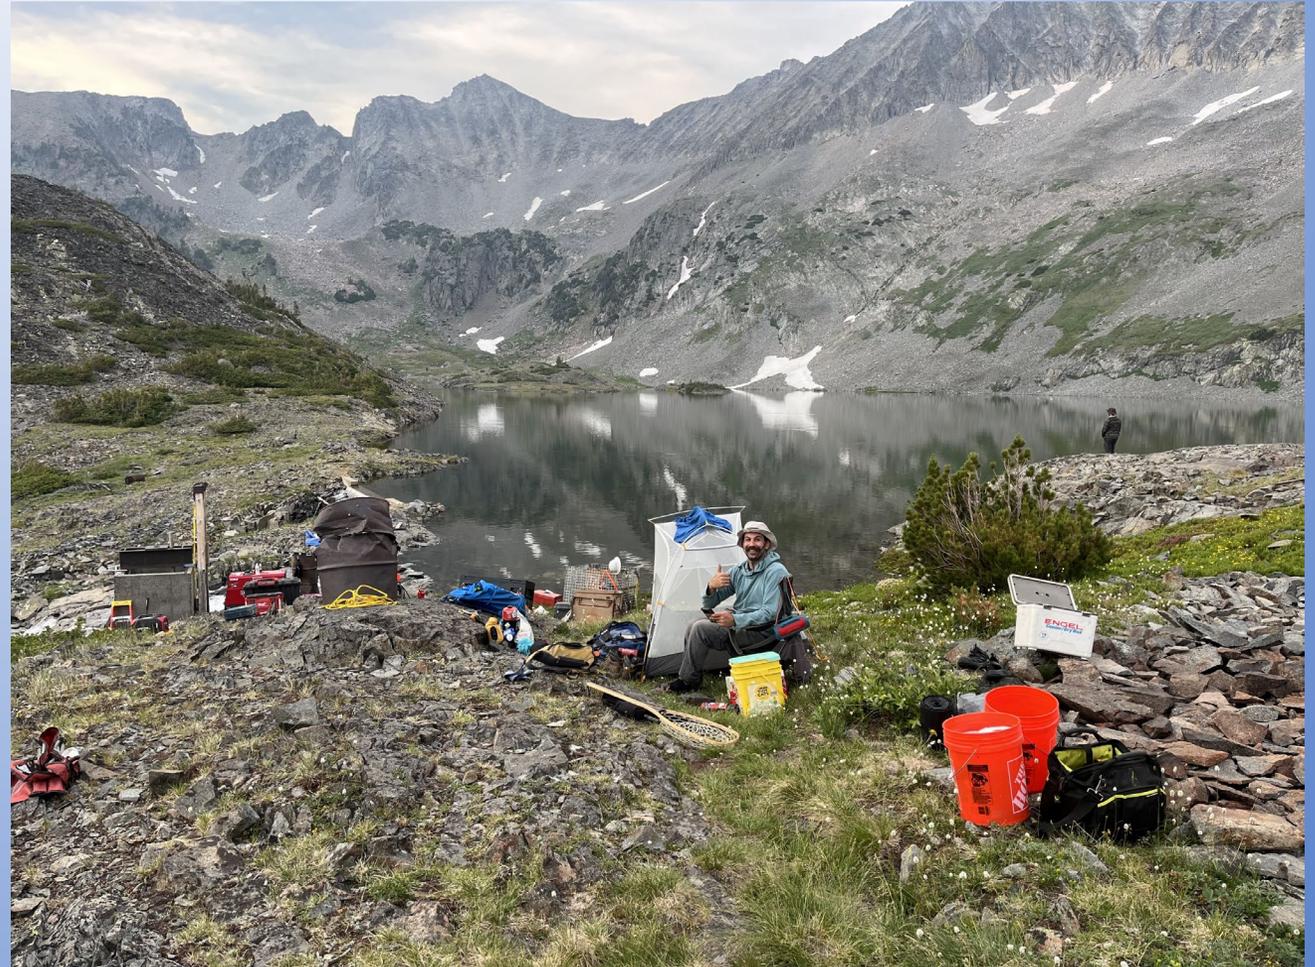
EMERGENCY REPAIR COMPLETE WITH 2 DAYS OF ONSITE WORK

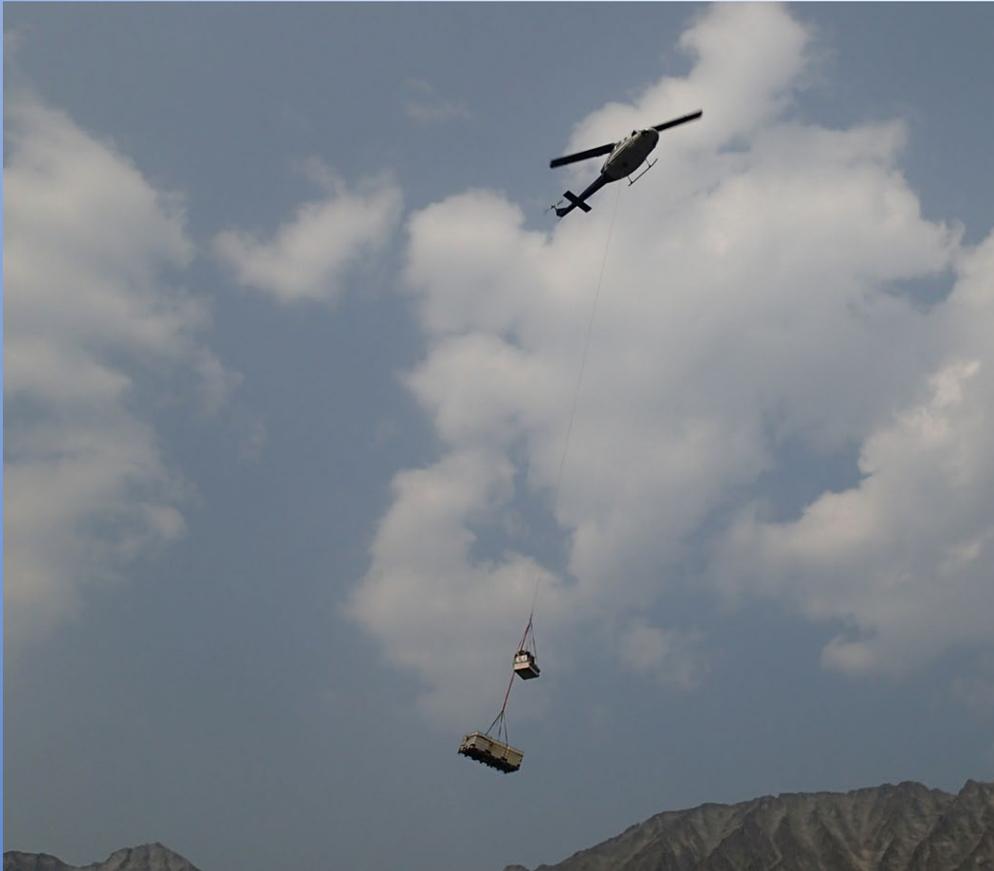
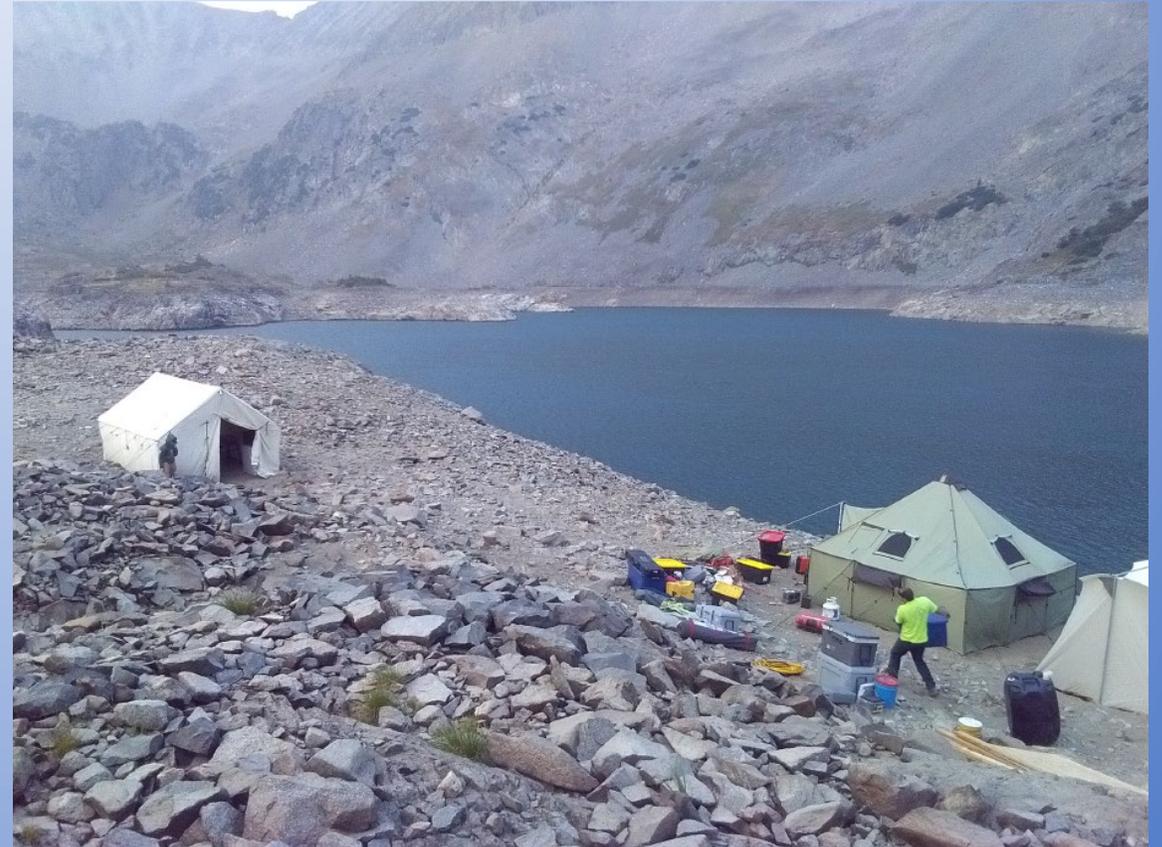
The Emergency Repair worked, but it did not address the primary causes of the gearbox failure...exposure of the gearbox to weather

- Install Permanent Structure Over Gearbox
- Install Operation System to Operate Gate Remotely
- Install Telemetry and Monitoring System to Observe and Monitor Reservoir, System, & Weather Conditions
- Install Reservoir Level Monitoring System
- Install Outlet Flow Monitoring System
- Install Saddle Dike to Protect Structure
- Repair Existing Dam

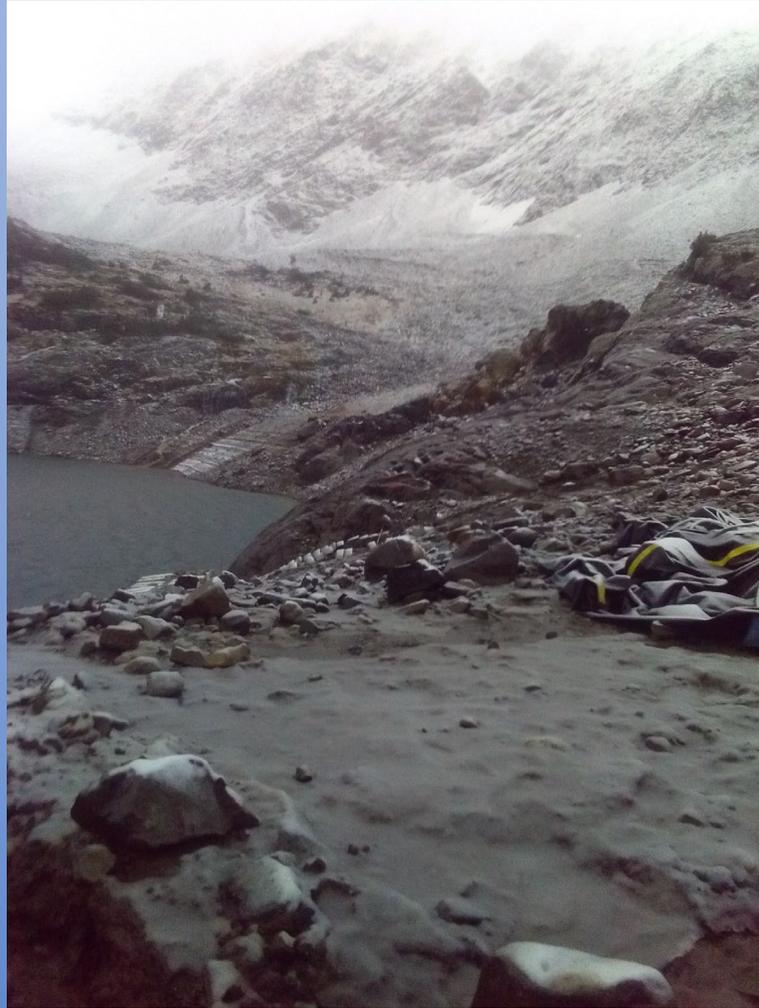
## CONSTRUCTION PROBLEMS

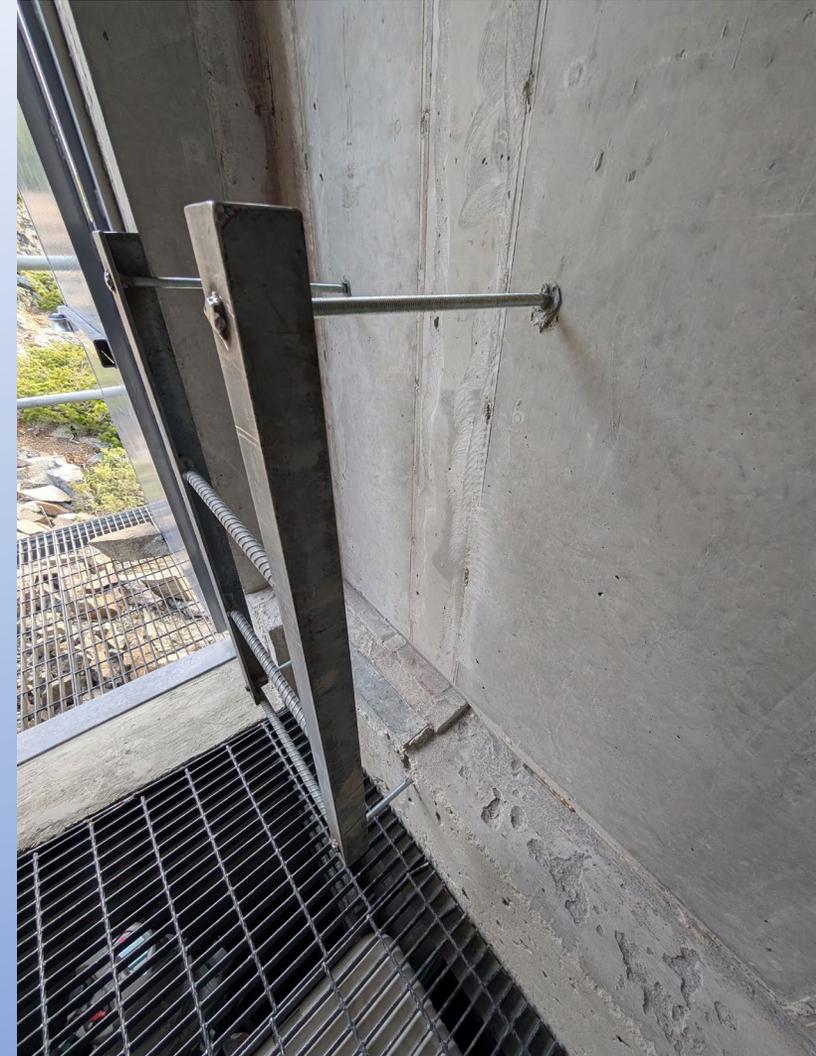
- Once we didn't have that "thing", and the "thing" couldn't wait.
  - The 3/4-inch anchor bolts and nuts we had brought for the ladder went missing somewhere (presumably flown out by accident).
  - So, anchor bolt epoxy and a welder did the trick.
  - The ladder was properly "tested" prior to being put into service.

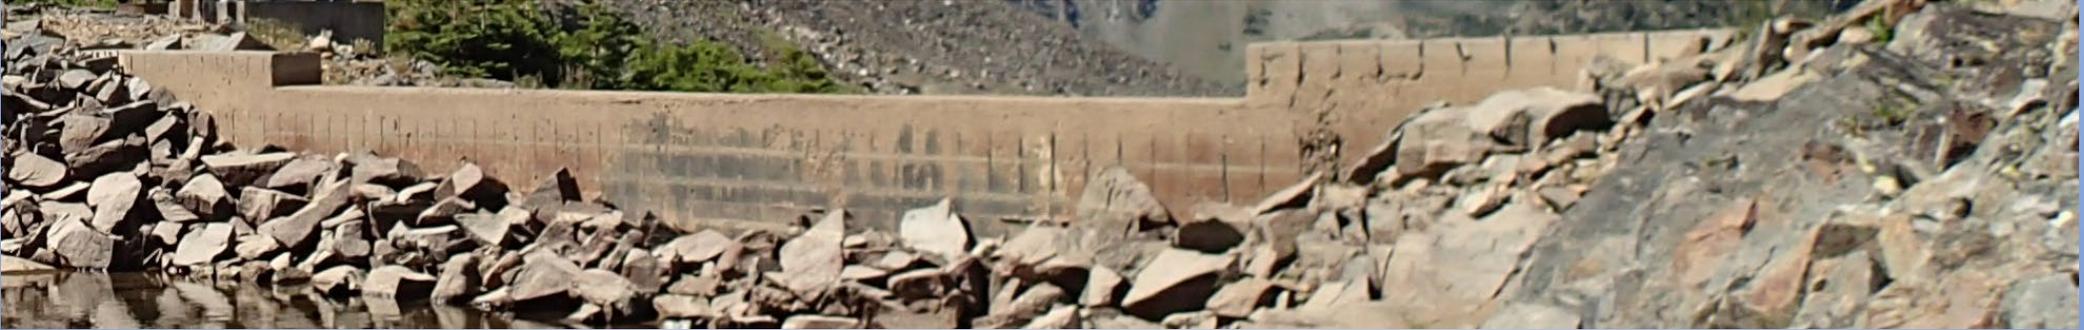
Before

- Concrete was deteriorating due to corrosive water
- Repaired cracks and installed epoxy cured cement coating to surface
