Visual Inspections of Outlet and Drain Conduits on a 5-year Cycle

Chadrick Hill – Civil Engineering Specialist,
The Montana Department of Natural Resources and Conservation,
Water Resources Division

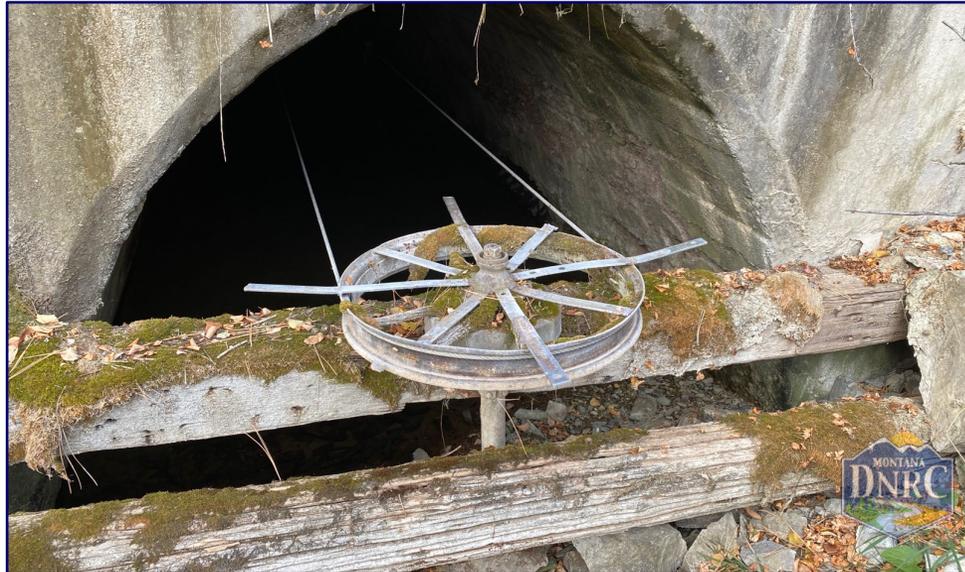
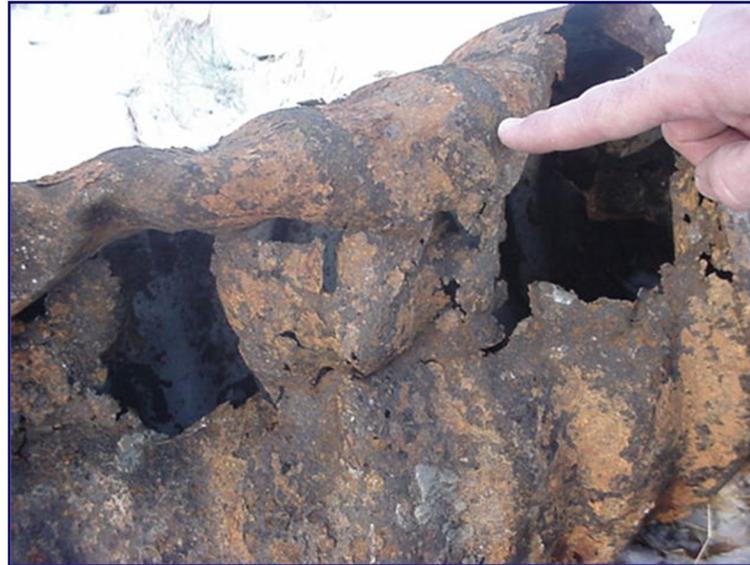
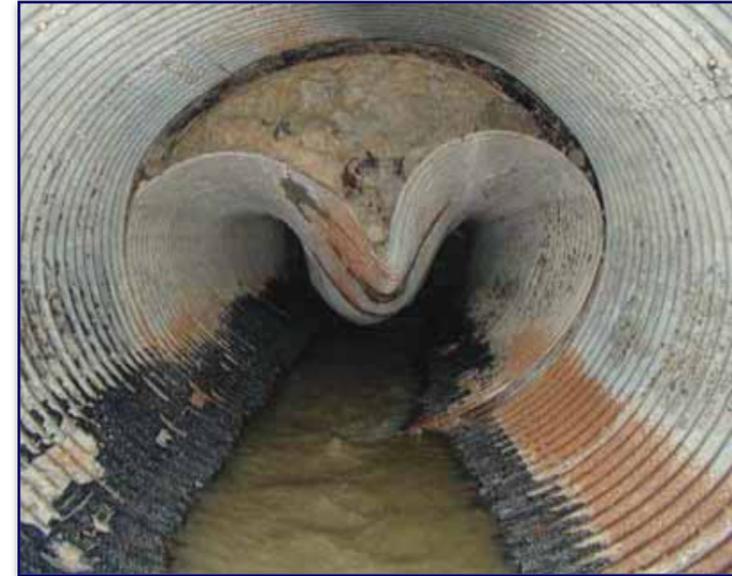
Deficiencies found include inoperable gates, deterioration of CMP, worrisome cracks in concrete, and concerning pipe deflection.

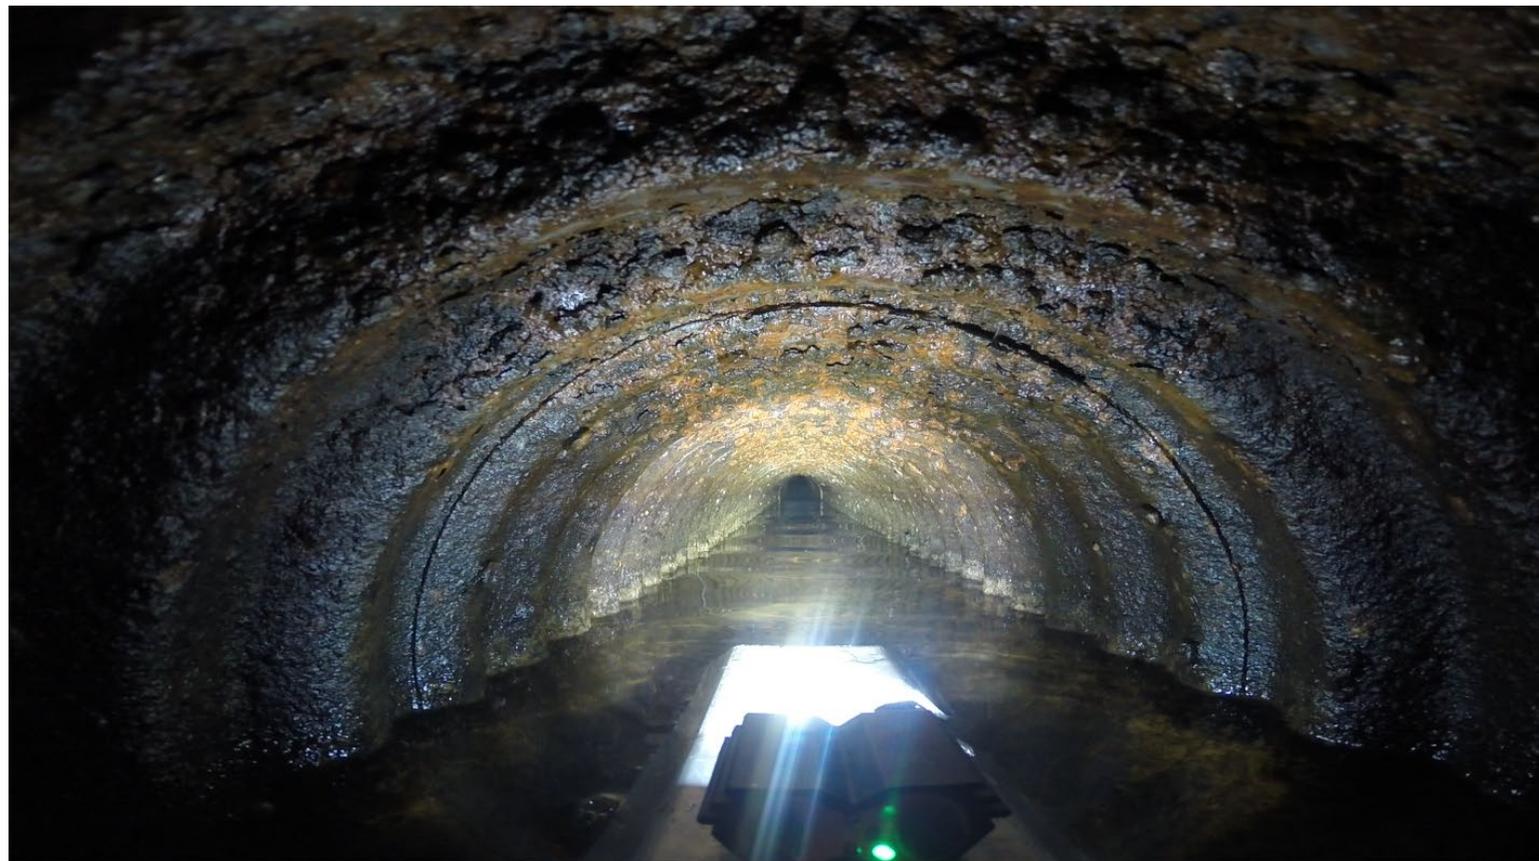
- **CMP**

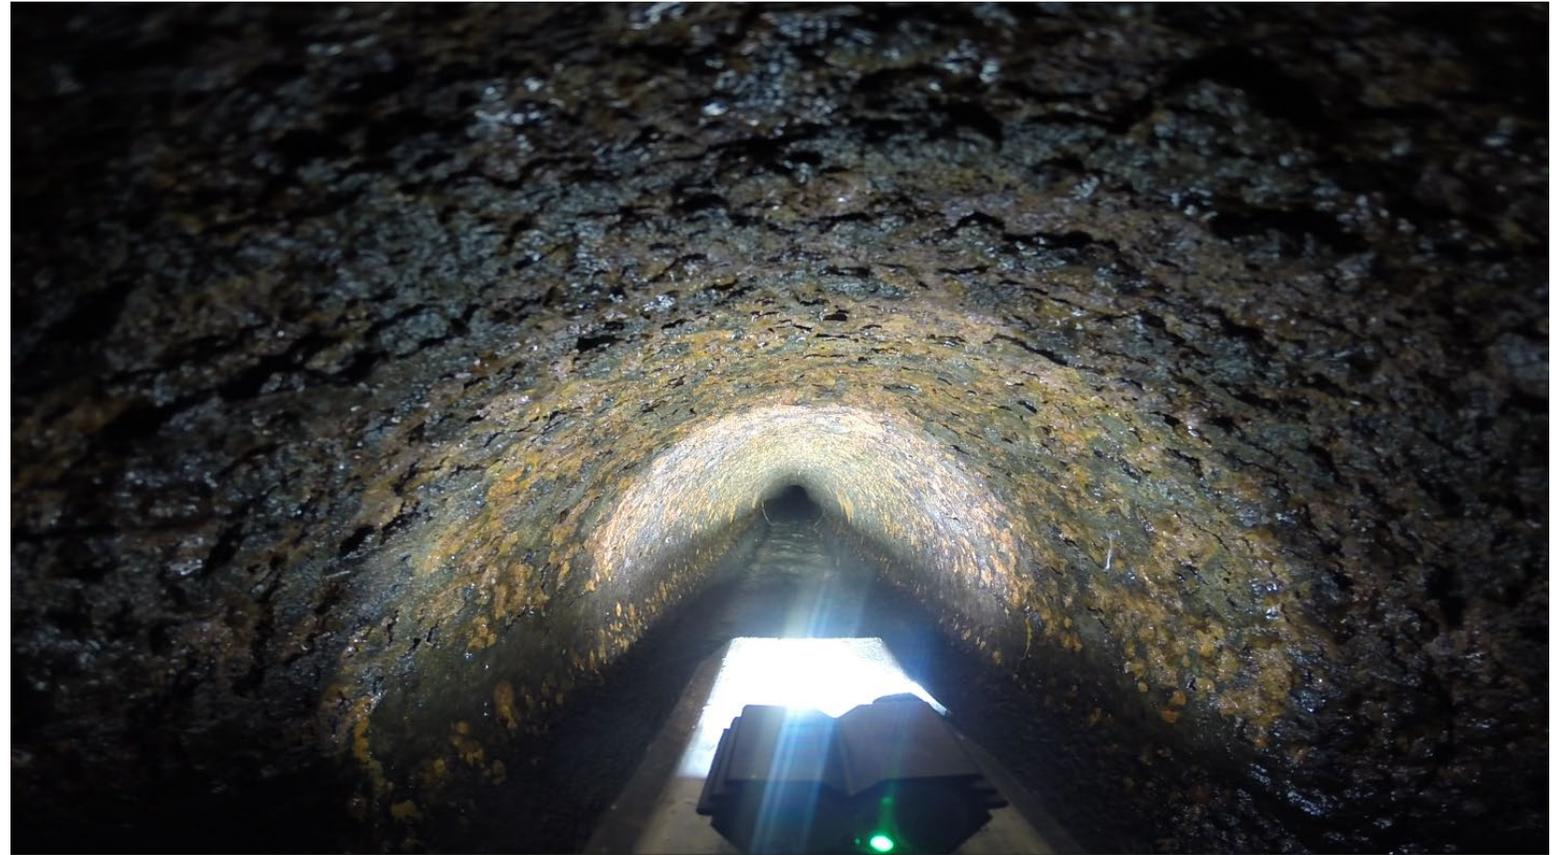
- CMP
- **Concrete**

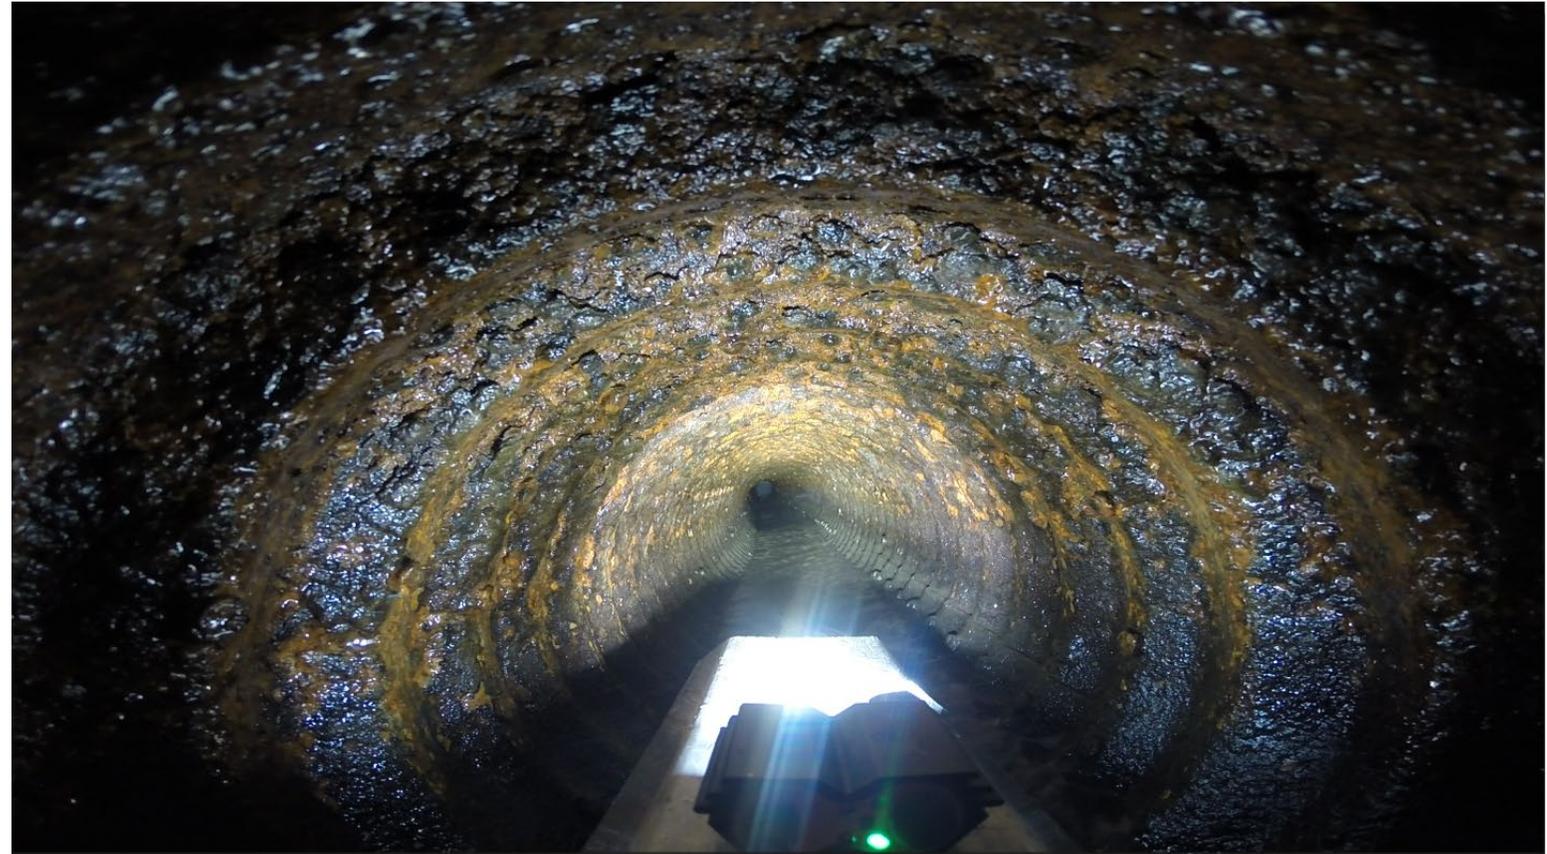
- CMP
- Concrete
- **CMP**

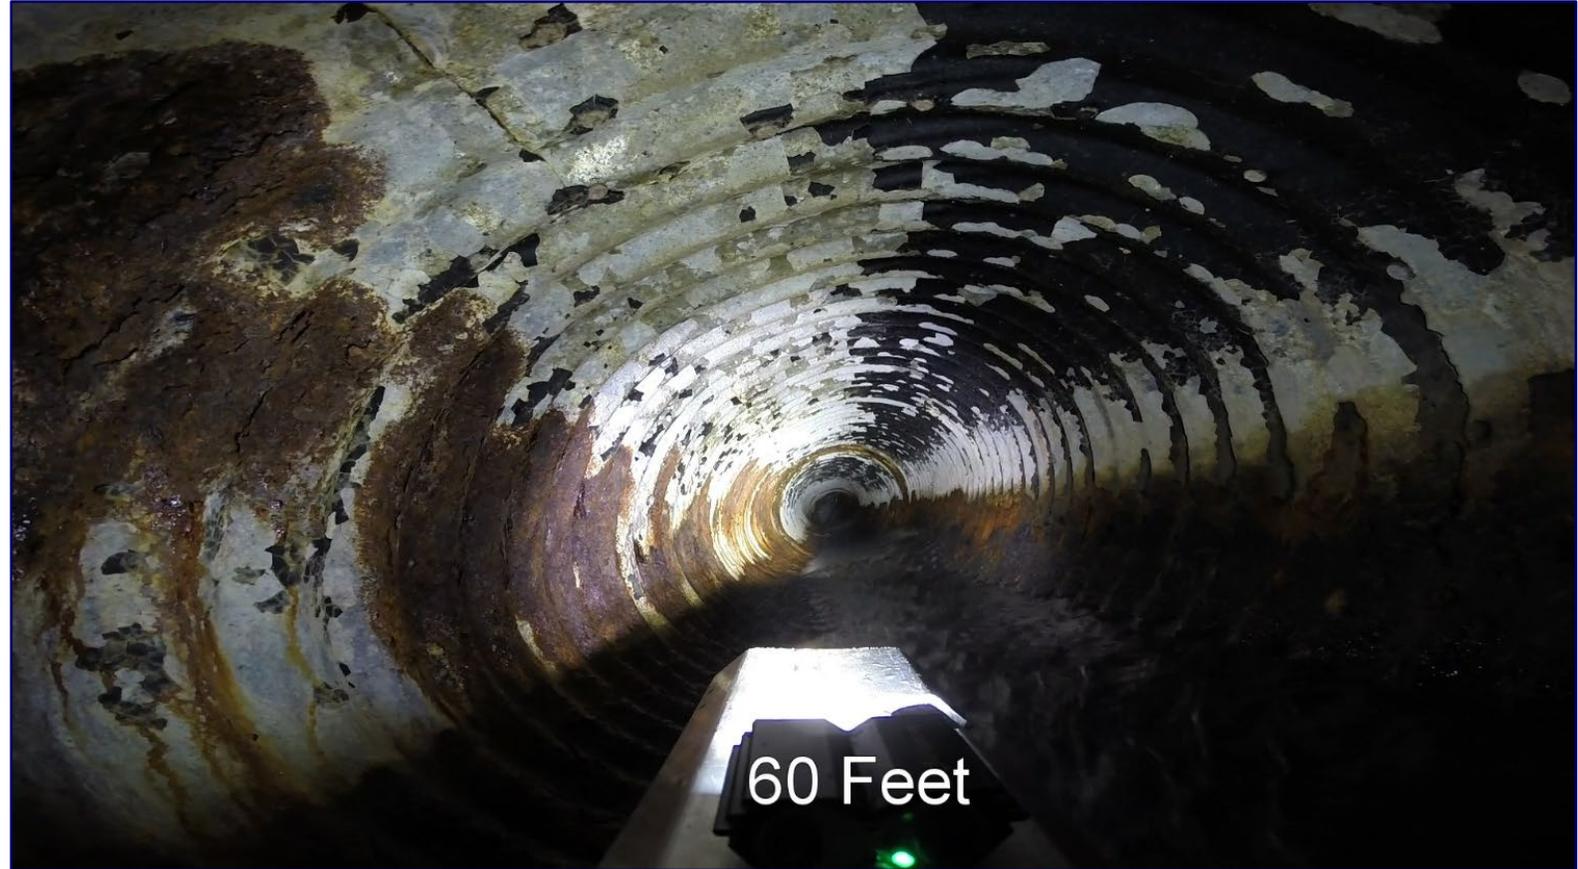
- An inspection of the pipe was conducted during a field tour/workshop in 2015
- 60 Feet

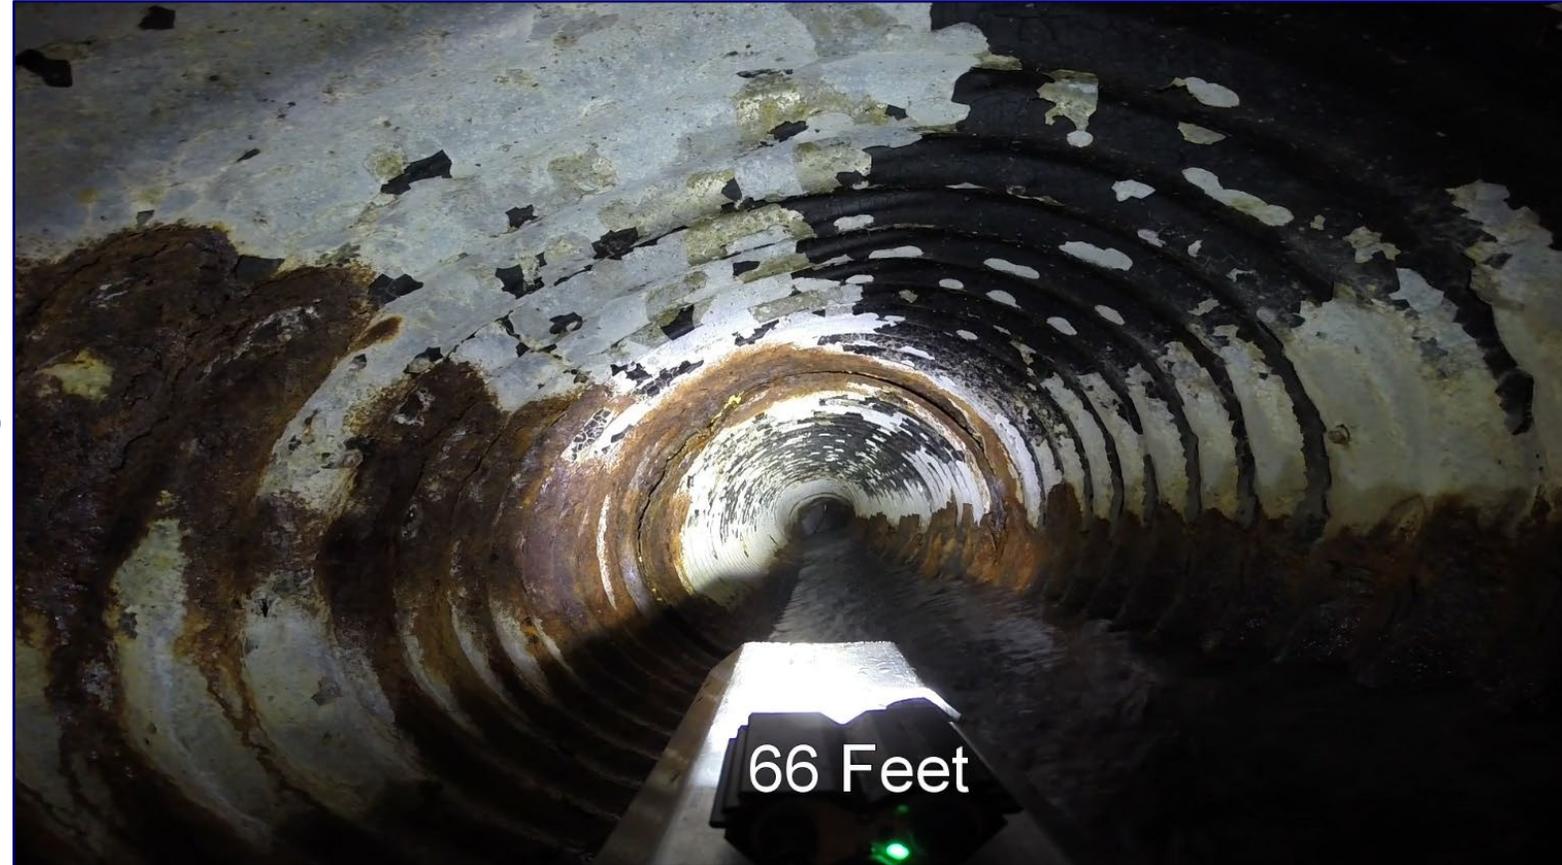
- An inspection of the pipe was conducted during a field tour/workshop in 2015
- 66 Feet

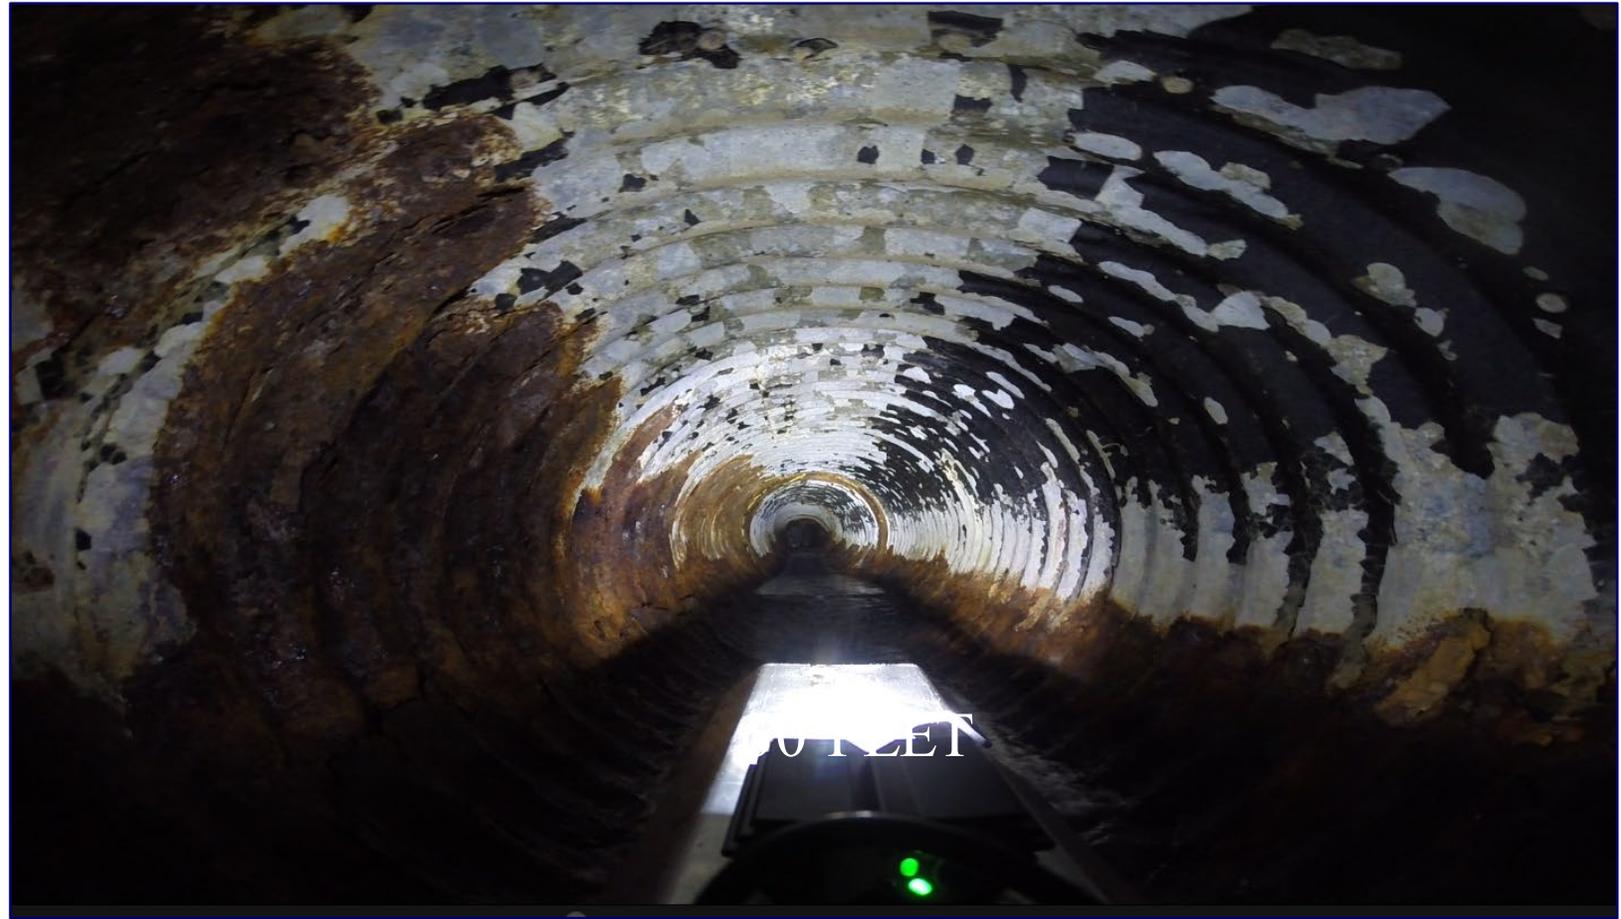
- 2018 Inspection
- 60 Feet

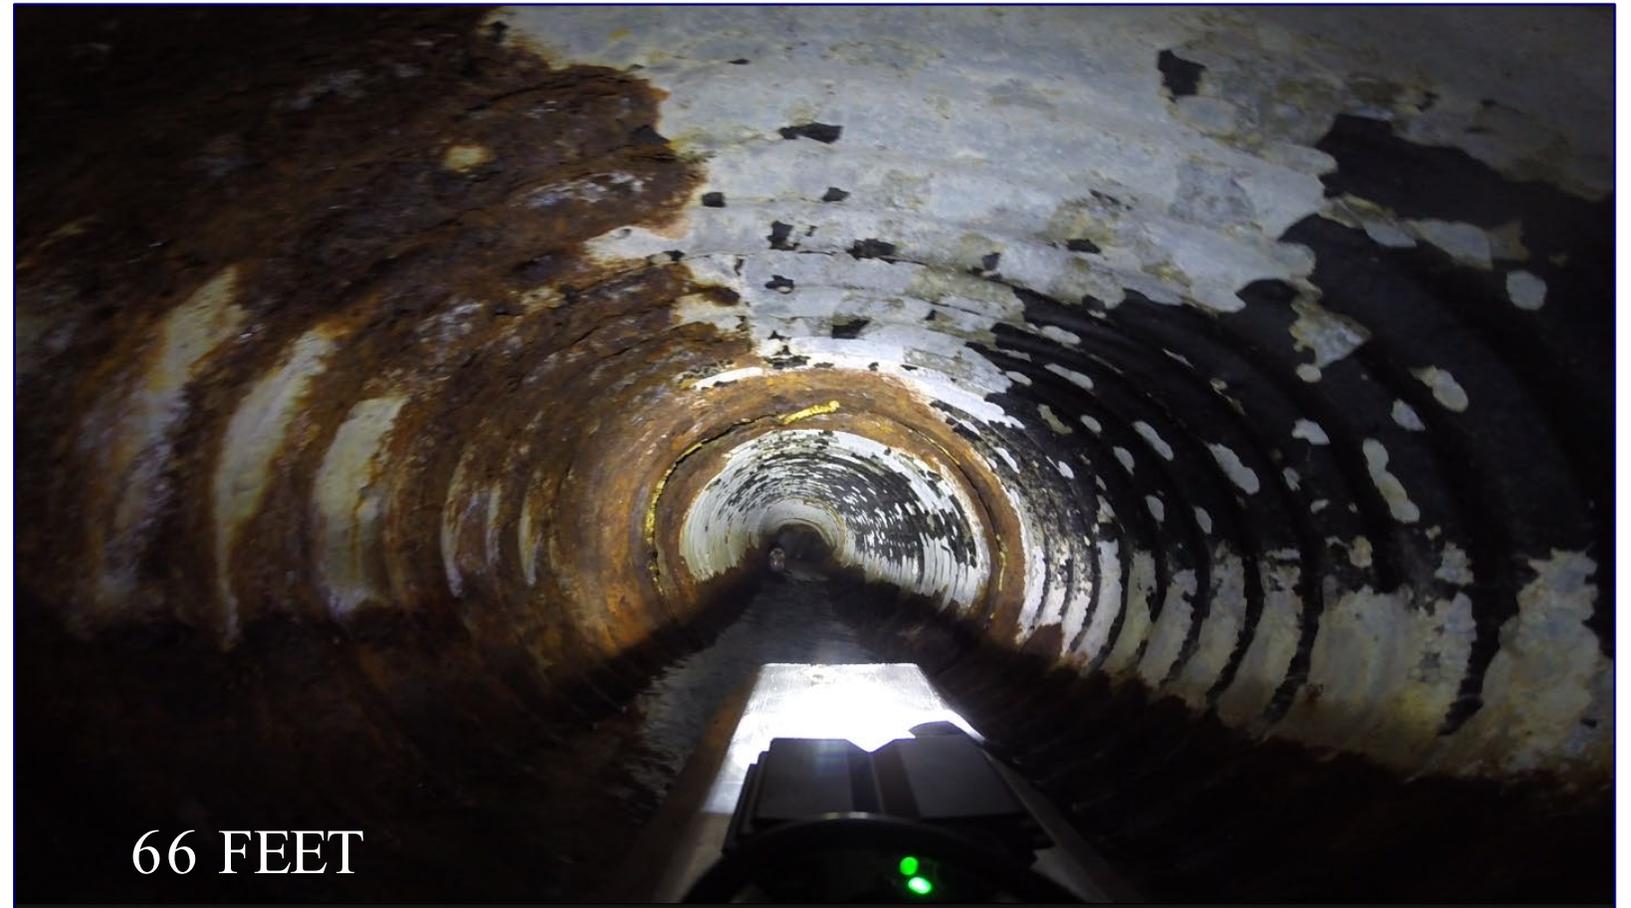
- 2018 Inspection
- 66 Feet

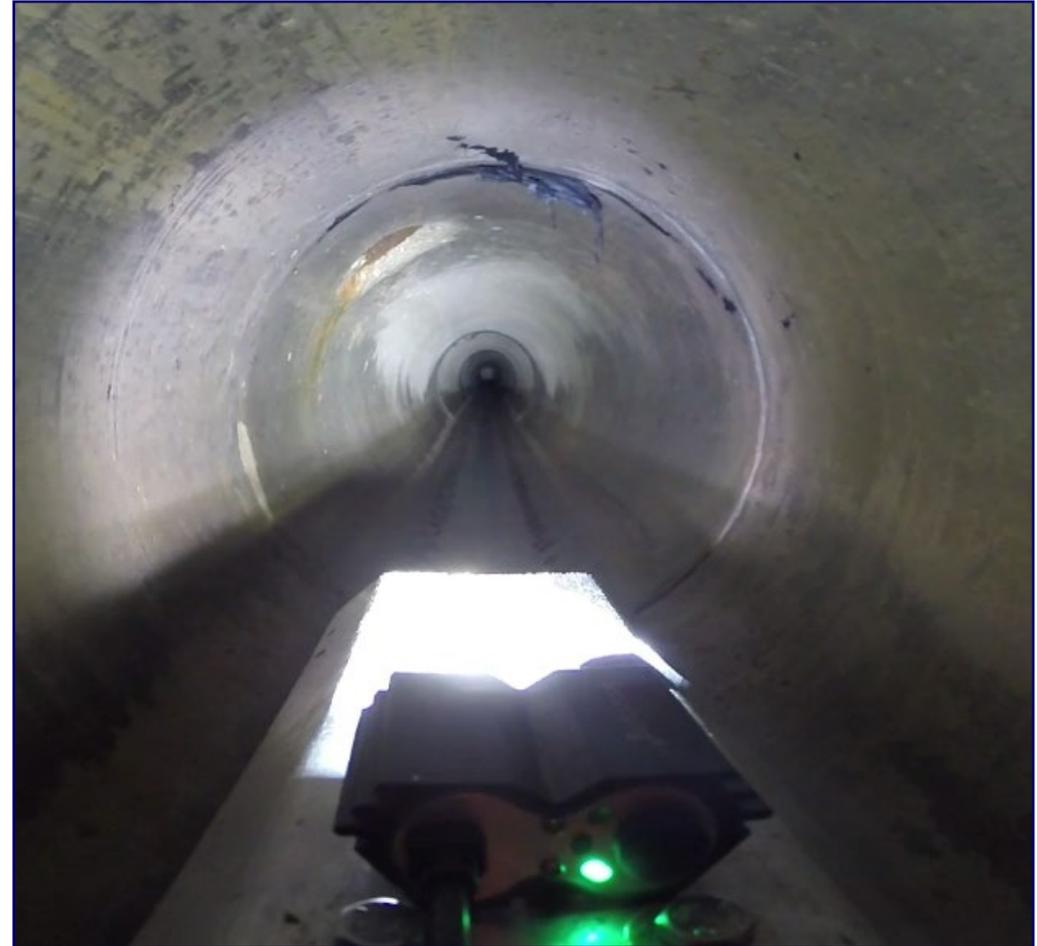
- **During the inspection, a hole was found in the concrete exposing the steel cylinder**

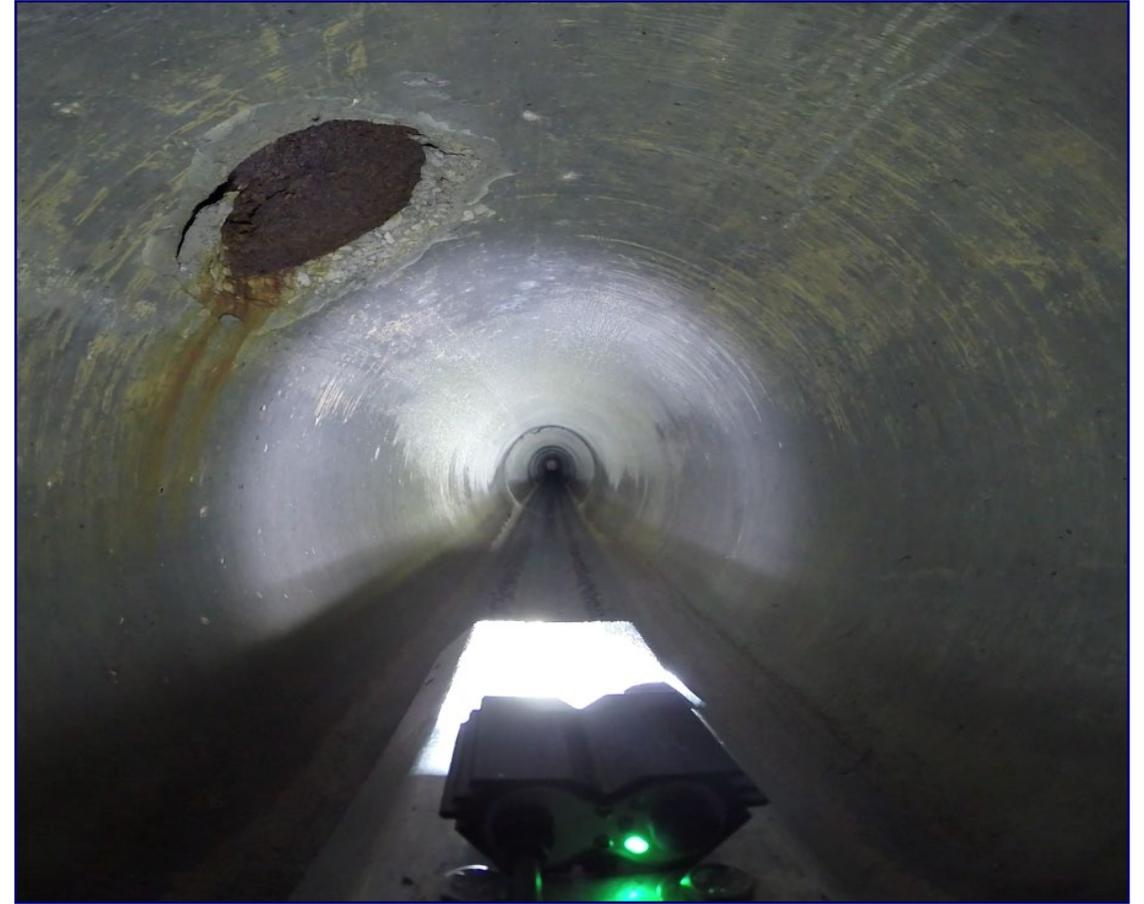
- During the inspection, a hole was found in the concrete exposing the steel cylinder
- **It was located about 133' from the downstream end of the outlet**

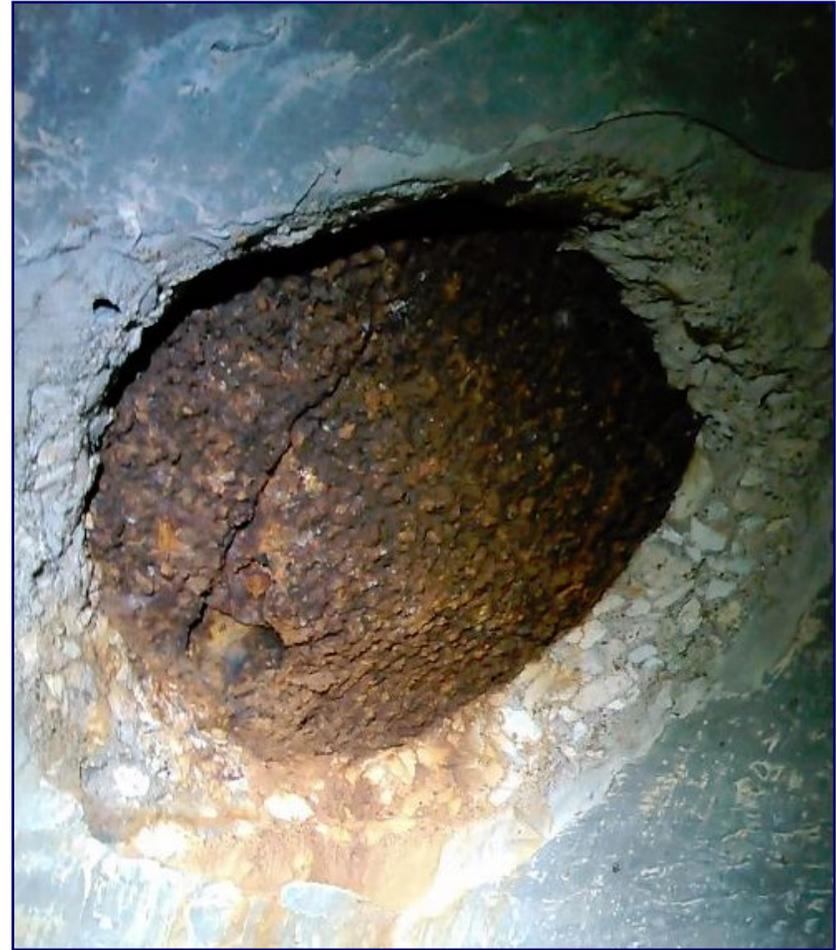
- During the inspection, a hole was found in the concrete exposing the steel cylinder
- It was located about 133' from the downstream end of the outlet
