From a Blemish to a “Butte”

Rehabbing Butte’s Basin Creek Dam #1

Justin Evertz, PE, Great West Engineering

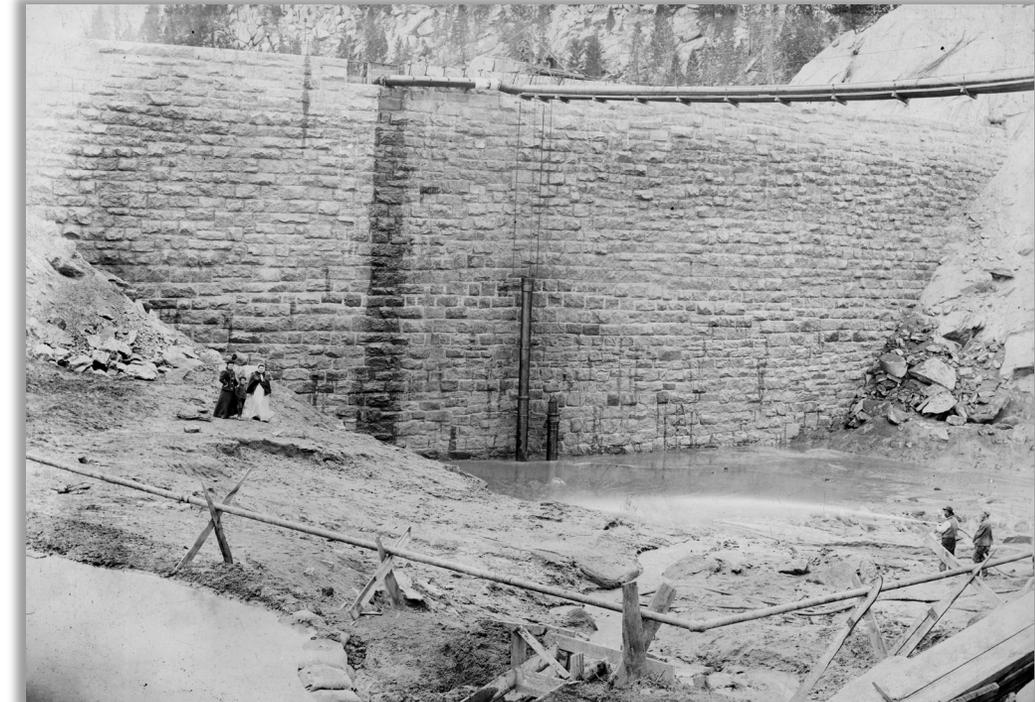
Original Construction

Year: 1897

Design: Curved Masonry

Height: 88 feet

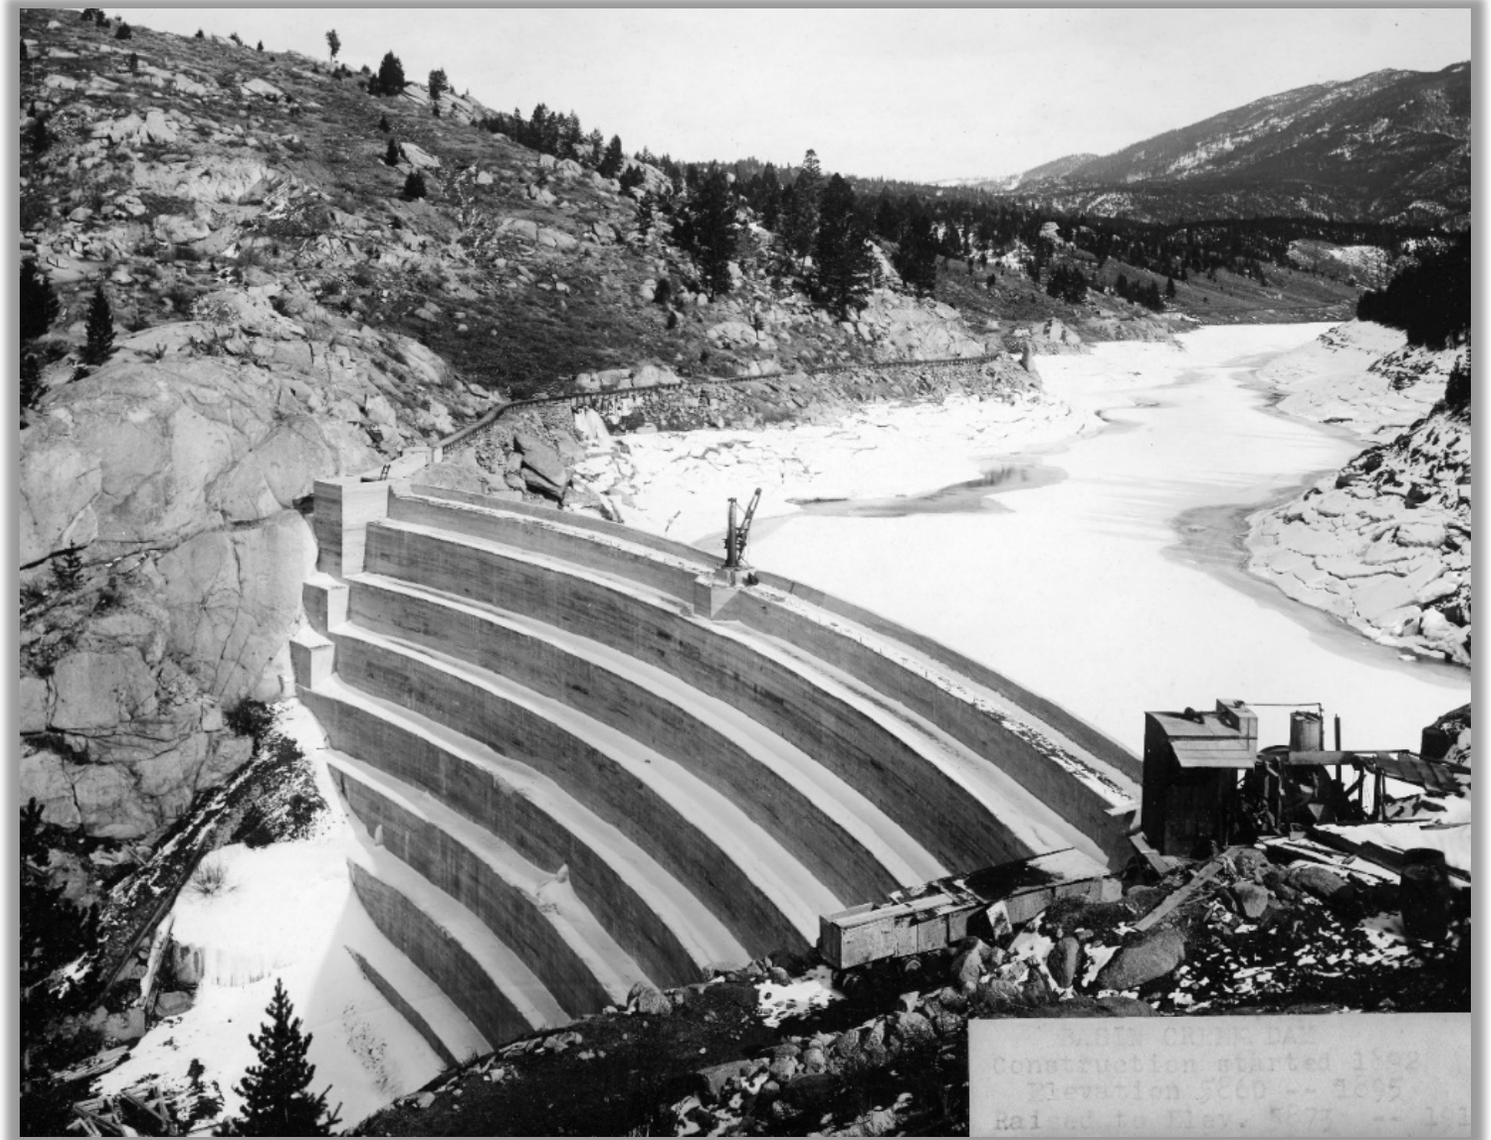
Modification

Year: 1913

Design: Mass Concrete

Height: 101 feet

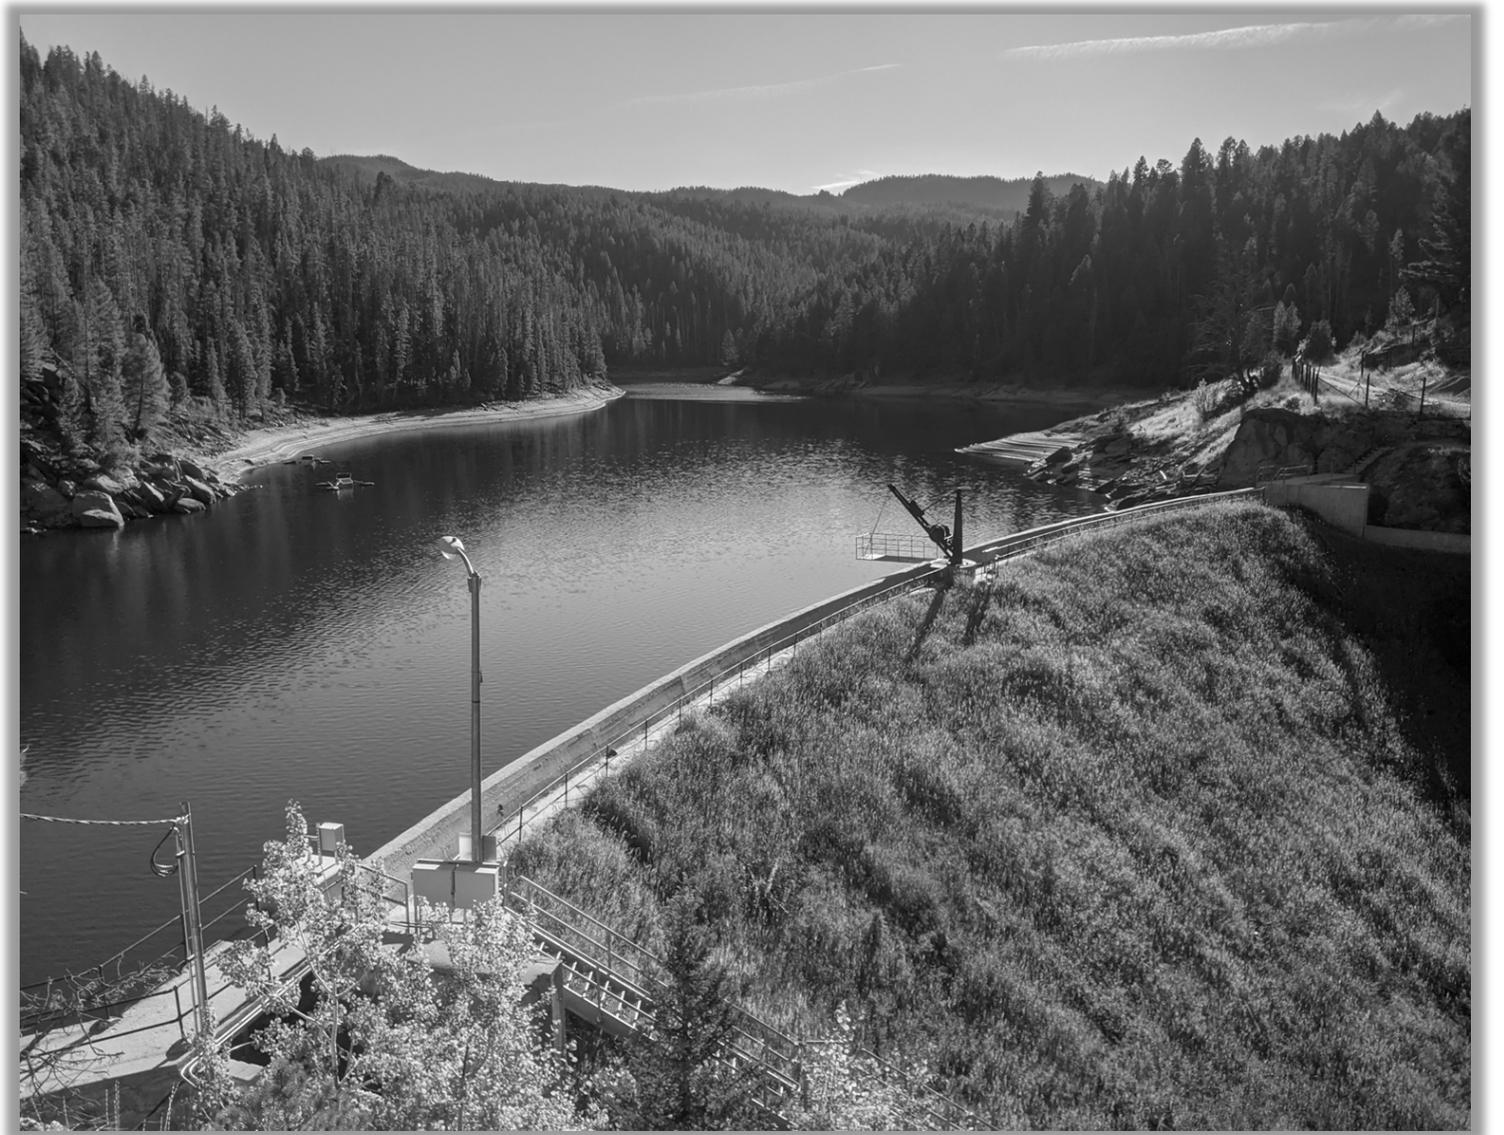
Modification

Year: 1930s

Design: Embankment Berm

Height: 101 feet

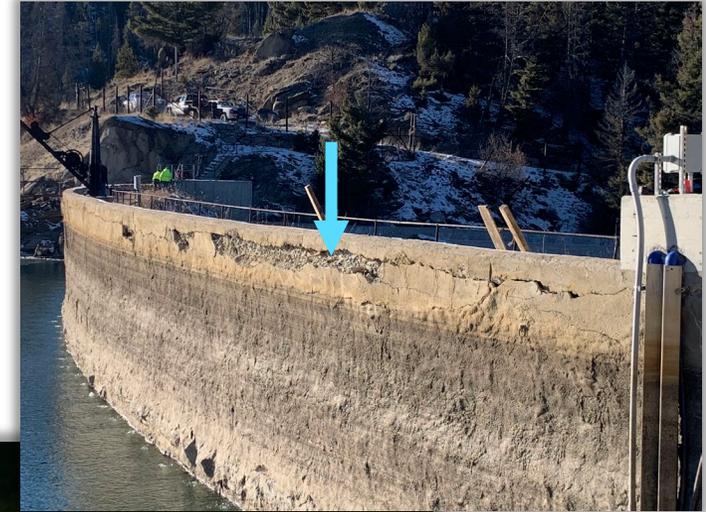
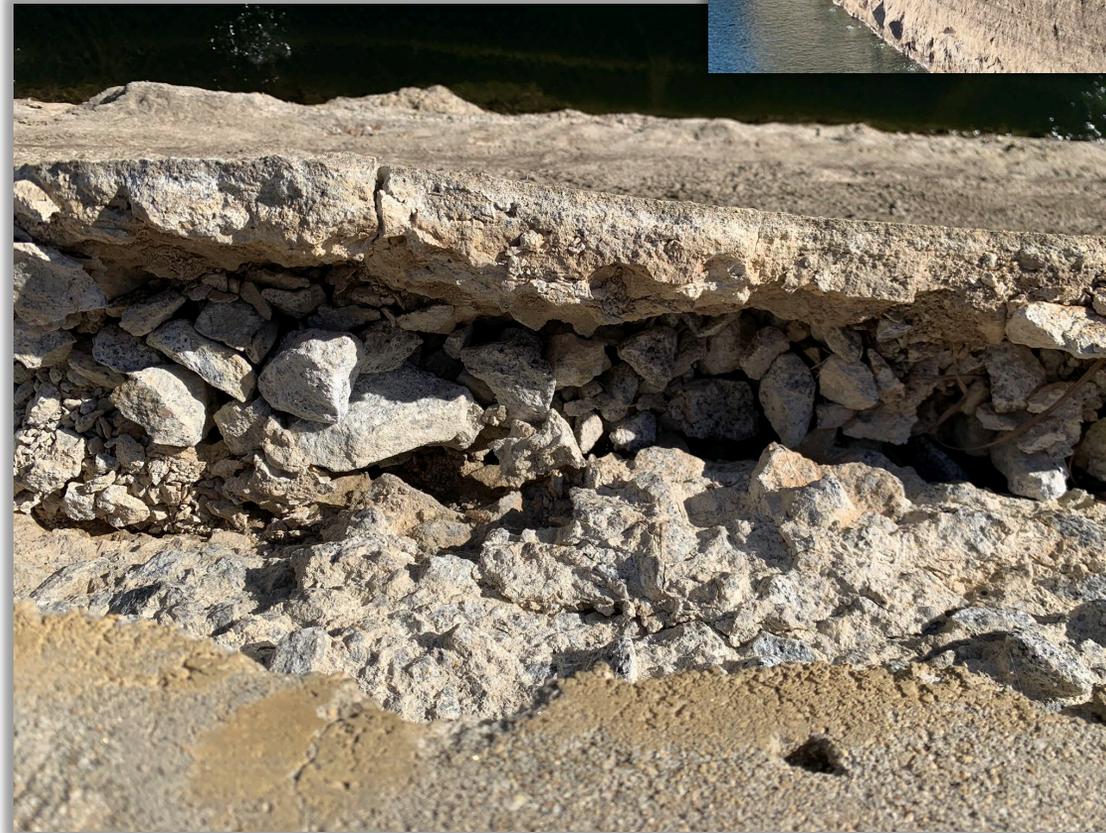
Deterioration of upper mass concrete had been identified in prior inspections and was being monitored.

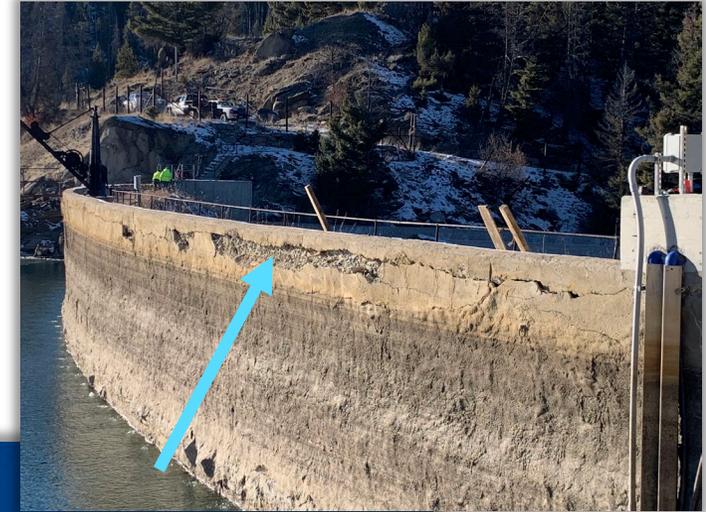
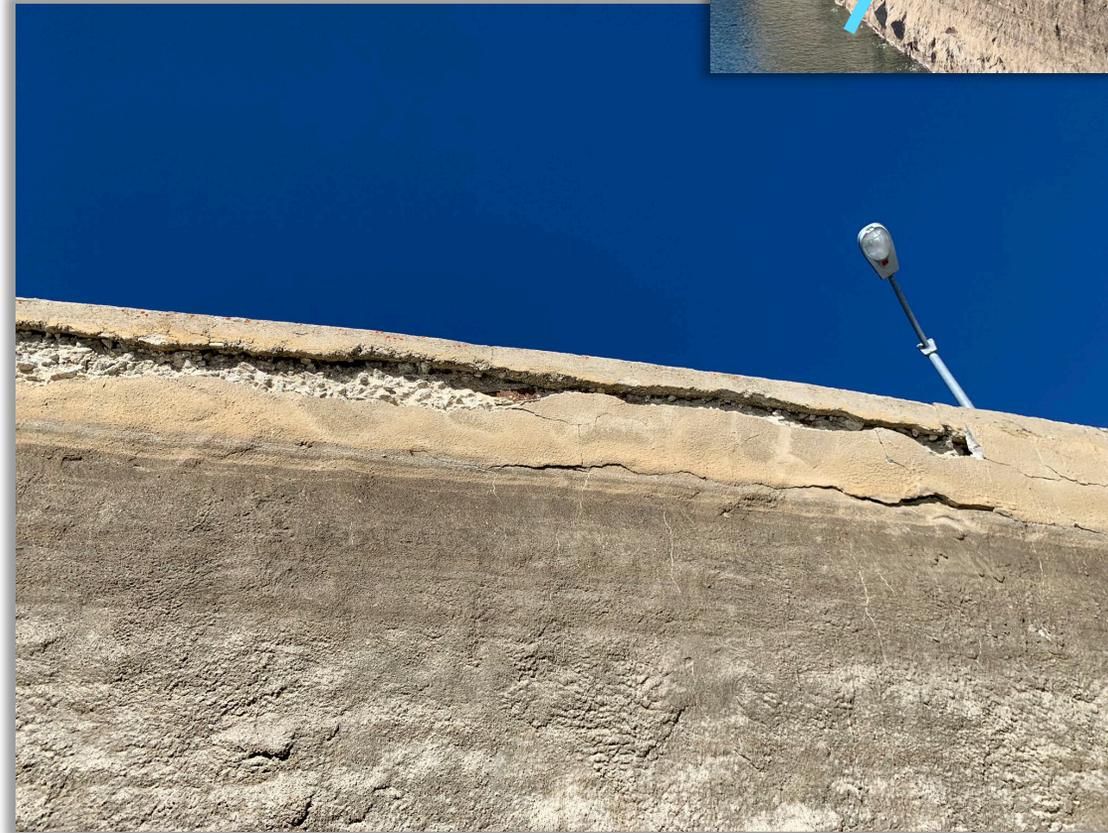
The 2019 inspection noted the rate of deterioration had increased significantly.

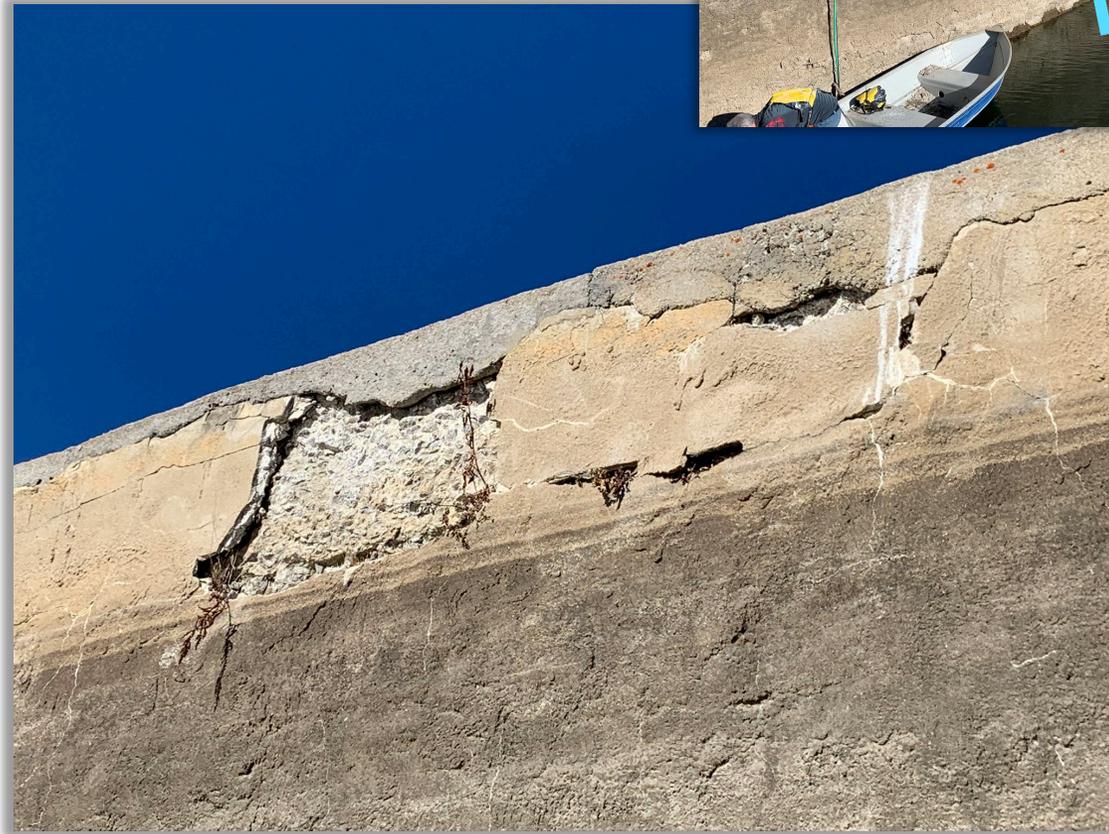
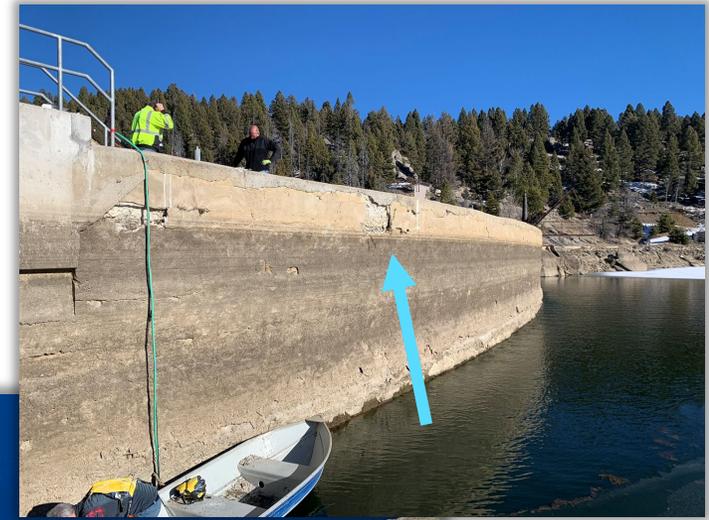
The 2019 inspection recommended that a plan be developed to address concrete deterioration within the next year.

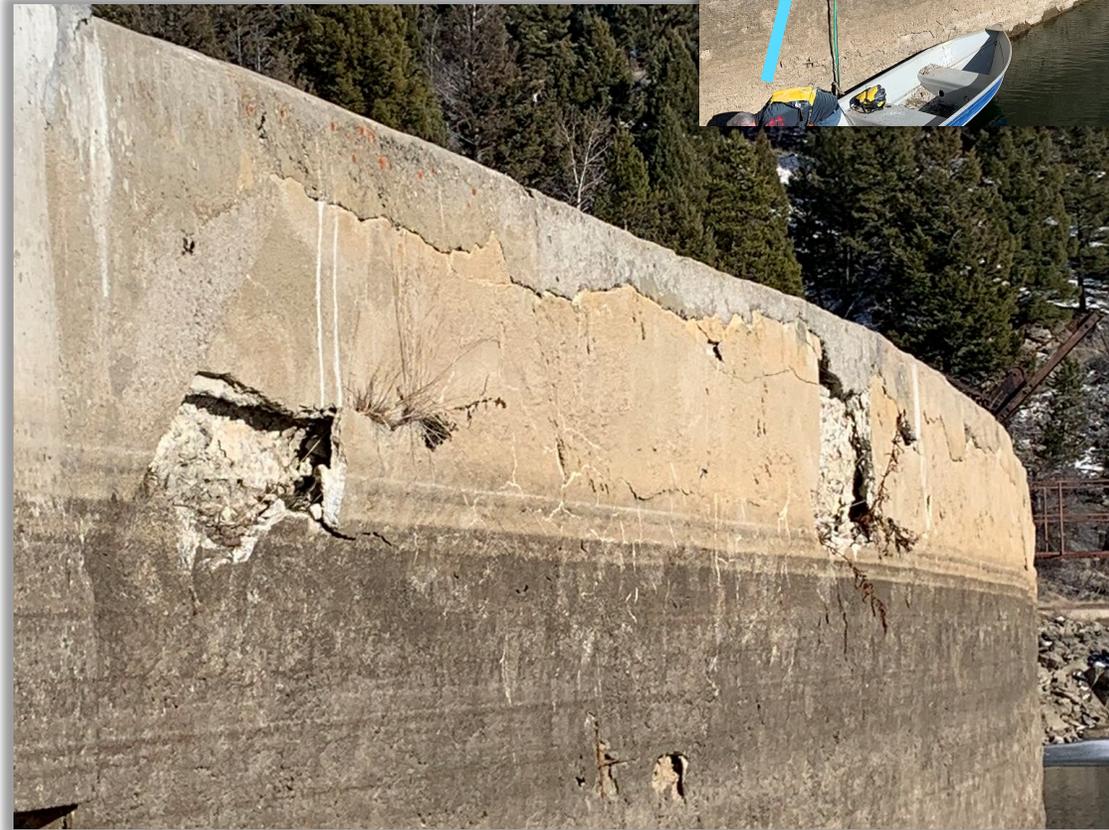
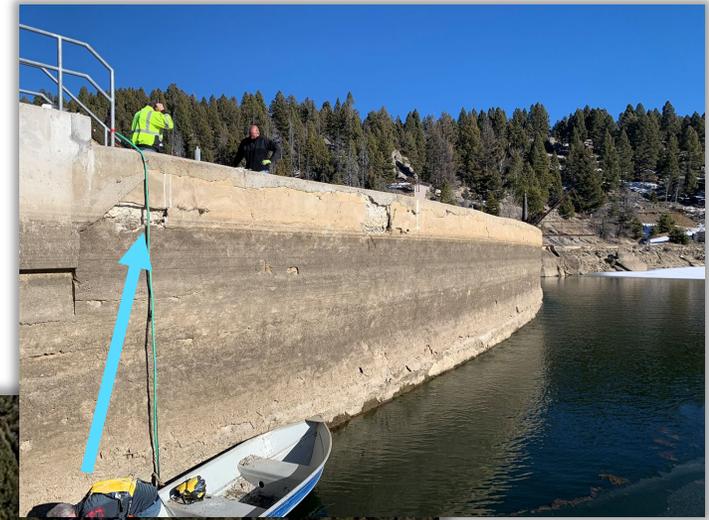
Comments provided by Montana DNRC expressed concern and if the deterioration was left unaddressed, DNRC would impose reservoir restrictions.

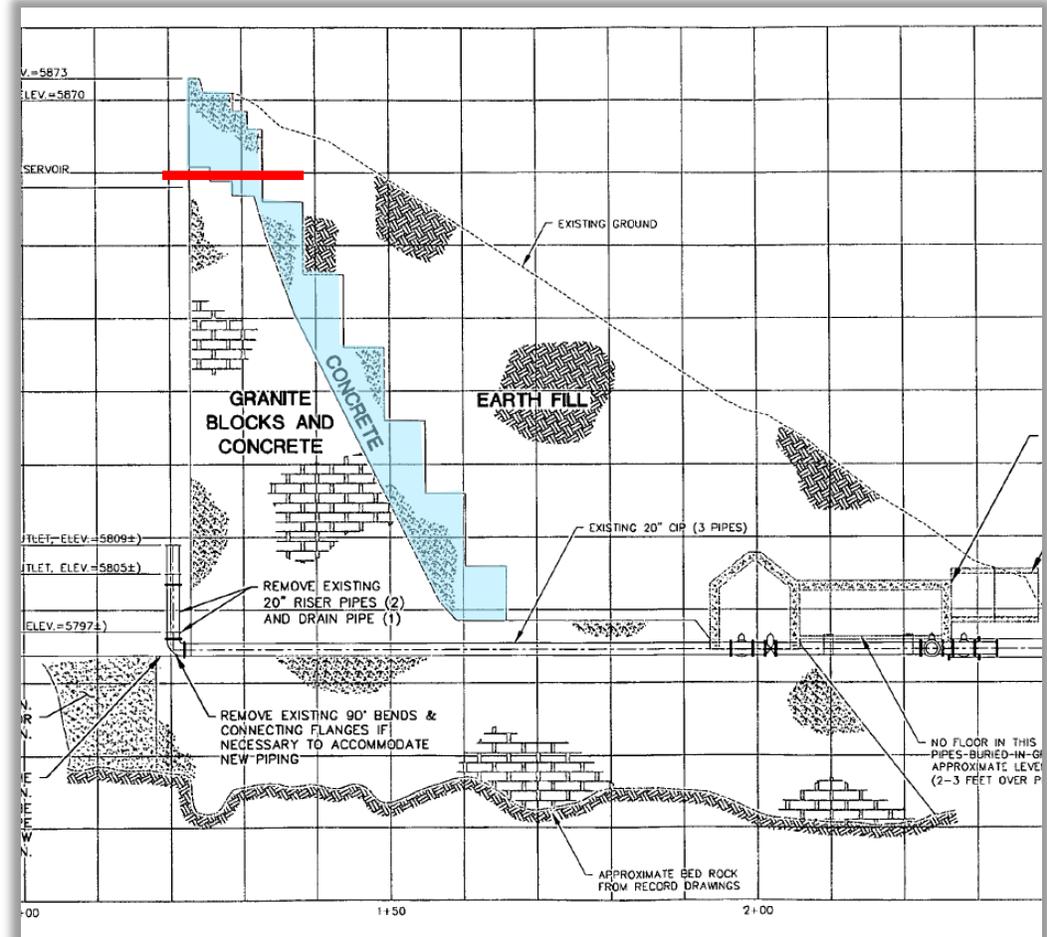
STABILITY ANALYSIS

- Structural Evaluation
 - Critical analysis plane – mass concrete/masonry cold joint
 - >500-year flood overtops upstream parapet
 - Stability not adequate for overtopping conditions

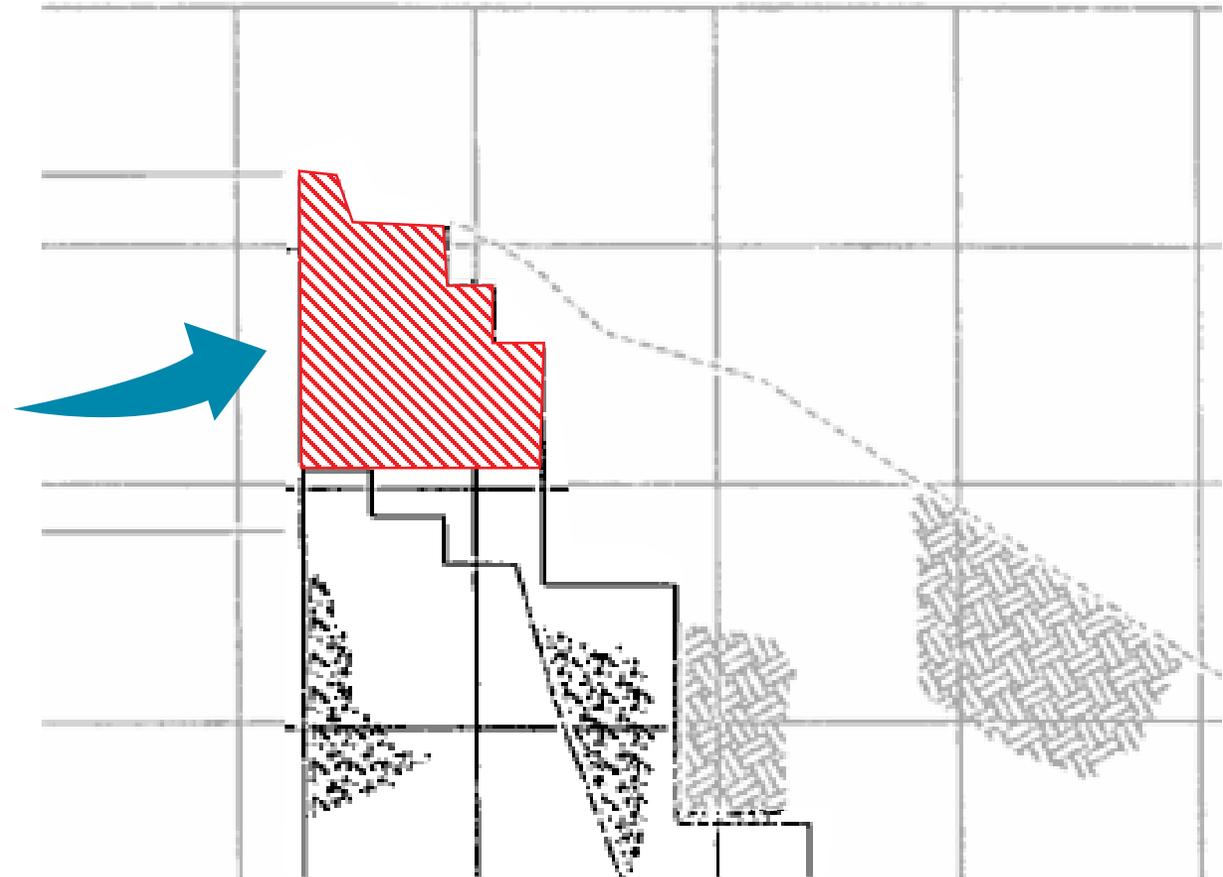
ALTERNATIVE #3

Fully remove
and replace the
top 13-feet of
the dam

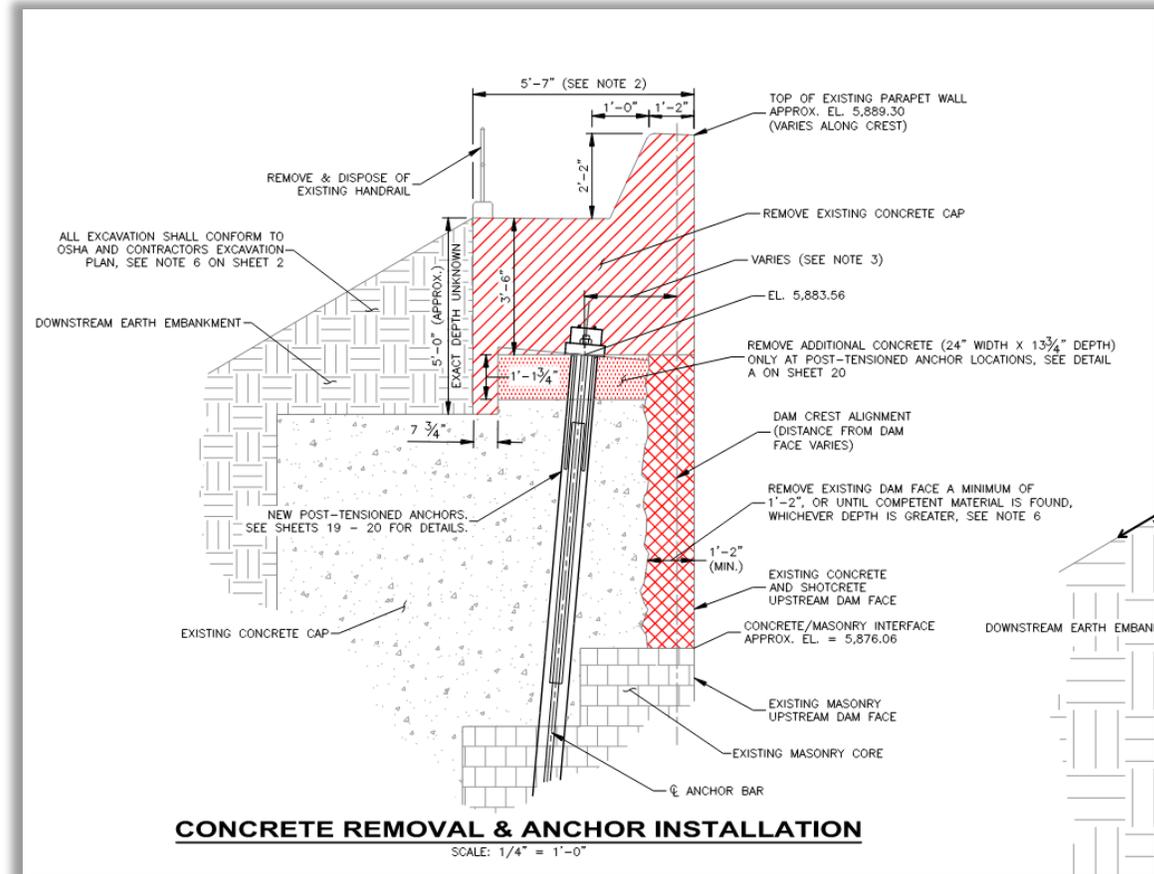
CONCRETE OVERLAY

- Address concrete deterioration
 - Remove deteriorated concrete
 - Install reinforced concrete overlay
 - Prevent additional freeze-thaw damage

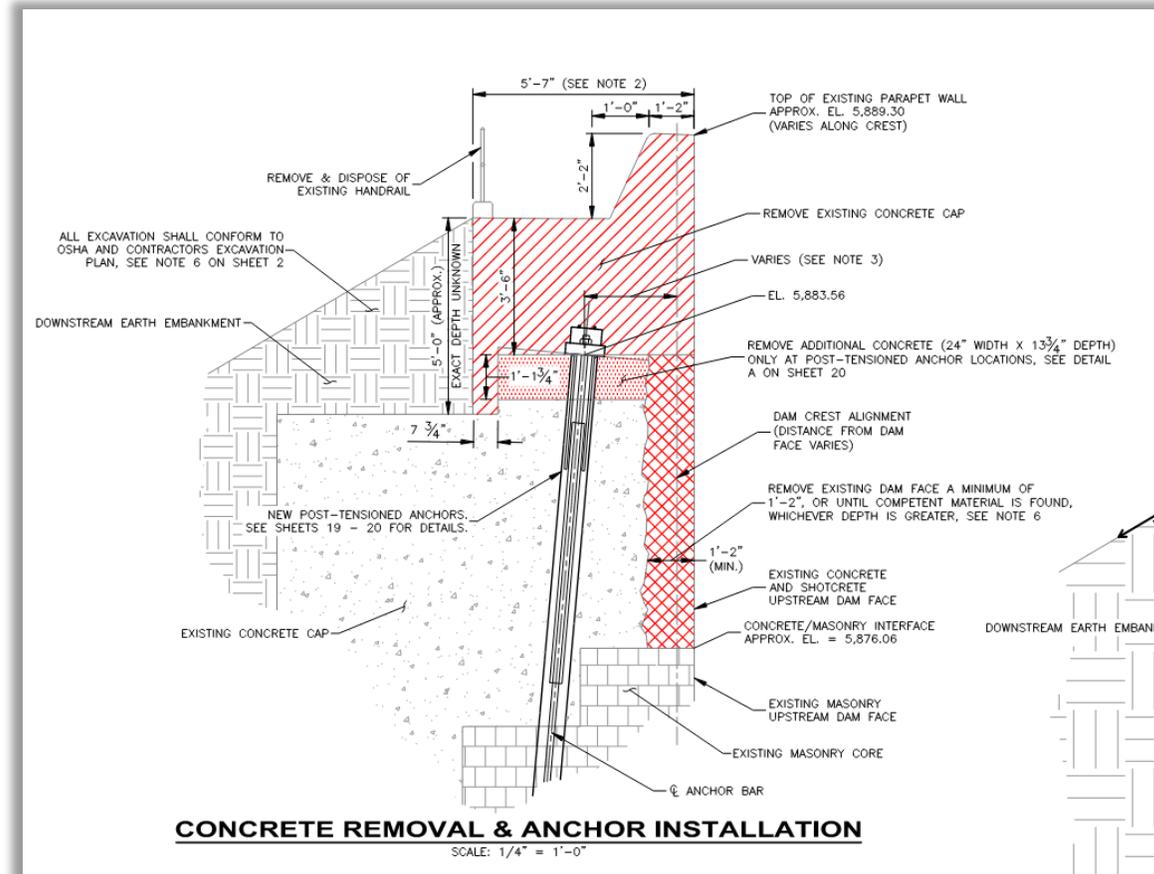
POST-TENSIONED ANCHORS

- Address stability concerns
 - Install post-tensioned anchors to stabilize upper mass concrete
 - Bar anchors chosen; more cost effective than strand anchors
 - Reinforced concrete bearing pad for anchors

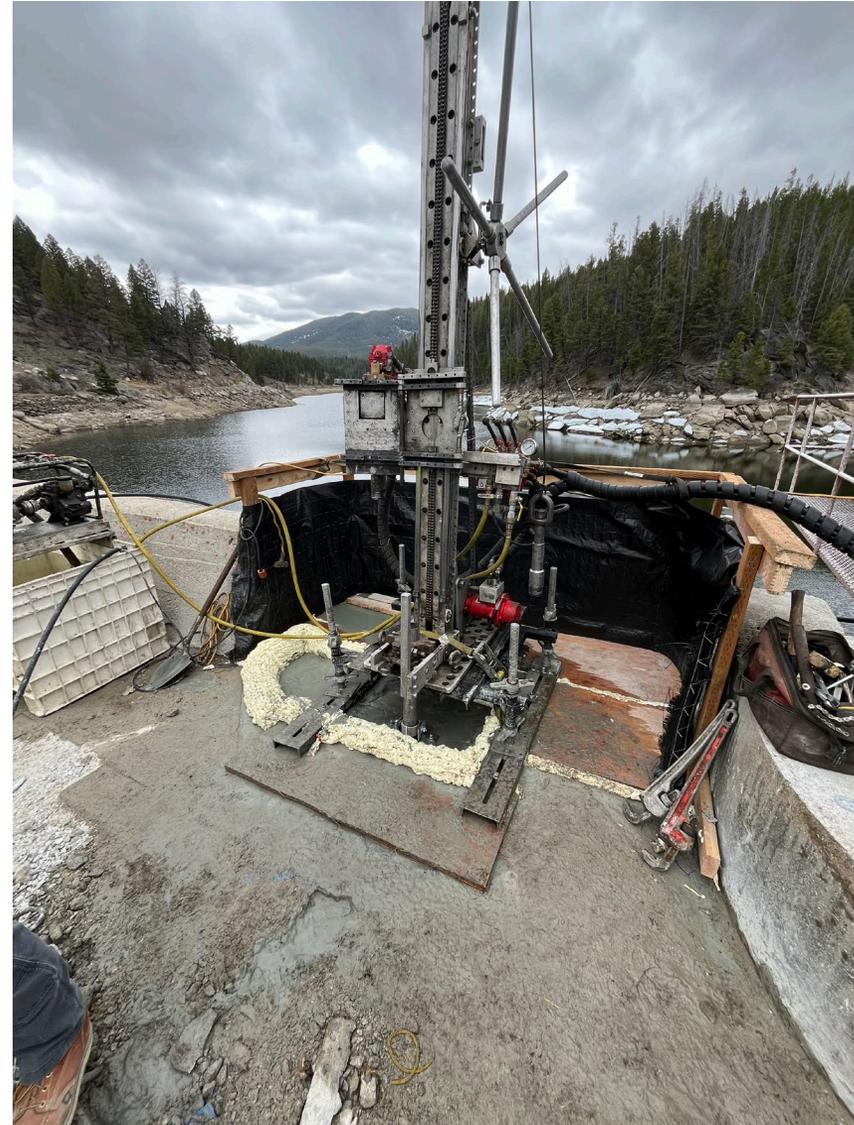
Pilot Hole Drilling/Core Samples

- Pilot holes were prioritized early in the project so anchor design could be verified
- 5 week lead time on anchor bars once approved
- Utilized hand packable drill rig

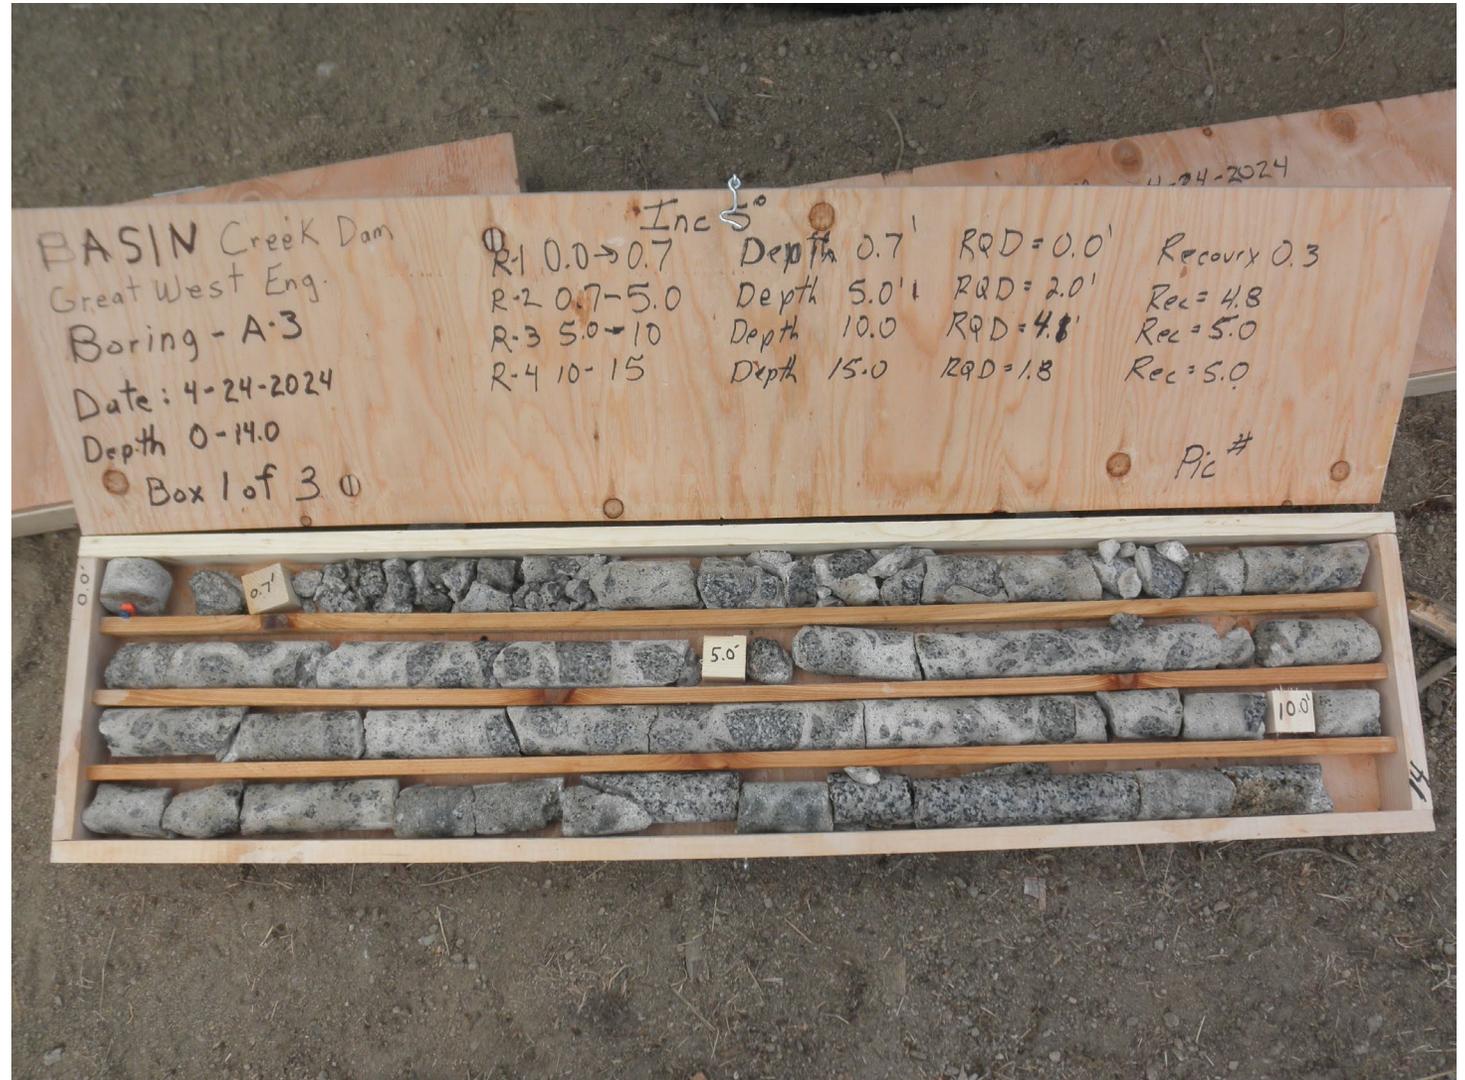
Pilot Hole Drilling/Core Samples

- Drilled 5 total pilot holes at anchor locations
- Pilot holes confirmed poor concrete in top 2-3 feet of overlay

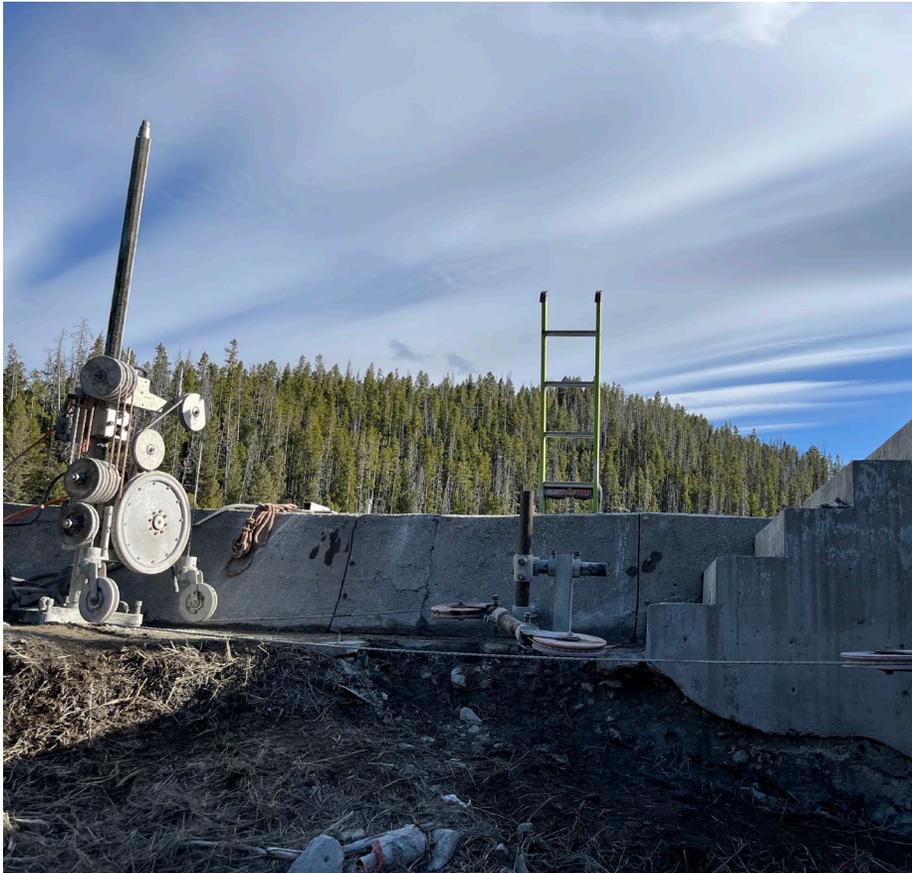
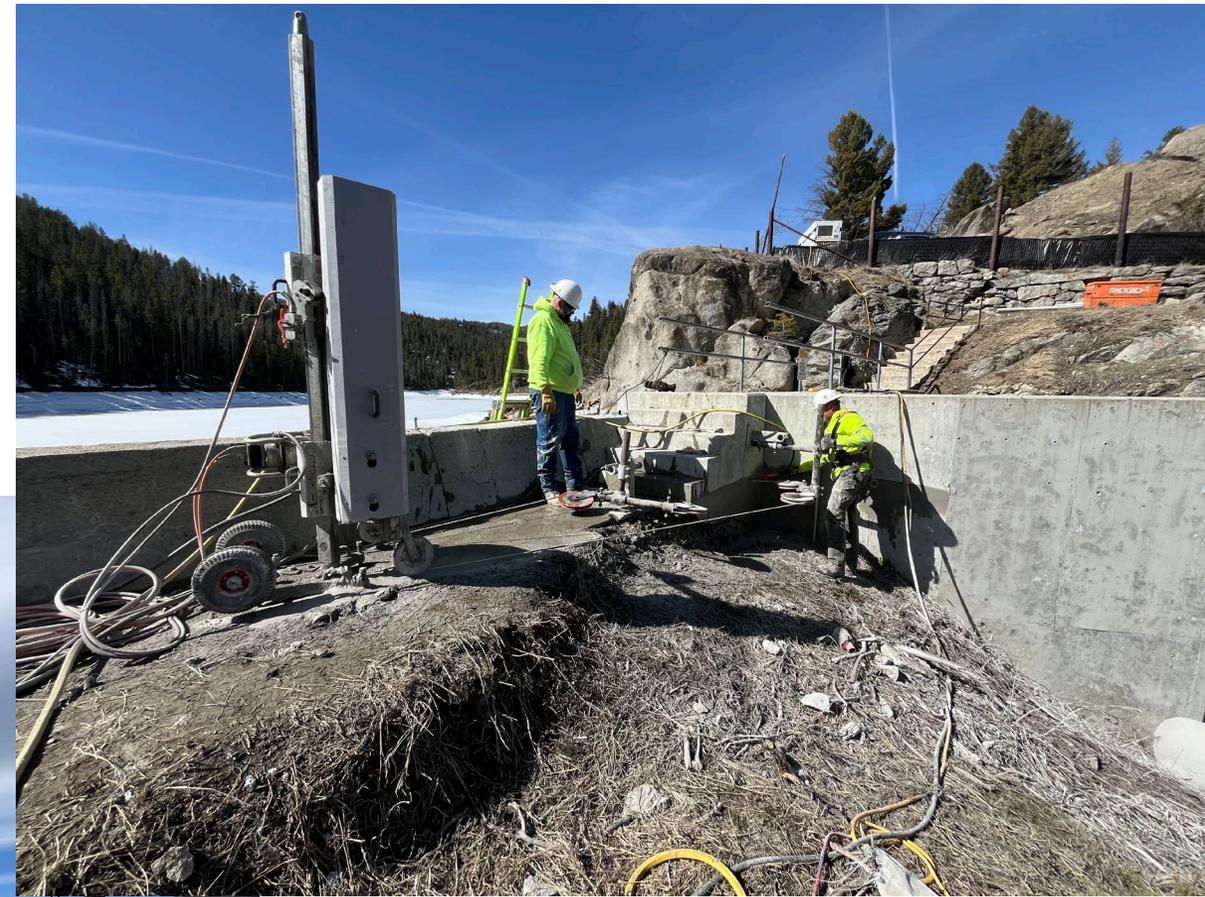
Concrete Removal

- Contractor elected to use wire saw to remove concrete

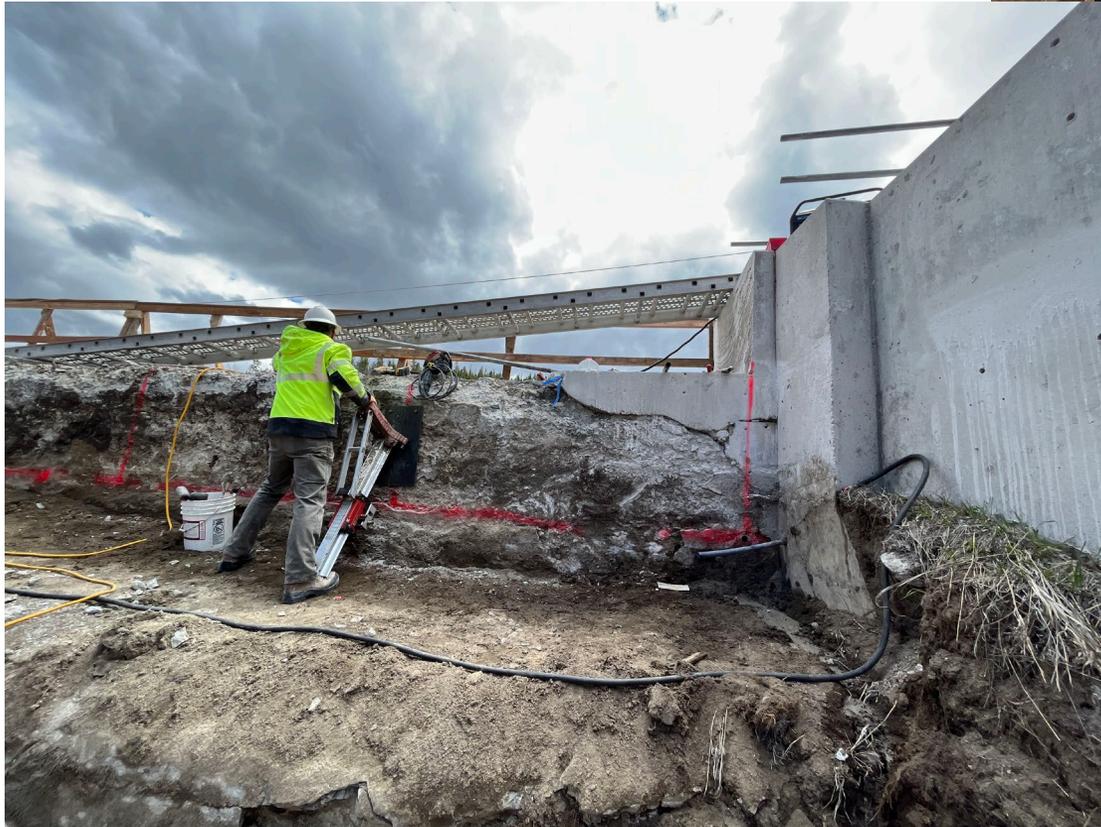
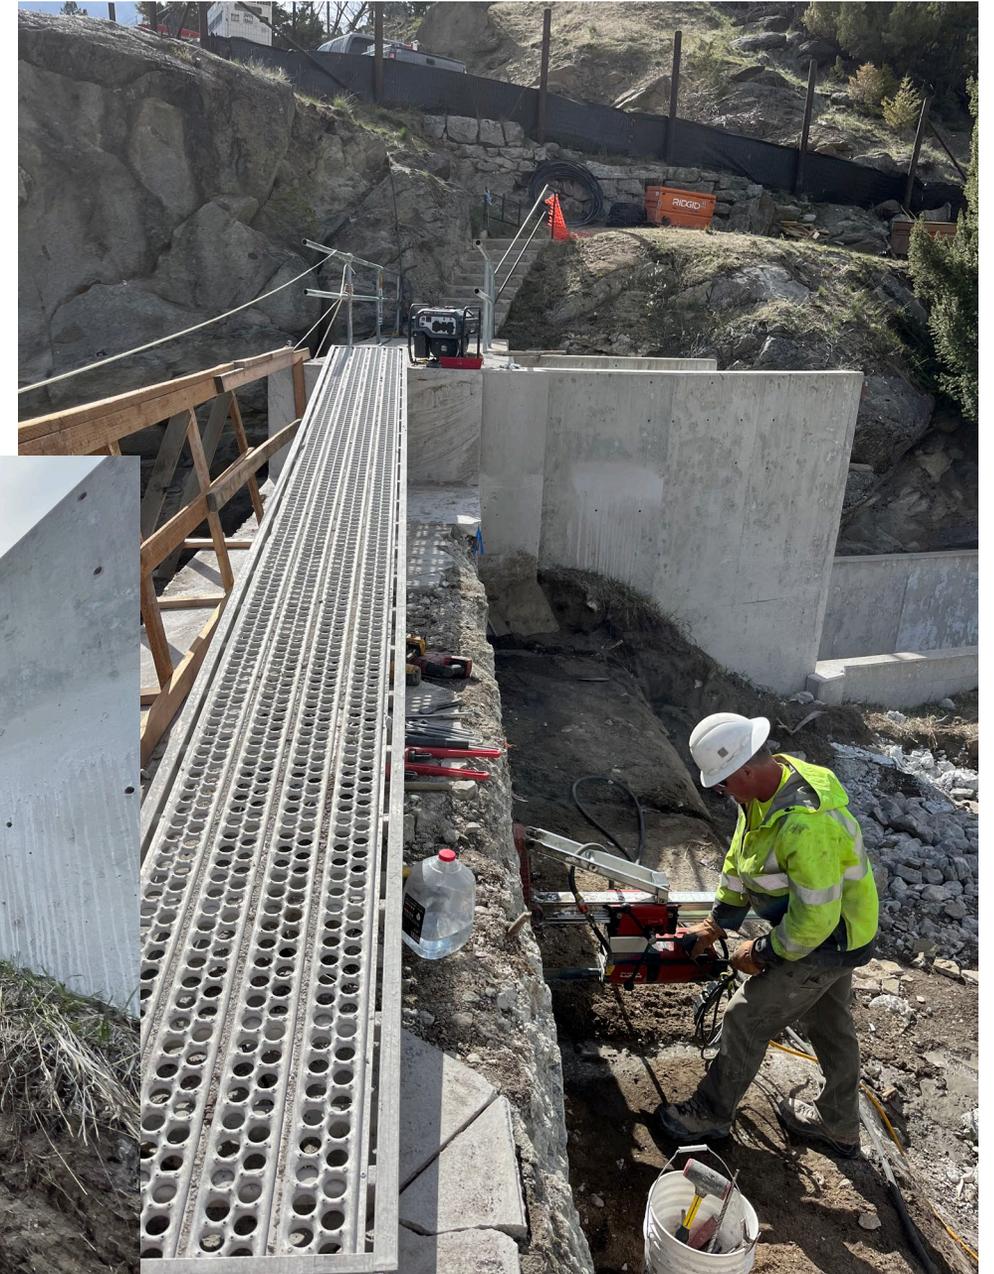
Concrete Removal

- Required core holes to be strategically and accurately drilled to run wire.

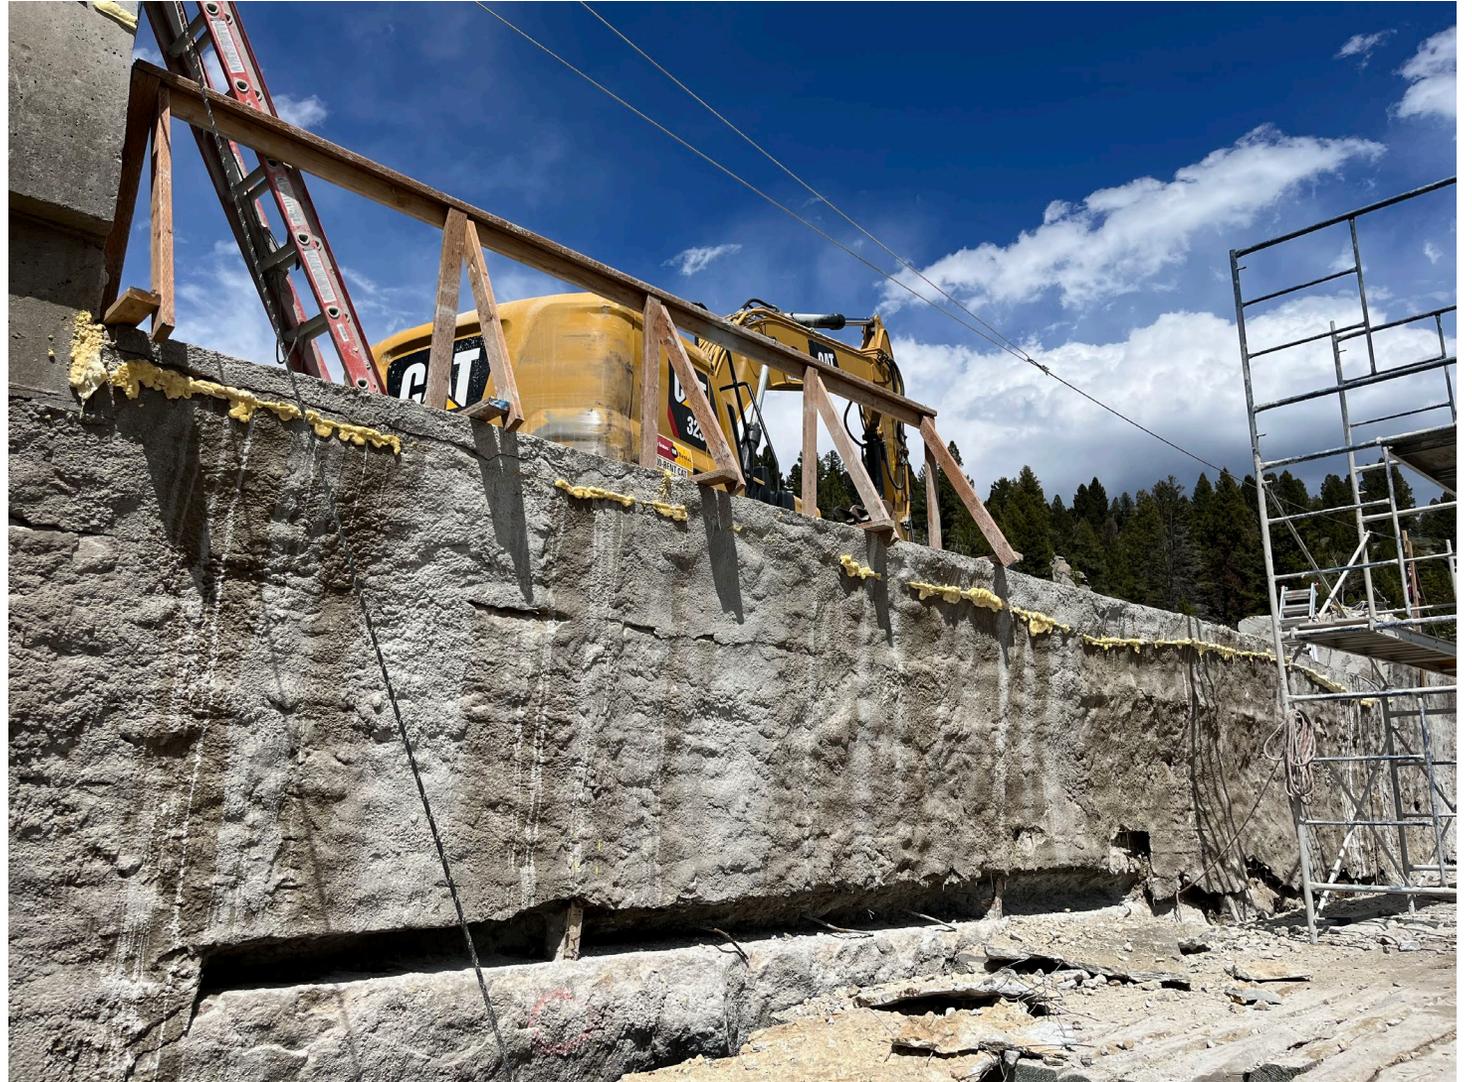
Concrete Removal

- Rail saw used to cut relief along concrete masonry interface
