From a Blemish to a “Butte”

Rehabbing Butte’s Basin Creek Dam #1

Justin Evertz, PE, Great West Engineering

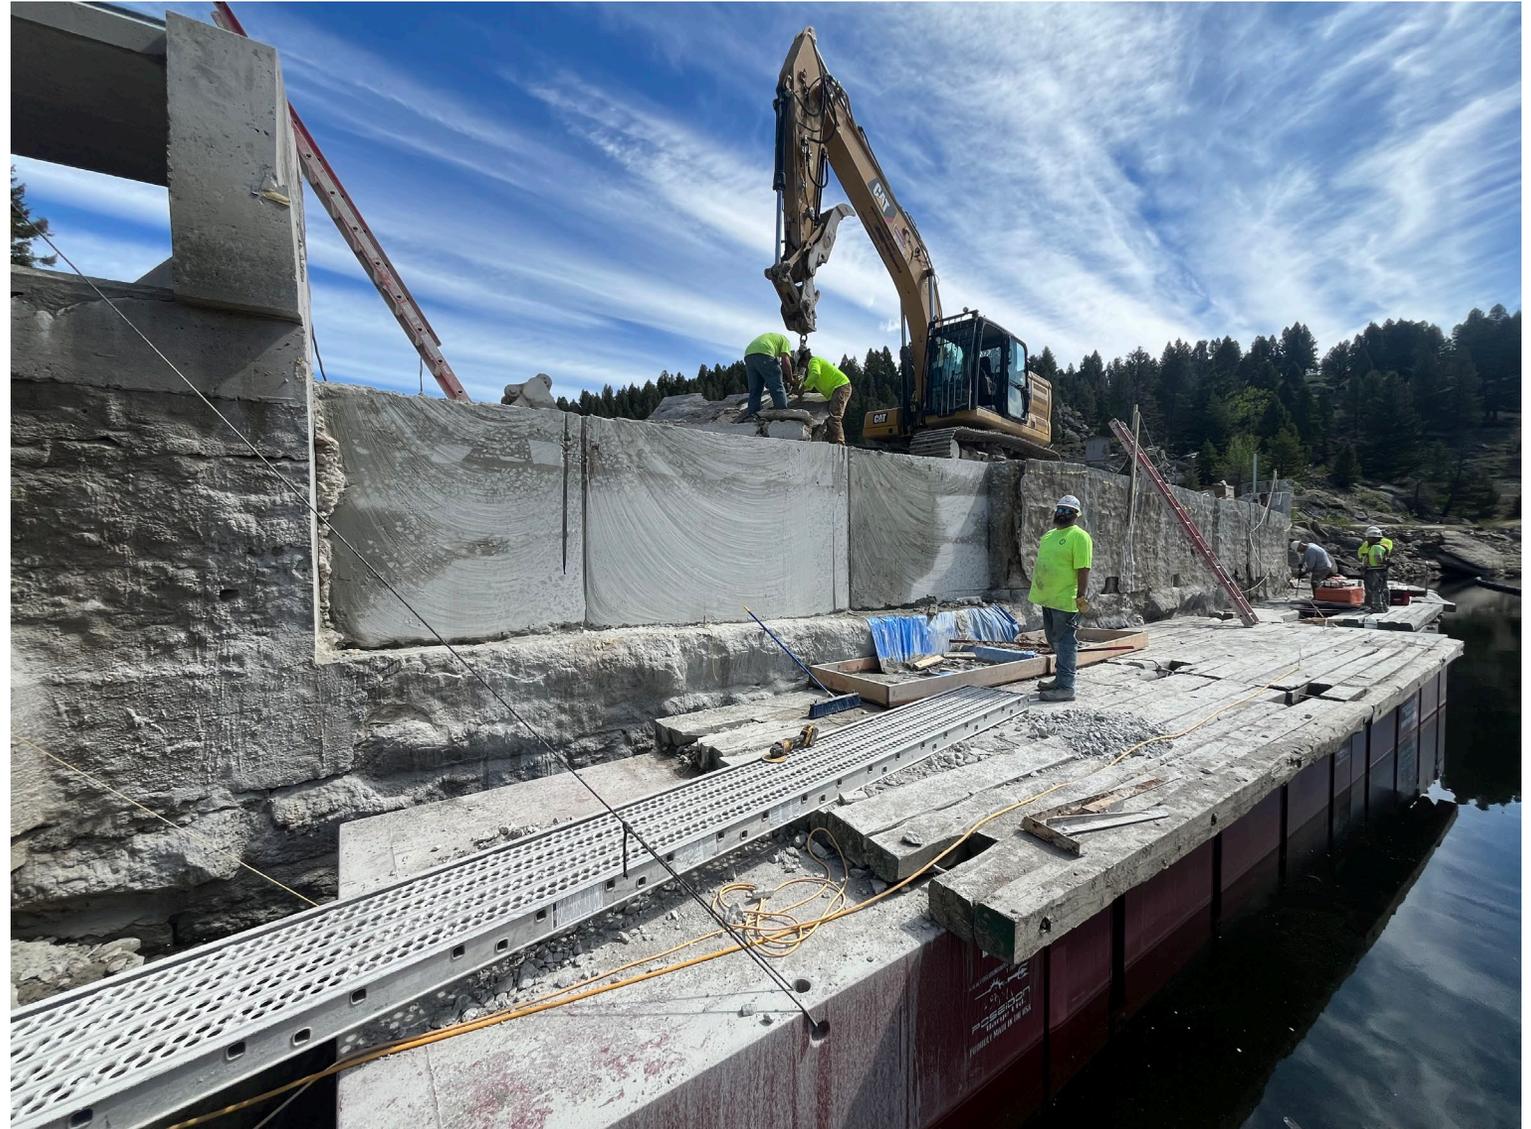
Concrete Removal

- Excavator used to lift cut mass concrete

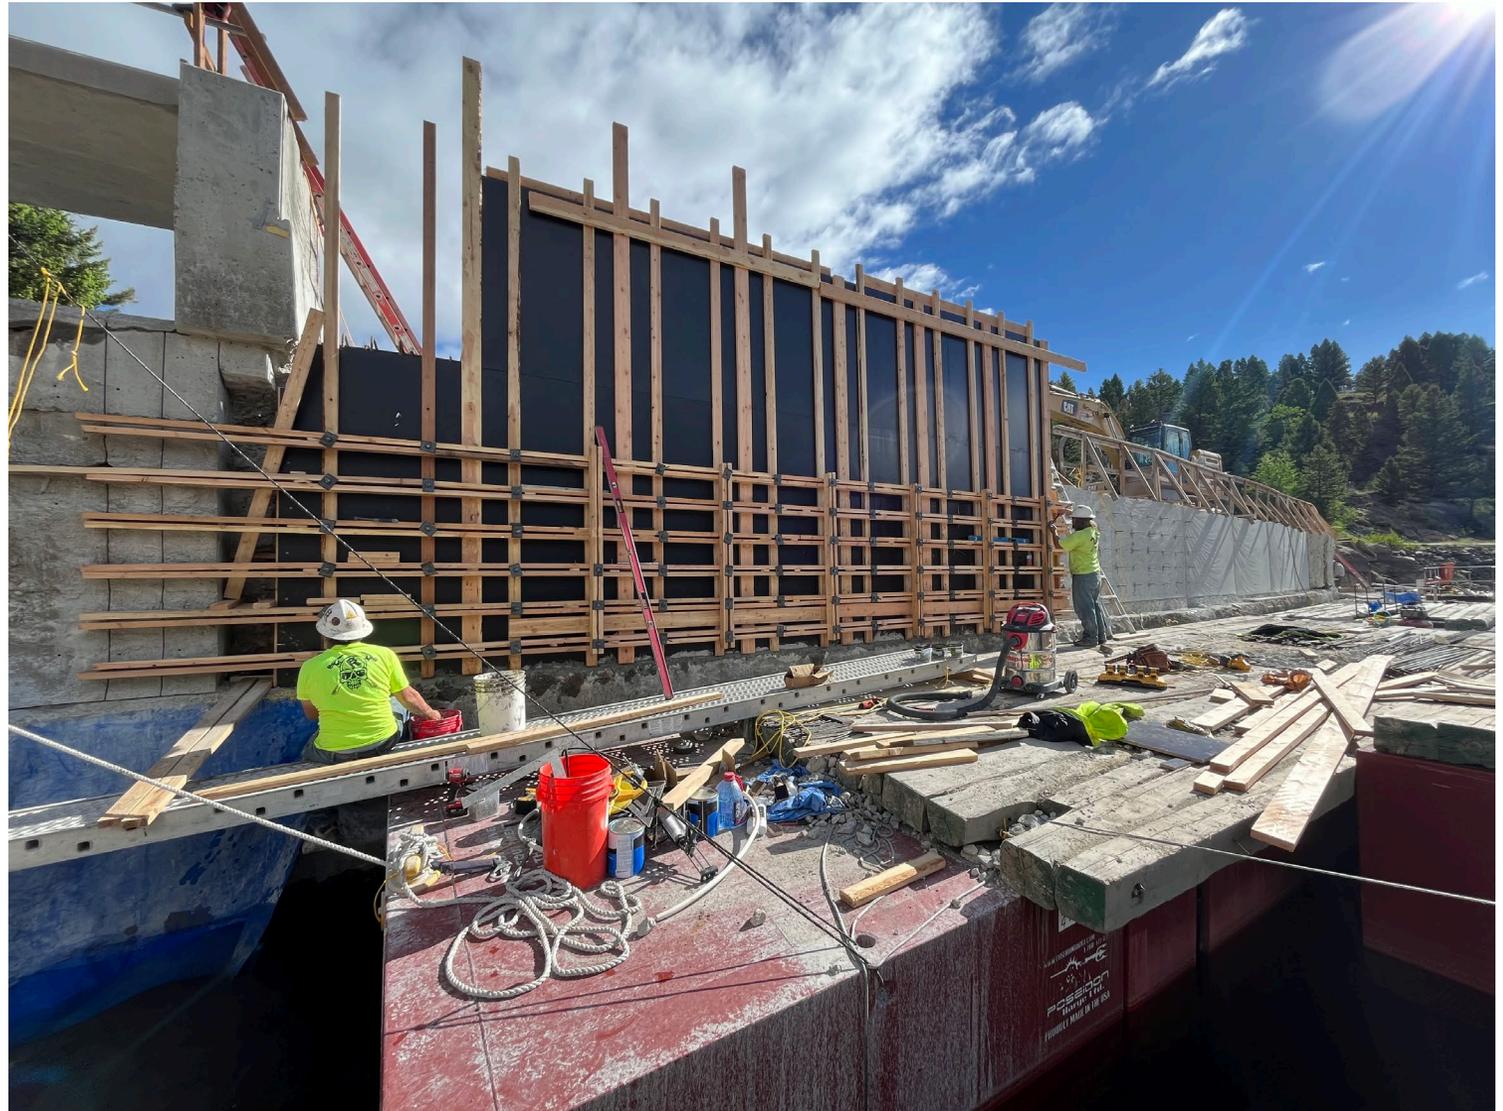
Pouring The Dam Face

- First pour on June 28th
- Generally poured 20 foot panels

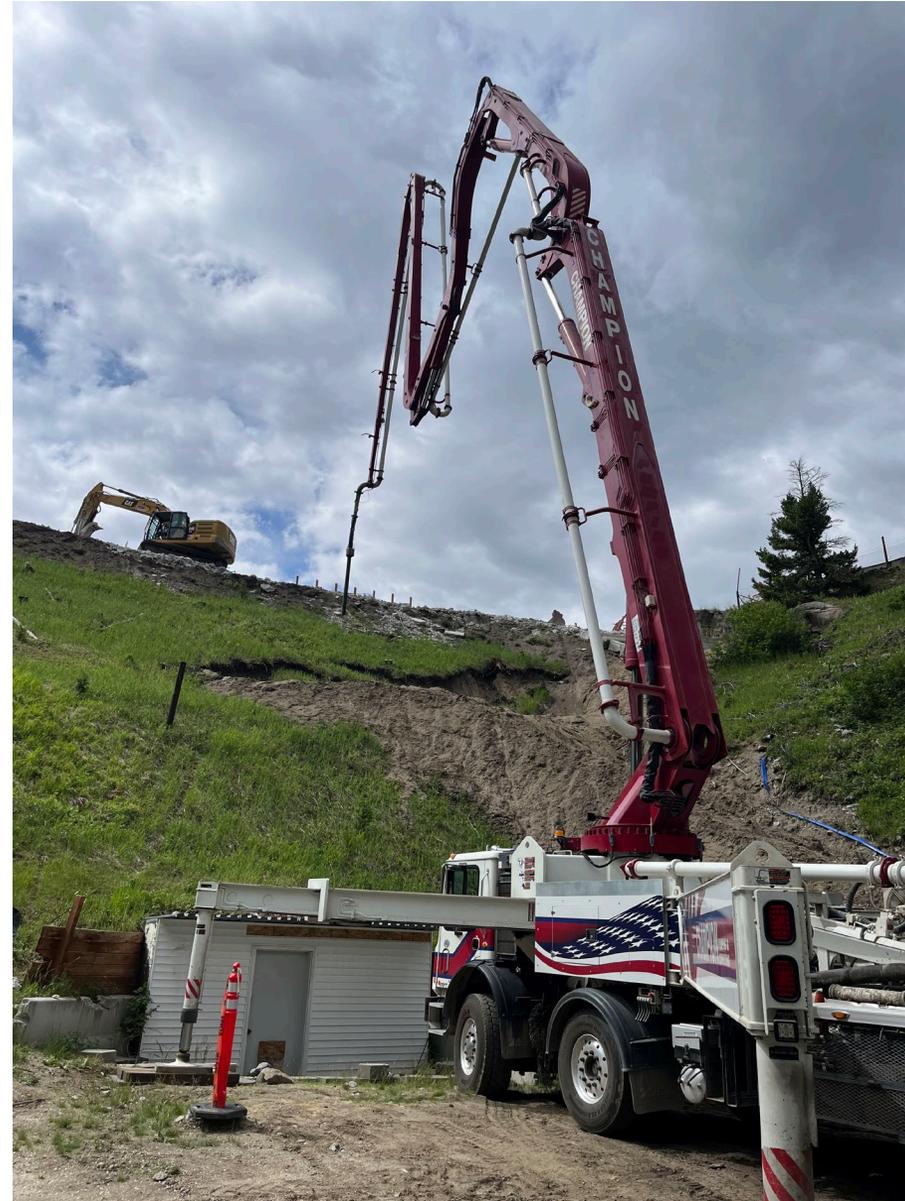
Pouring The Dam Face

- All pours were completed from the base of the dam
- Had to pump vertically 80 feet and 60 horizontally

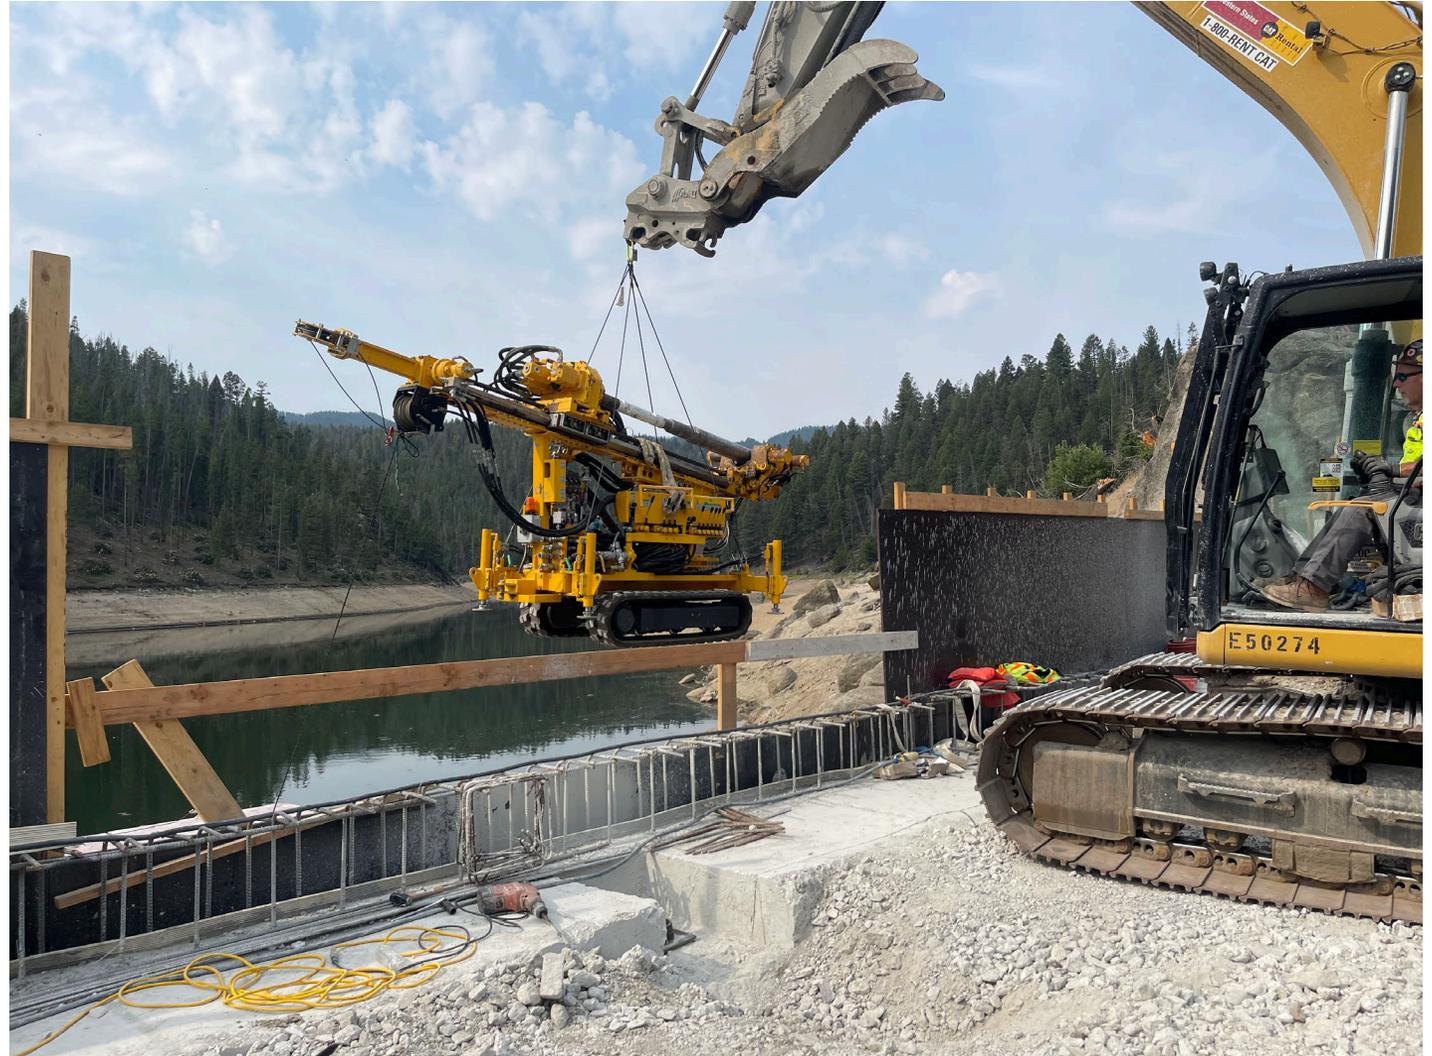
Post-Tensioned Anchor Installation

- Drilling started last week of July
- Drill rig transported by barge and lifted by excavator onto dam crest

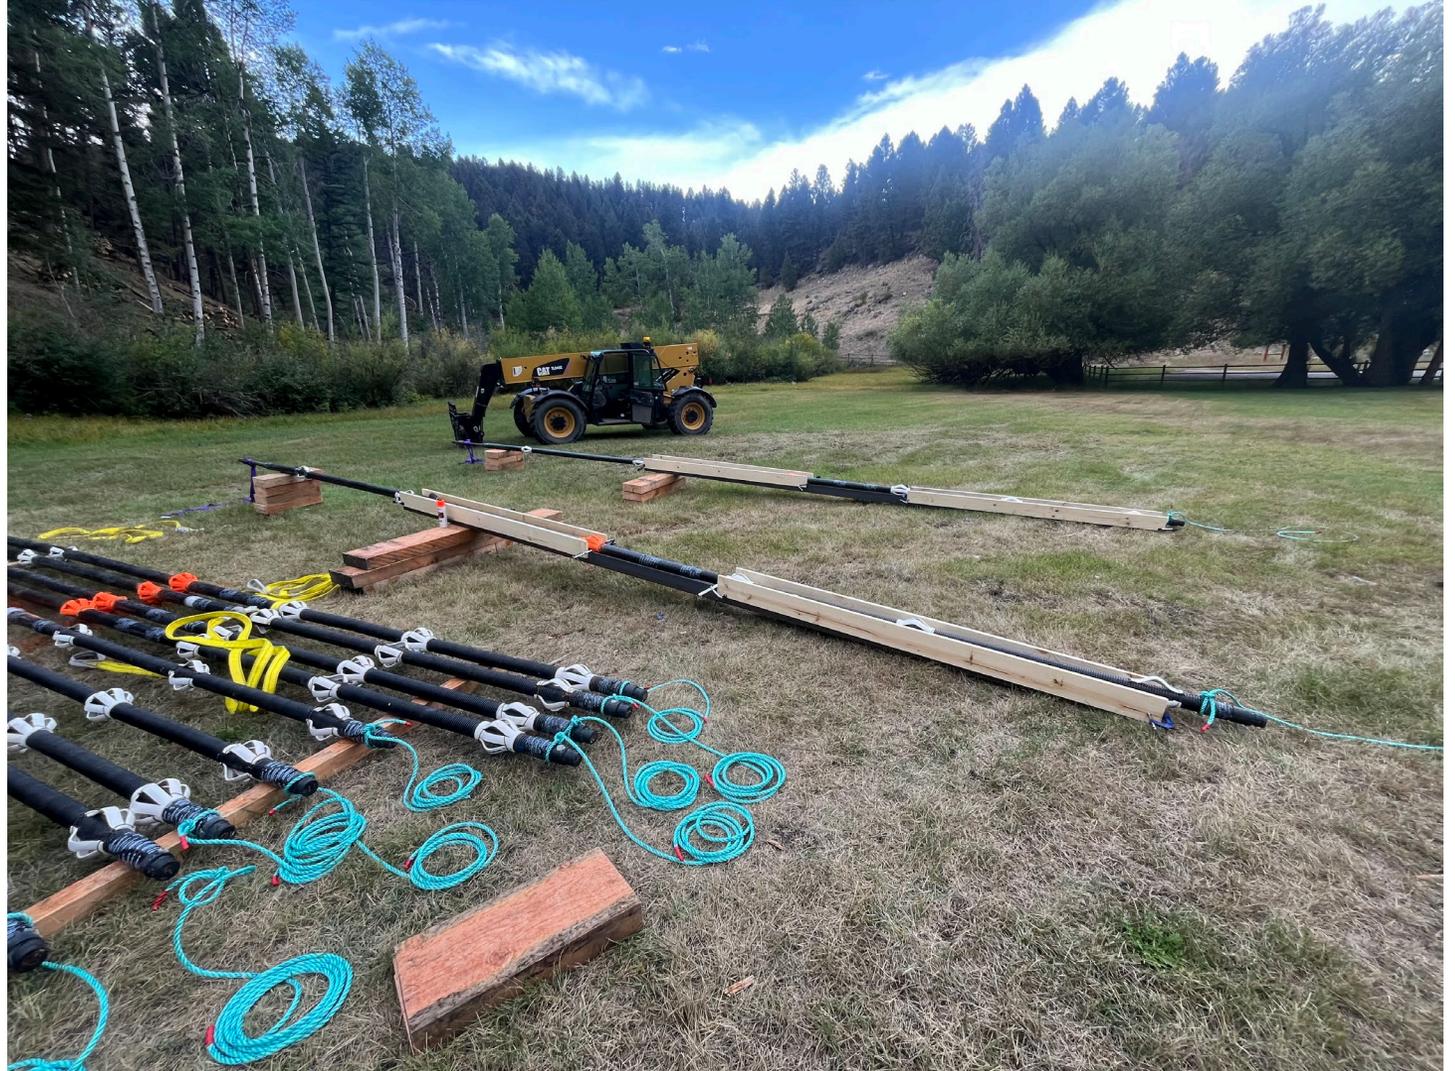
Post-Tensioned Anchor Installation

- PTAs originally planned for install via barge and excavator
- Pivoted and decided to use a helicopter instead

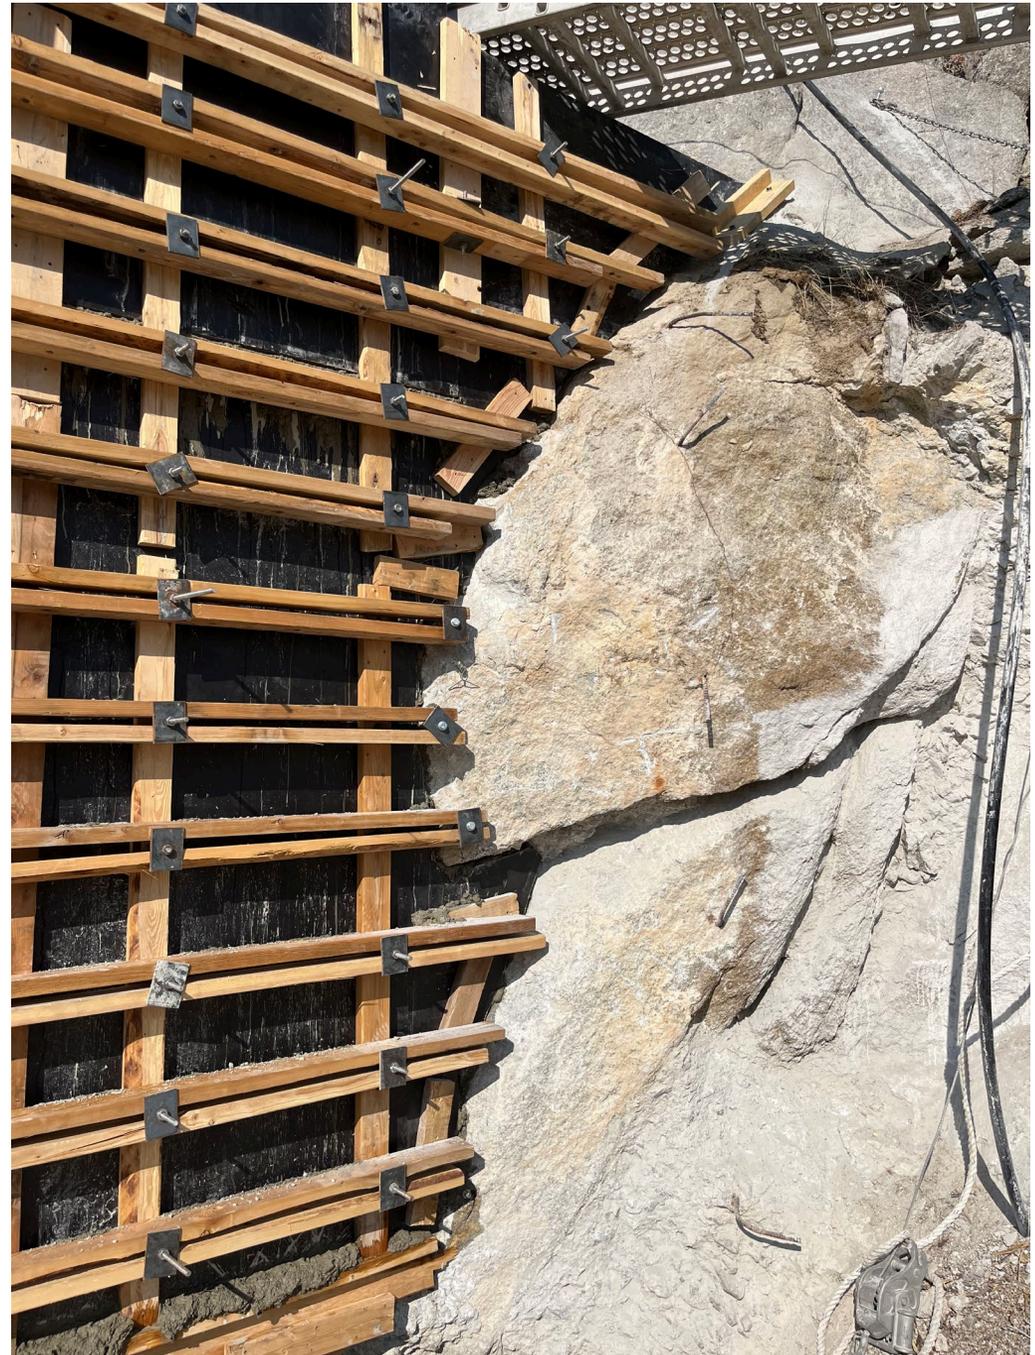
Final Concrete Installation

- Last pour October 15th
- Overlay and parapet were poured, along with stairs and new bypass spillway.
