# East Fork of Rock Creek Dam Rehabilitation

## DNRC State Water Projects Bureau

MADCS Annual Meeting, Billings,  
Oct. 7, 2026

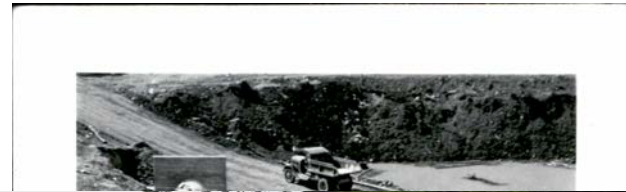
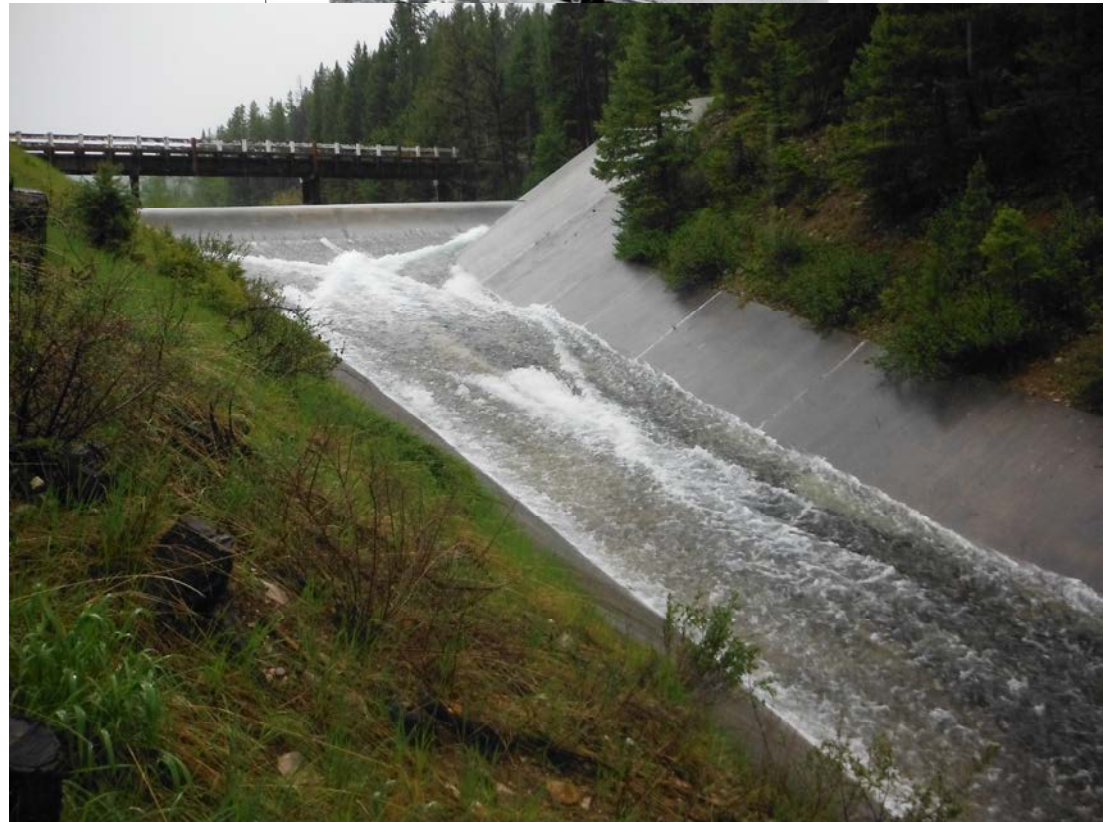
# Dam Safety Deficiencies

## Spillway Bridge

Piers within spillway approach

## Outlet Conduit

Collars, unfiltered toe exit

## Foundation Seepage

Unfiltered exits

## Spillway

Inadequate chute capacity,  
poor concrete

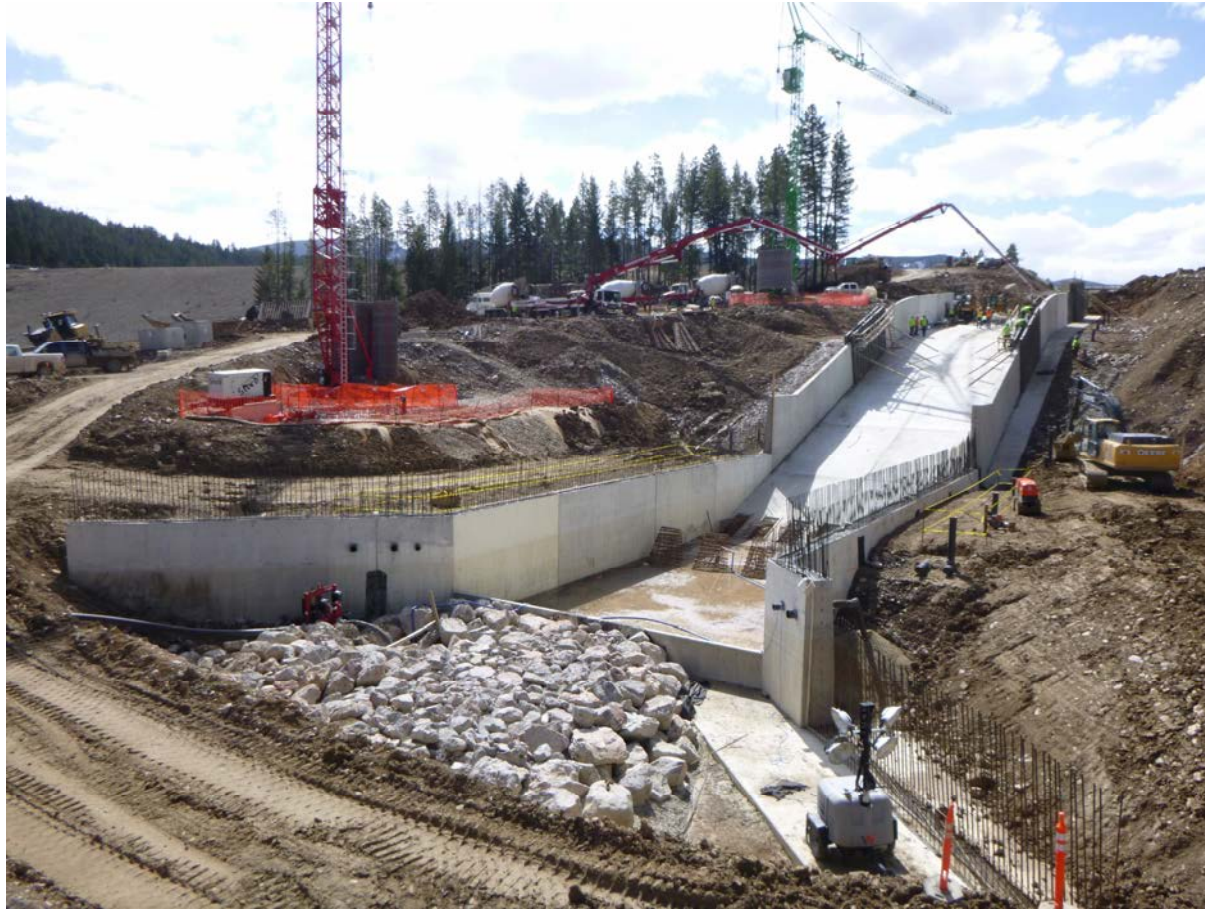
Construction equipment and materials  
Photo: DNRC

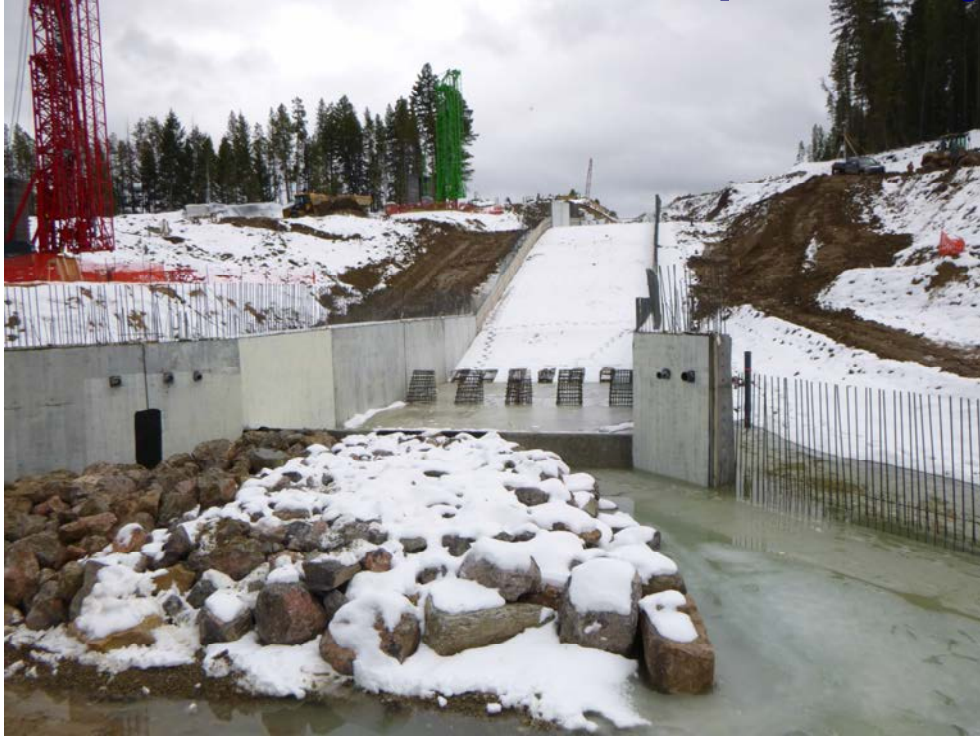
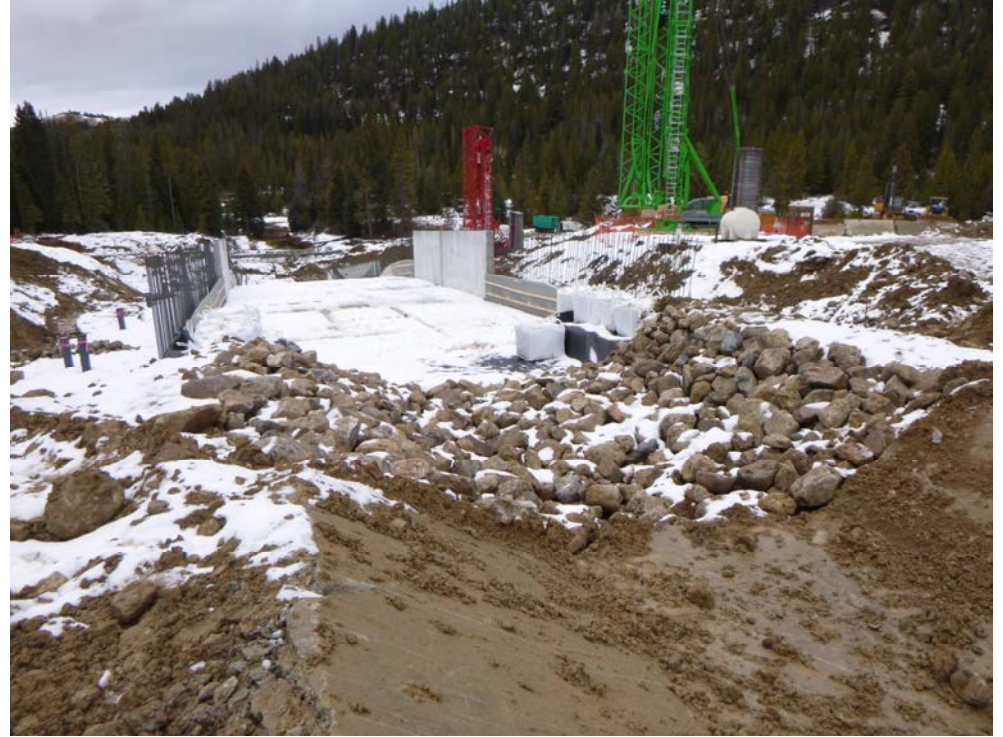
Winter Shutdown, 12/10/2025  
Photos: DNRC

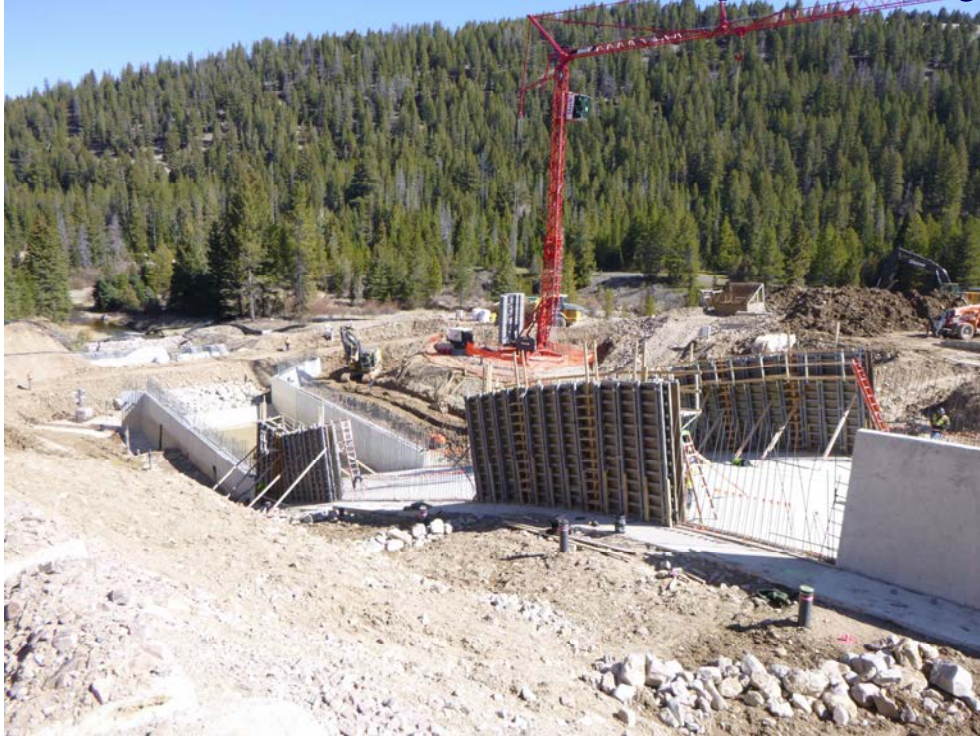
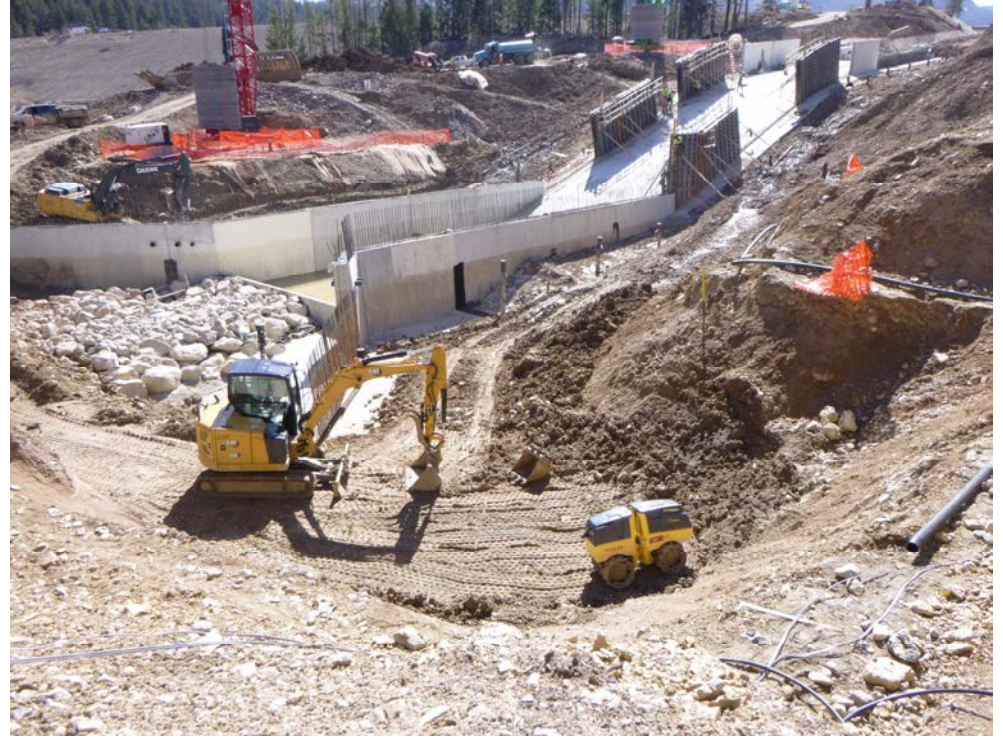
Spring Startup, 4/9/26  
Photos: DNRC

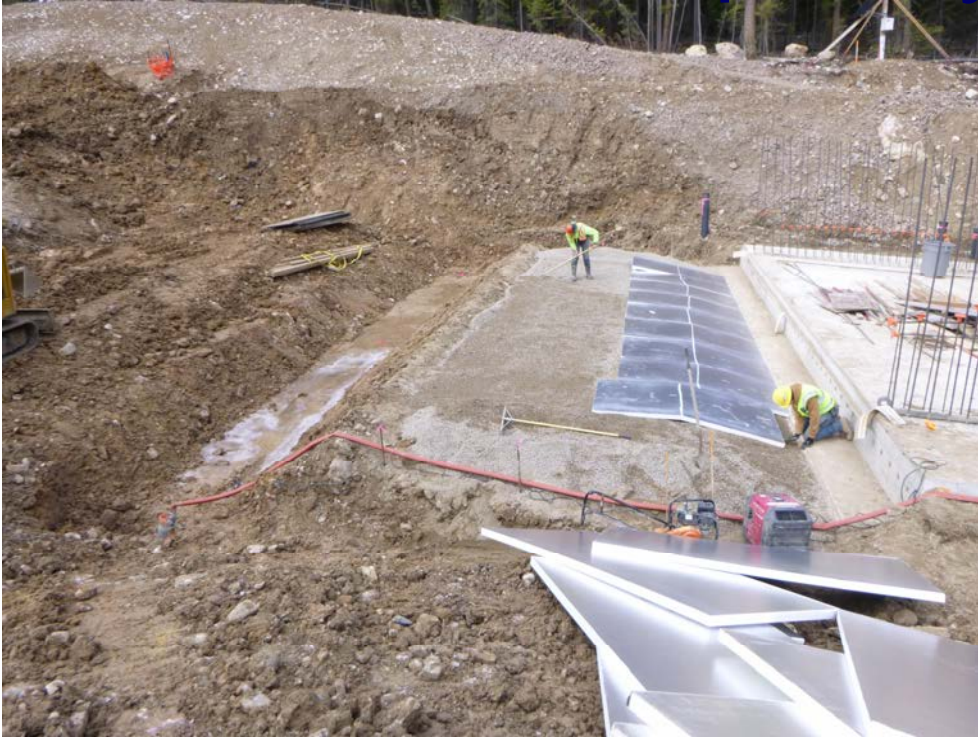
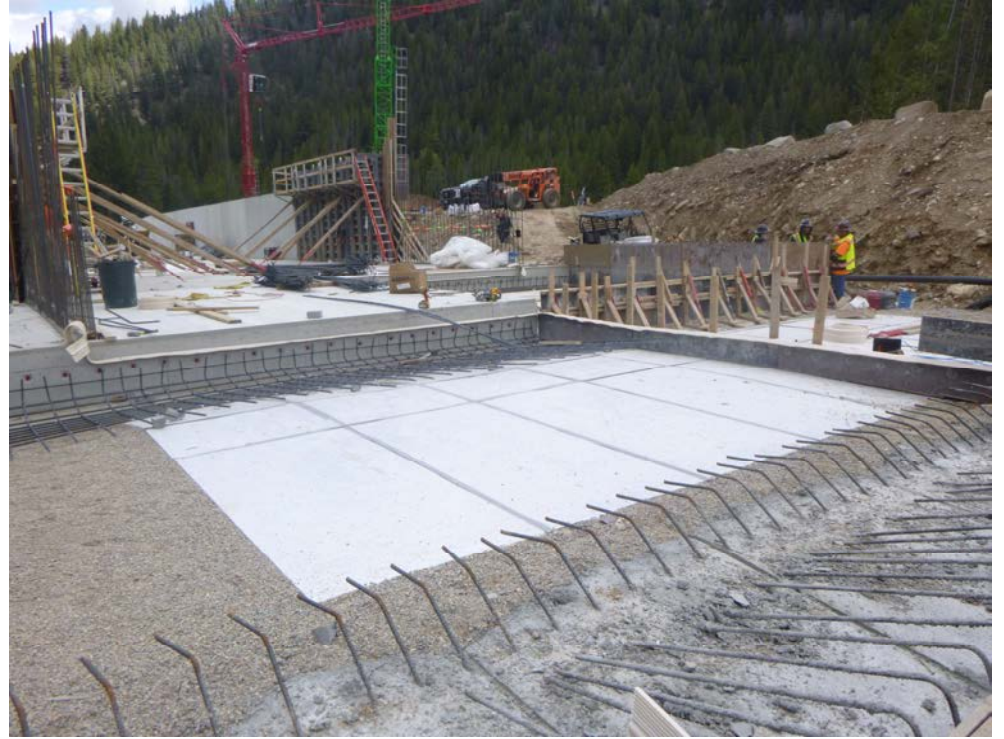
Foundation Preparation  
Photos: DNRC

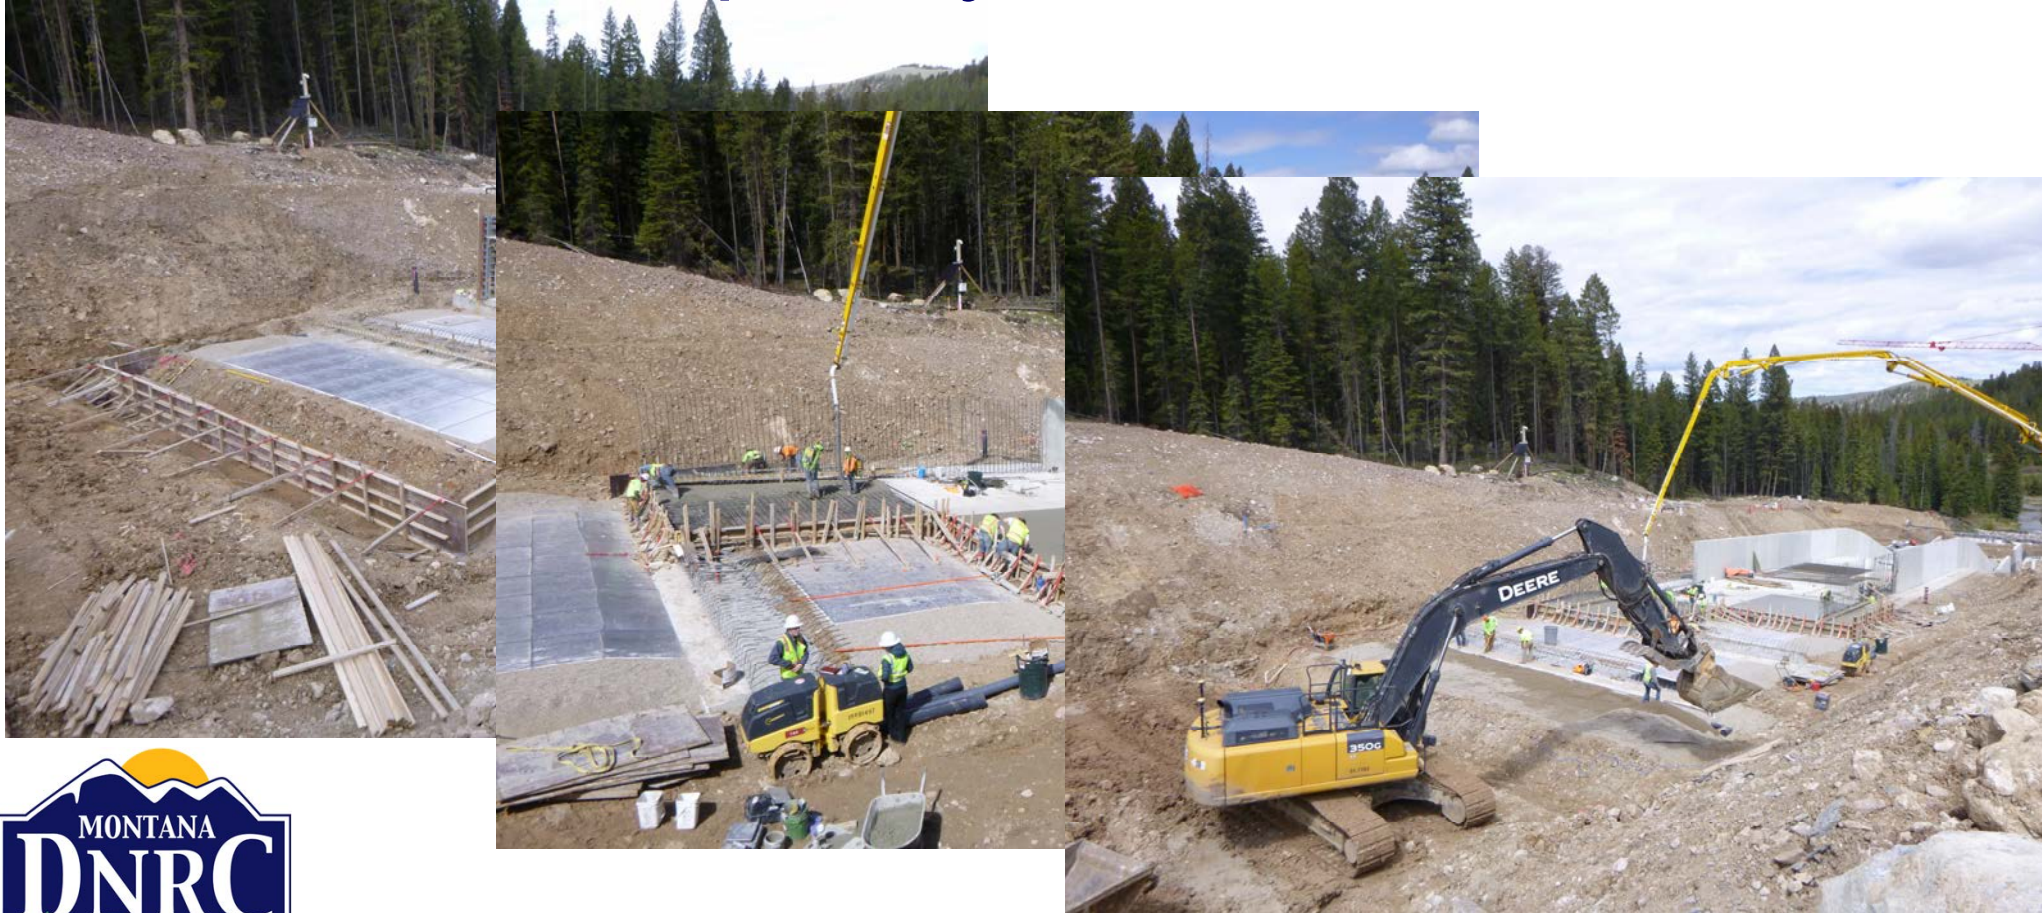
Construction Sequence  
Photos: DNRC
