# Montana Association of Dam and Canal Systems

## *2024 Rock Lake Operator Repair and Monitoring System Improvements*

Karl Kingery, P.E., CFM  
Water Resources Engineer

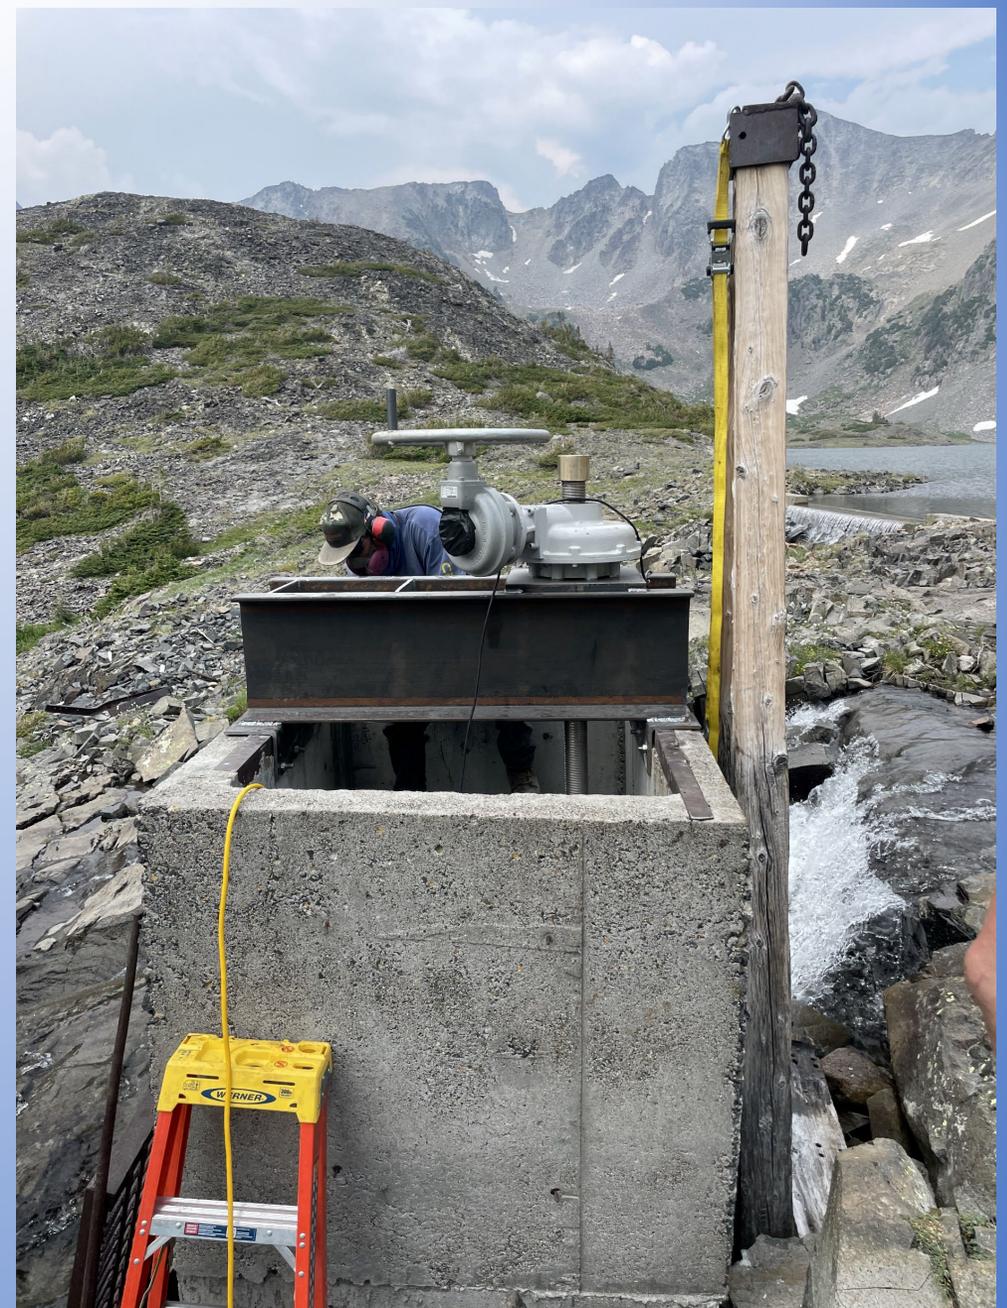
Planning for Repair, Sourcing of Materials, Equipment, Mobilization to Site and Installation of Emergency Fix  
All **Performed in 6 Days**

Emergency Repair Completed on July 23, 2024

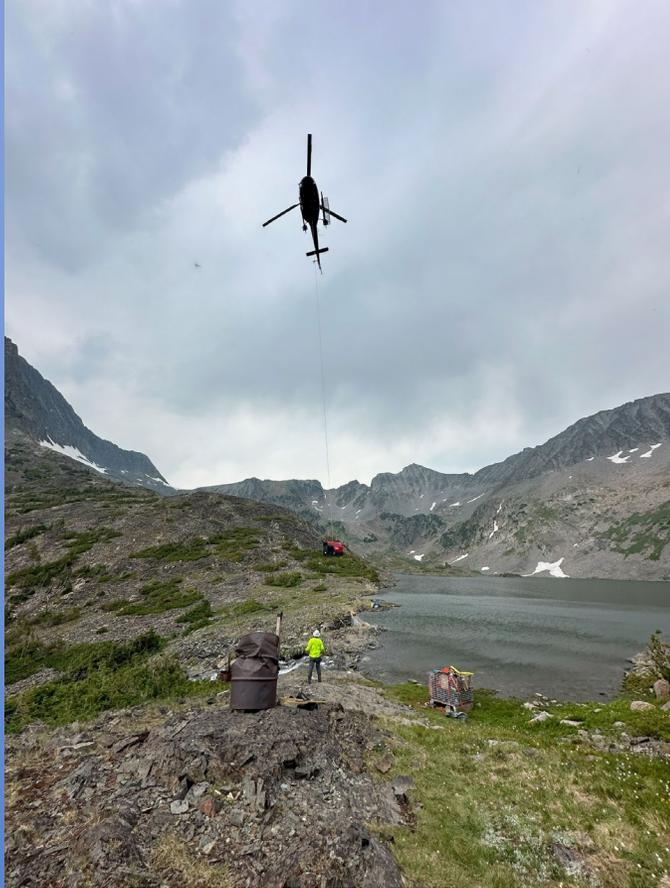
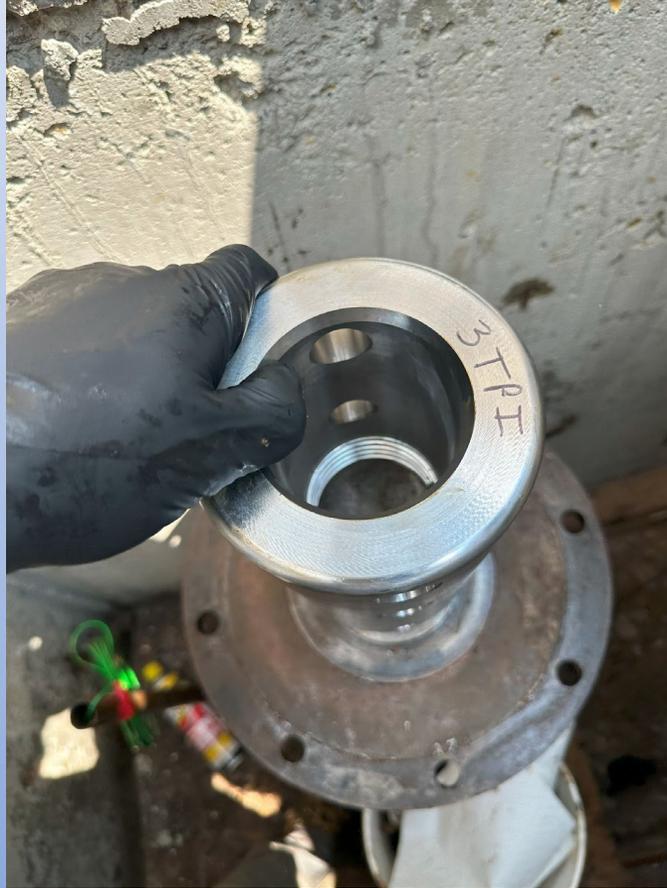
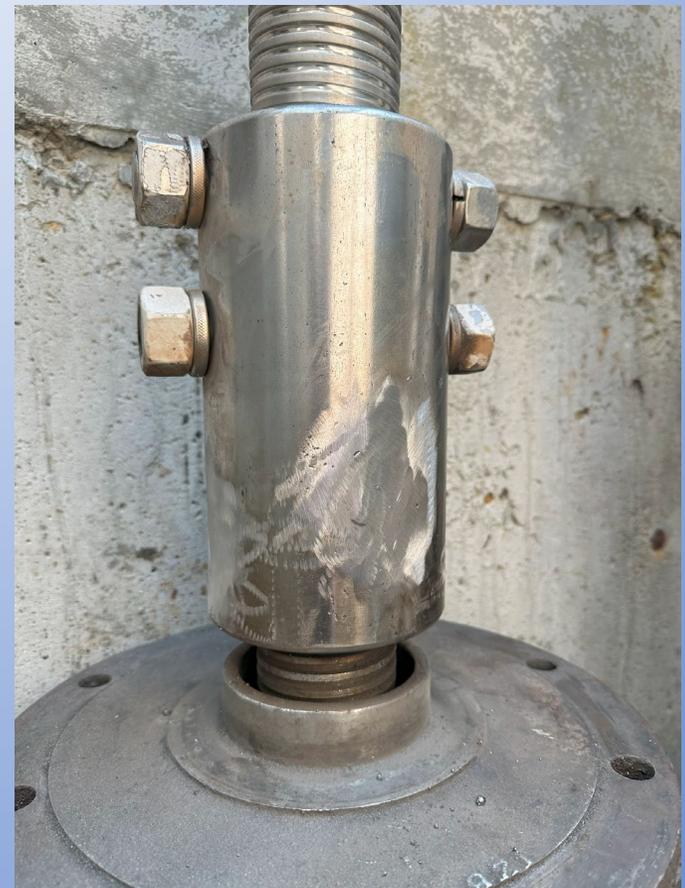
HERE IT COMES

AND

IT FITS!

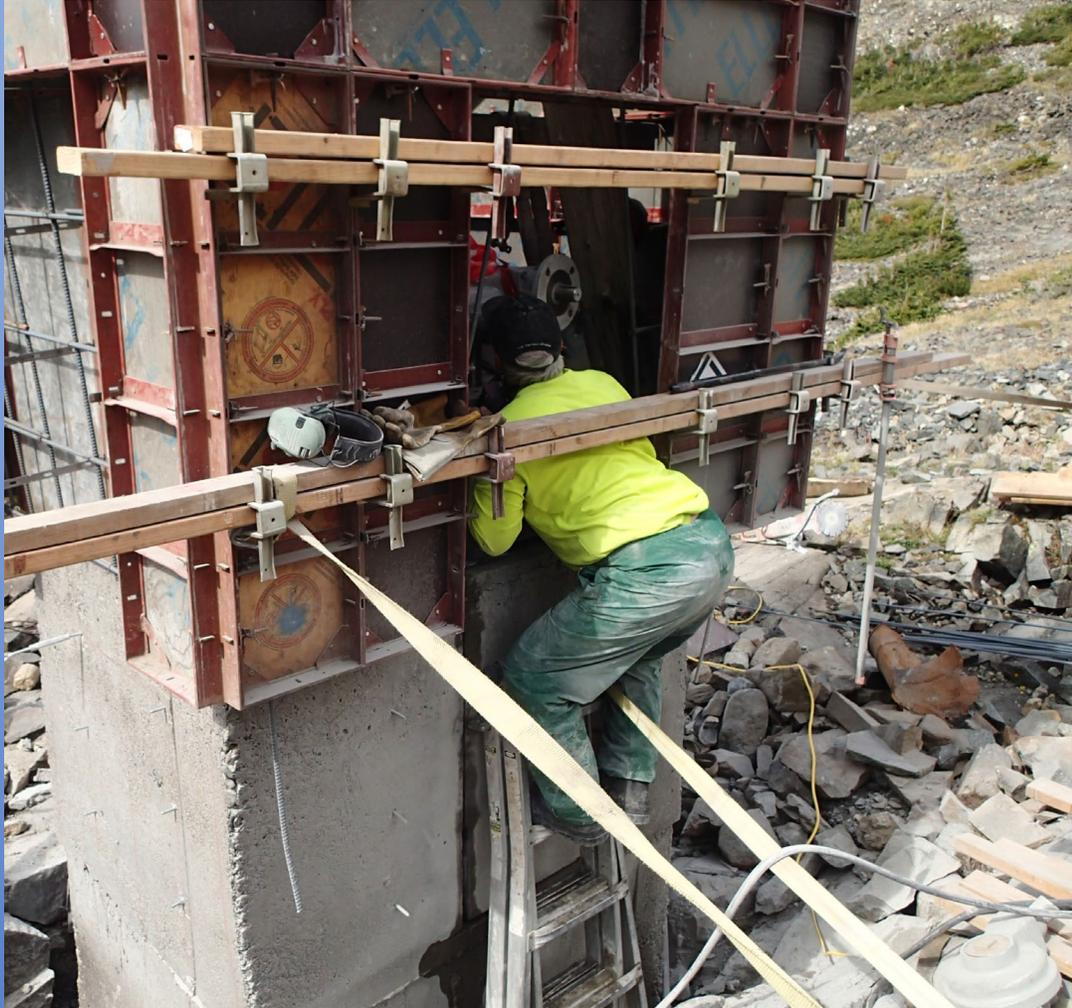
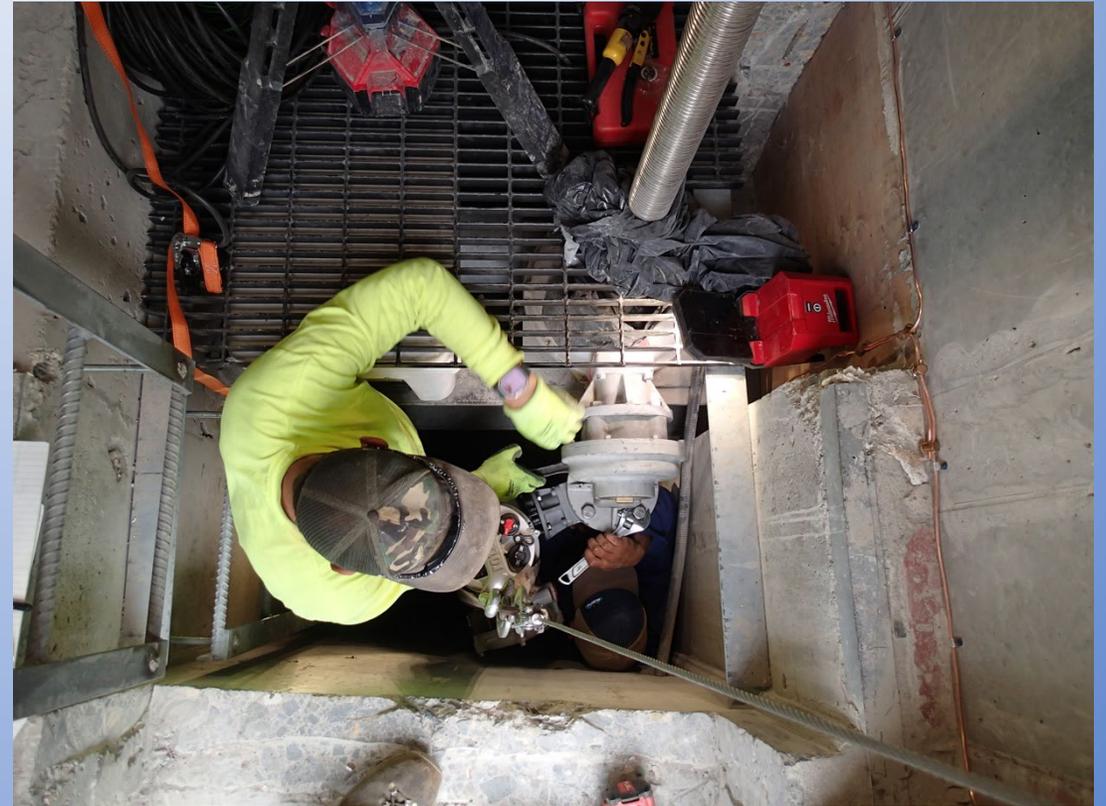
- Sometimes it was a tight fit.

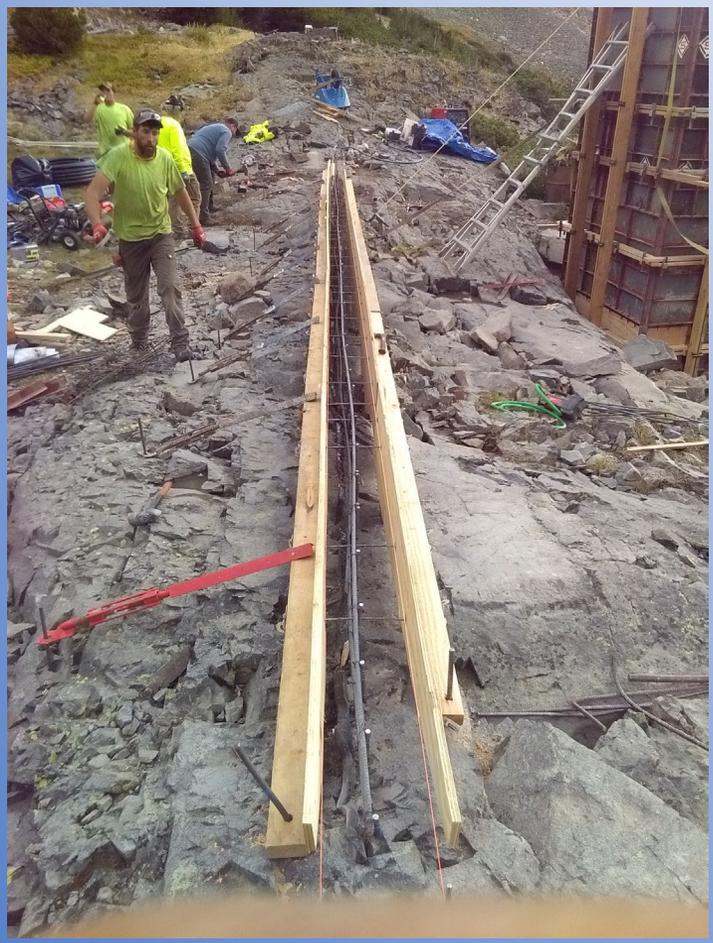
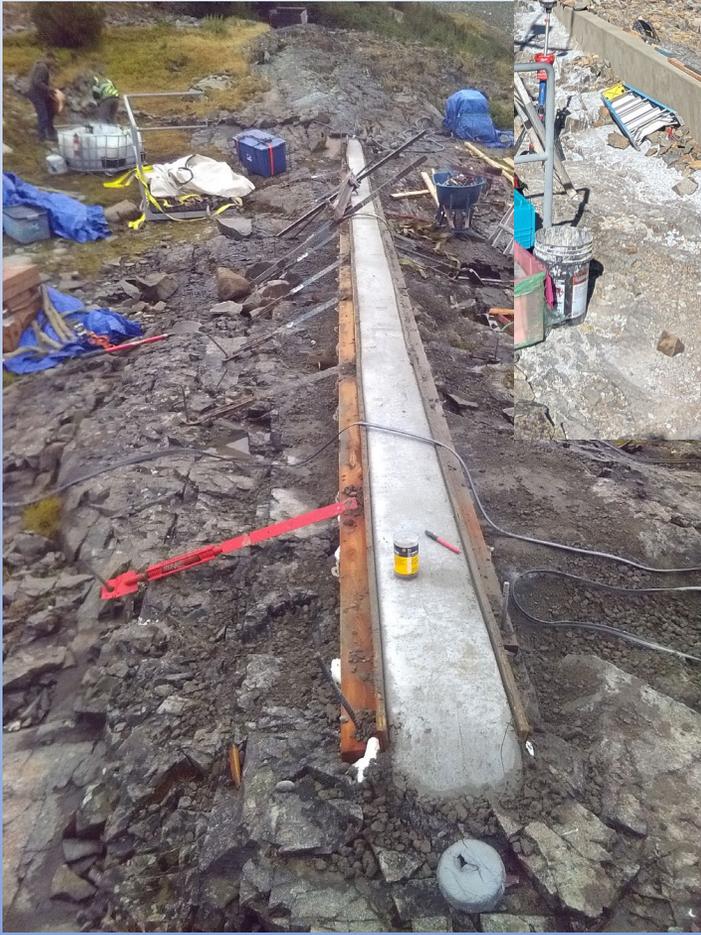
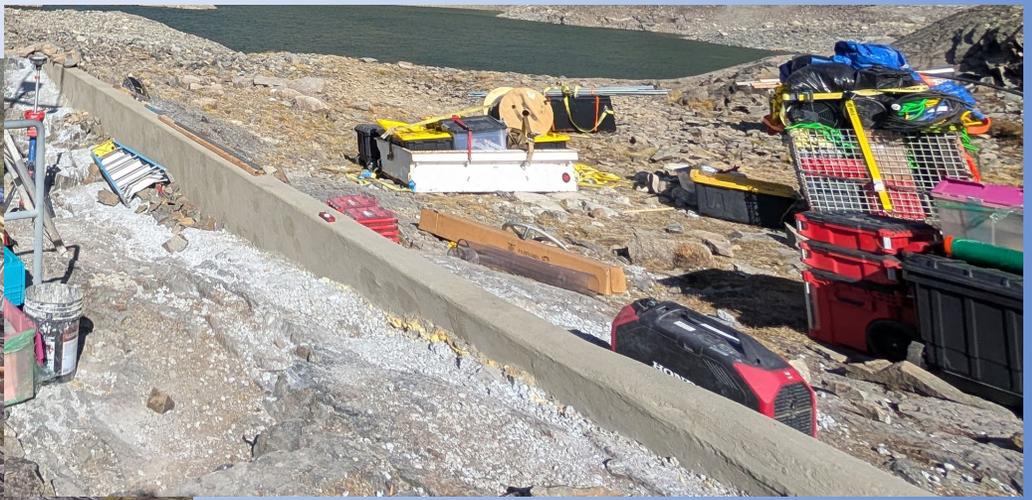
# Saddle Dike

- Protects system from flood waters

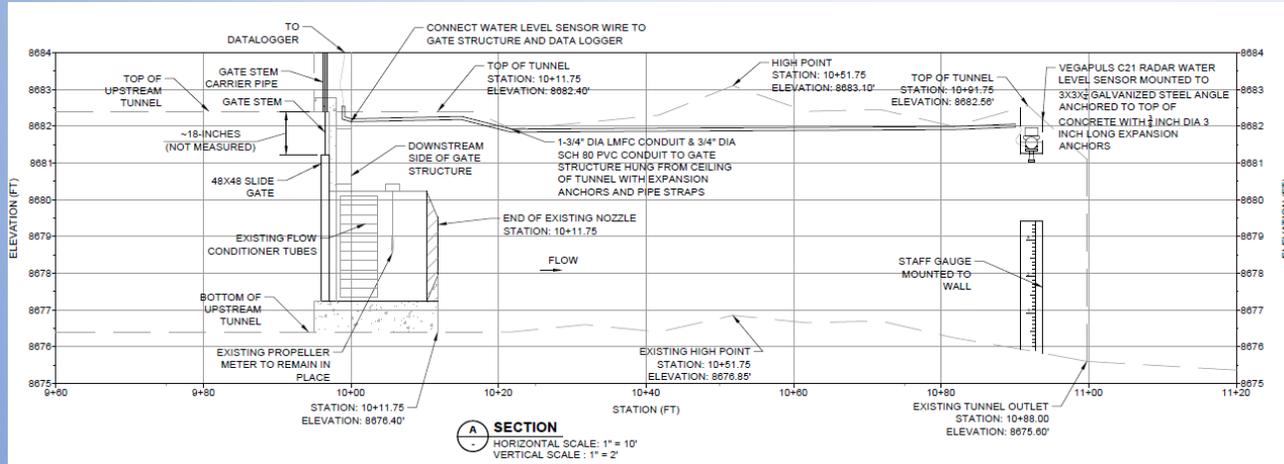
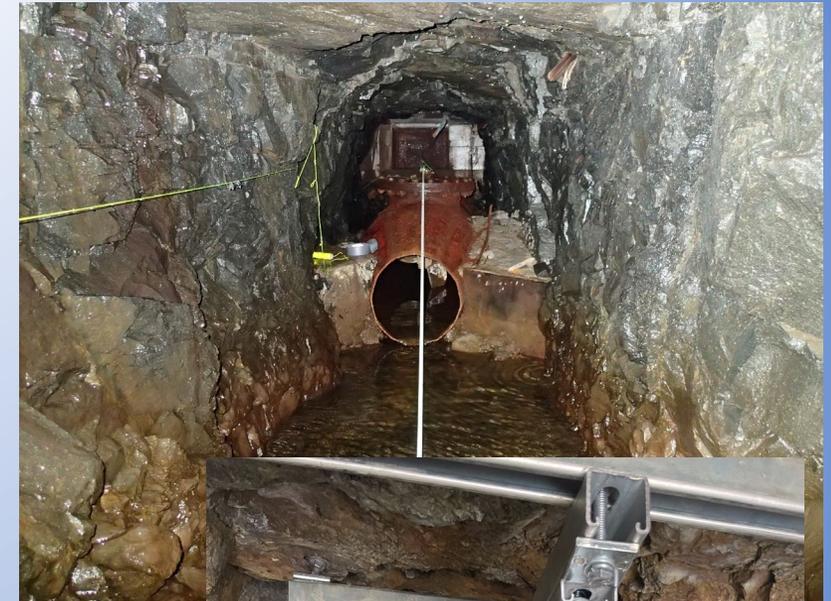
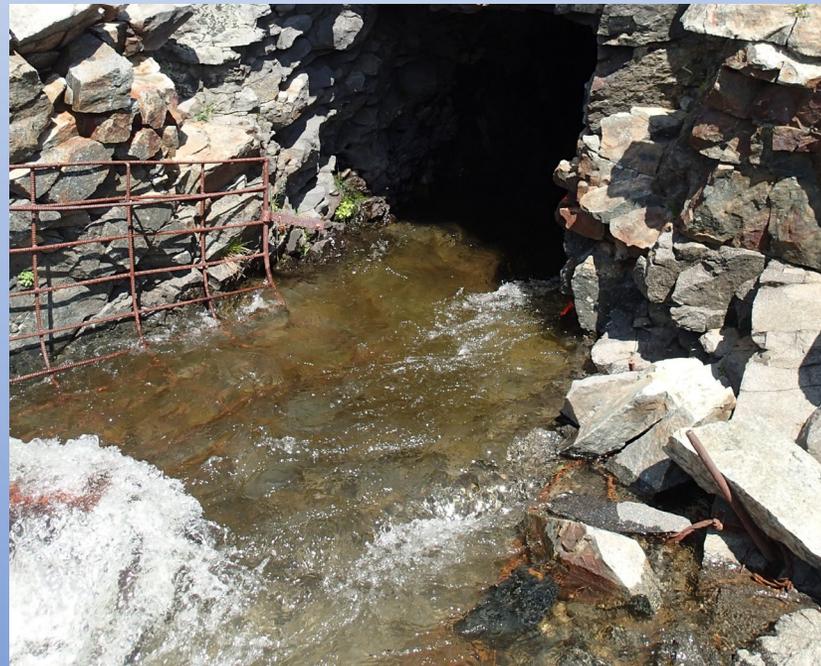
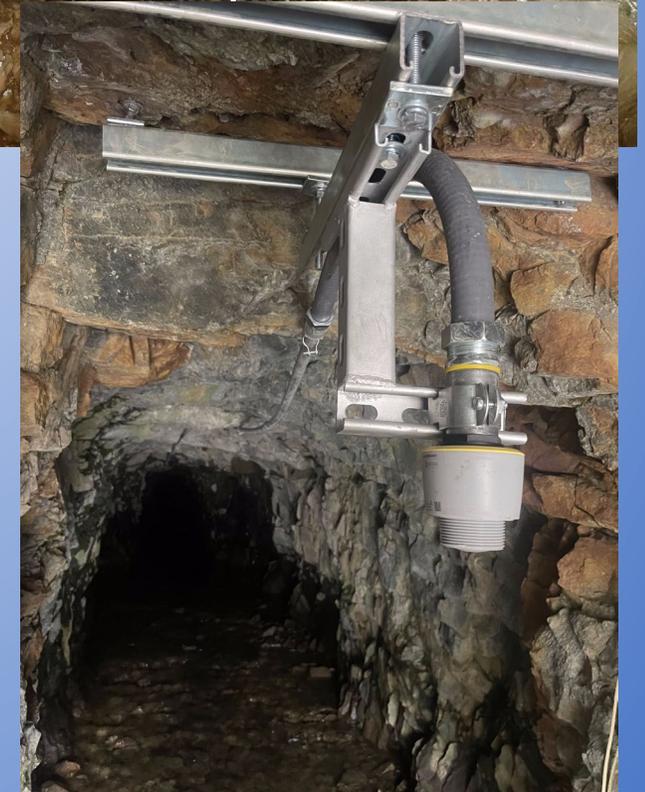
# Outlet Tunnel Monitoring

- Installation of a cutthroat flume was too expensive, so prepared custom outlet rating curve
- Avoided Changing Outlet Flow profile
- Supercritical flow conditions
- Measurements taken using a radar water level sensor
- Custom curve developed based on Stage-Volume-Inflow-Drawdown Calculation

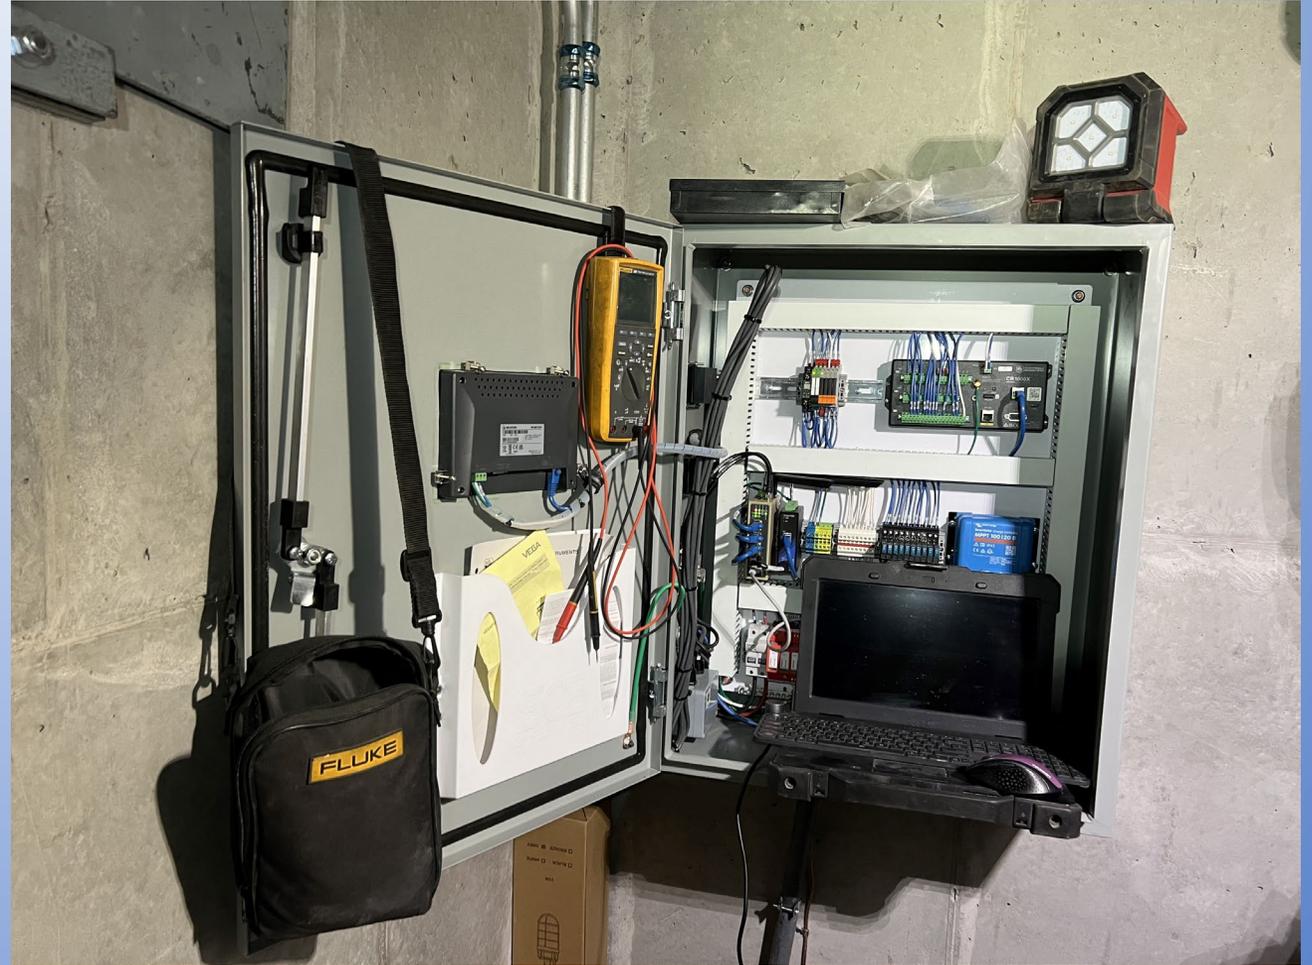
# Controls Construction

- Bringing Pre-assembled Materials Significantly reduced onsite time and risk of missing parts...unlike those 5/8 inch SS anchor bolt nuts
