A Reservoir Level Restriction Toolbox

Brent Zundel, PE, CFM
MT DNRC

Jeremy Franz, PE
CO DWR

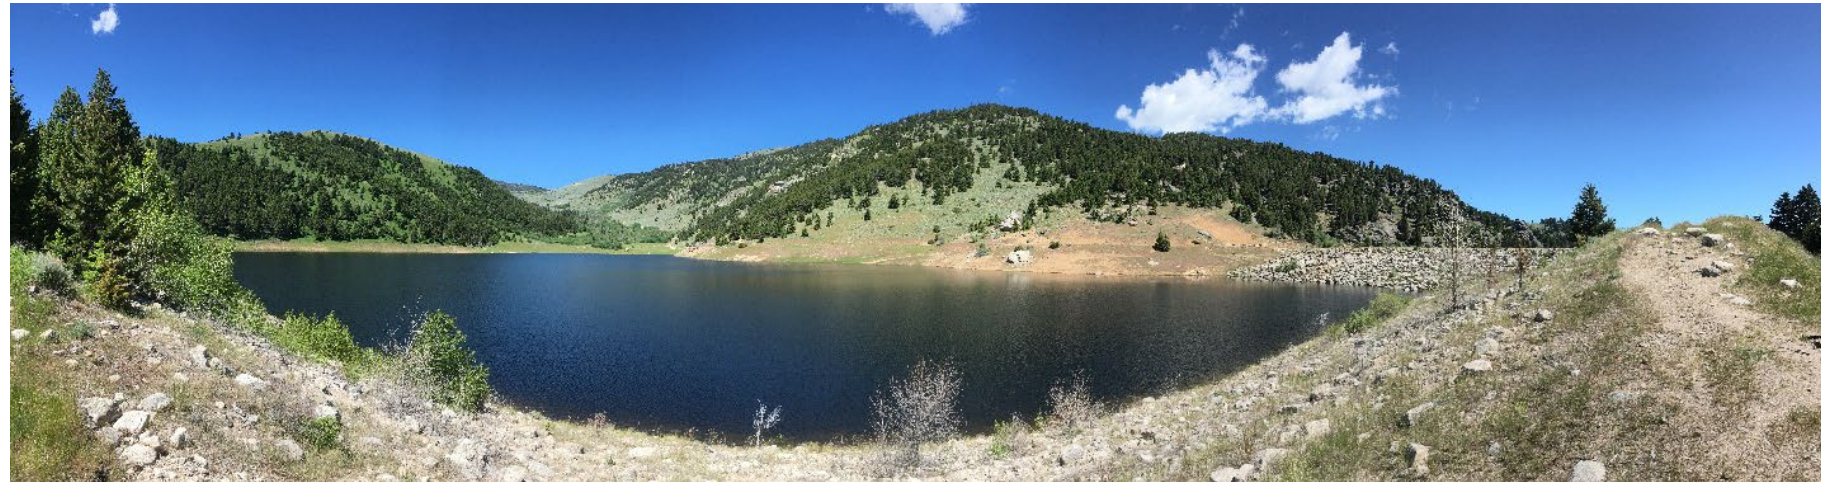
Case study – Muddy Waters

- 1950s construction, 80-ft, 1,500 AF high-hazard dam
- Historically very high seepage rates through embankment, glacial moraine – failed grouting attempt
- Sinkholes in reservoir; seepage upwelling downstream

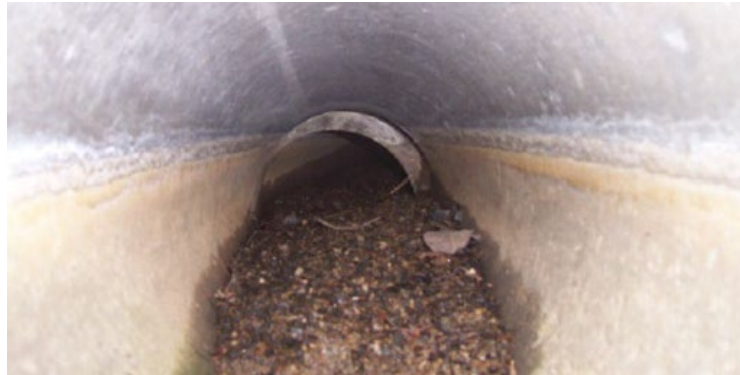
Case study – Muddy Waters

- Back-to-back “first fills” in 2010s
- Evidence of internal erosion

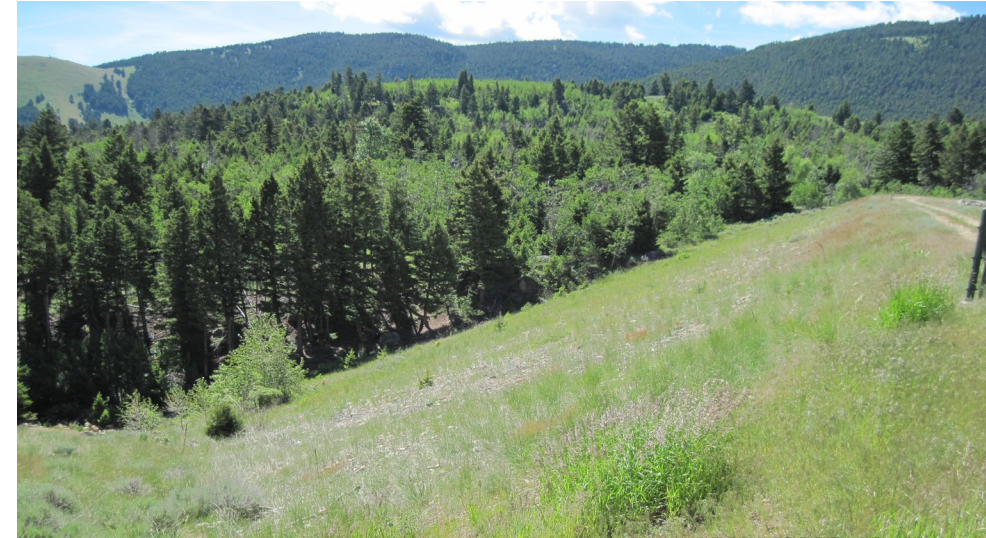
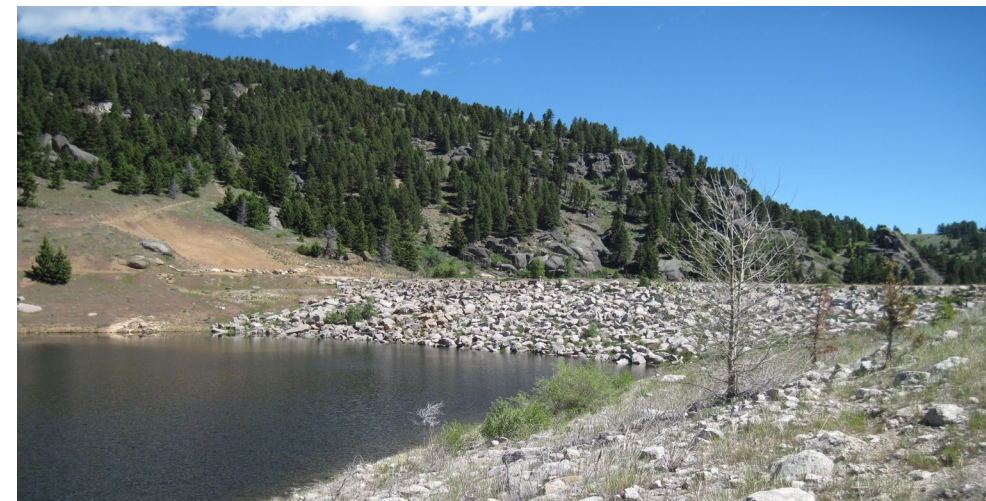
Case study – Muddy Waters

- Historical inspections: Drain flow initiates at 23 ft below spillway
- Recent measurements:
- Drain flow of 30 GPM at this elevation
- No sediment if flow under 20 GPM
- Restriction set 28 ft (1,000 AF) below spillway to minimize/eliminate flow
- Remote monitoring

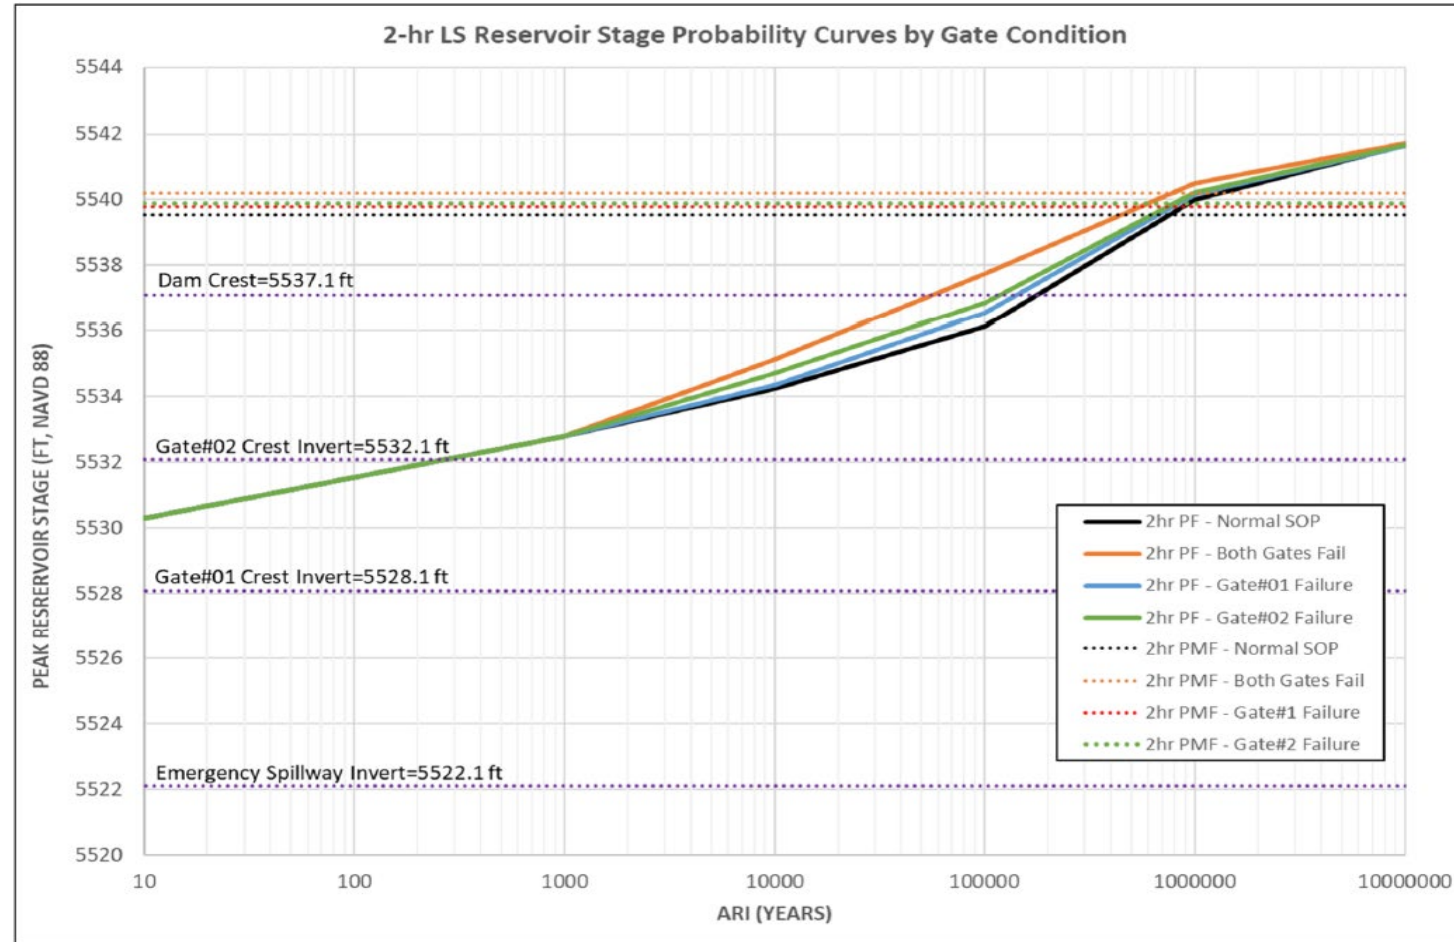
Hydrologic

- Example loading curve

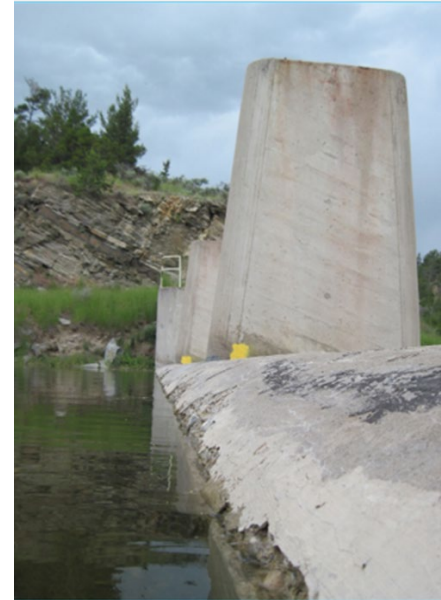
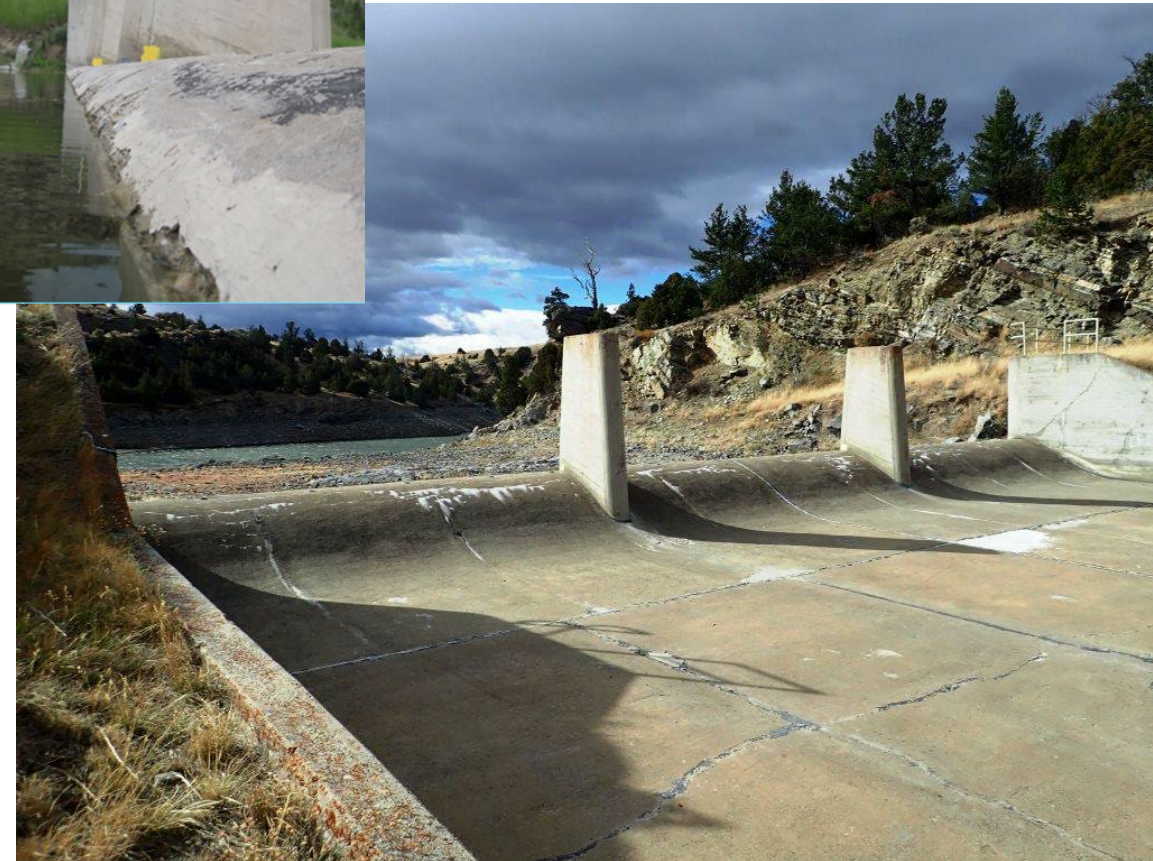
Case study – Stovepipe

- 20+ years of spillway deterioration (spalling, delamination, exposed waterstops)
- Extensive deficiencies discovered: joint-faulting, sub-slab voids, ASR

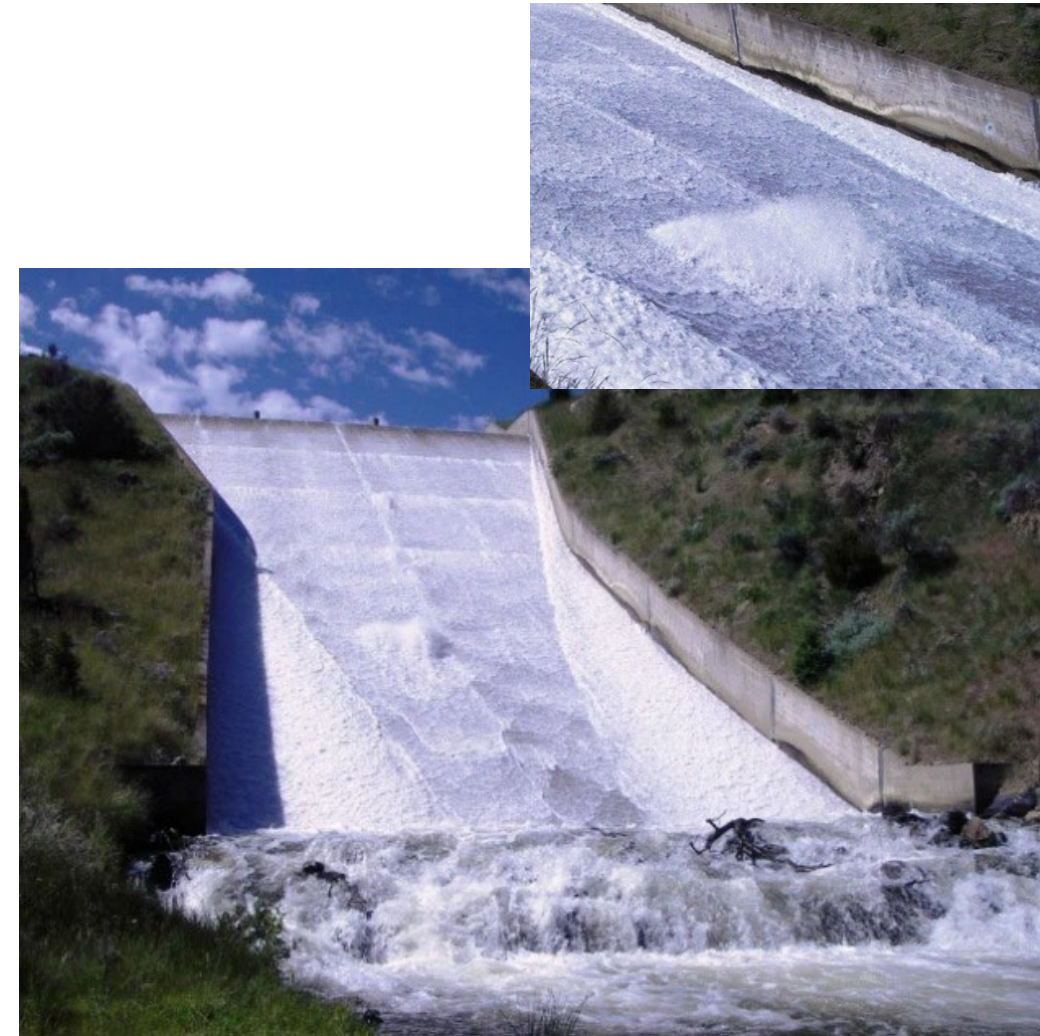
Case study – Stovepipe

- Review of historical spillway performance to recommend max depth over ogee crest
- Outlet 350 CFS + spillway 100 CFS = 450 CFS
- Pass routed 1% AEC event

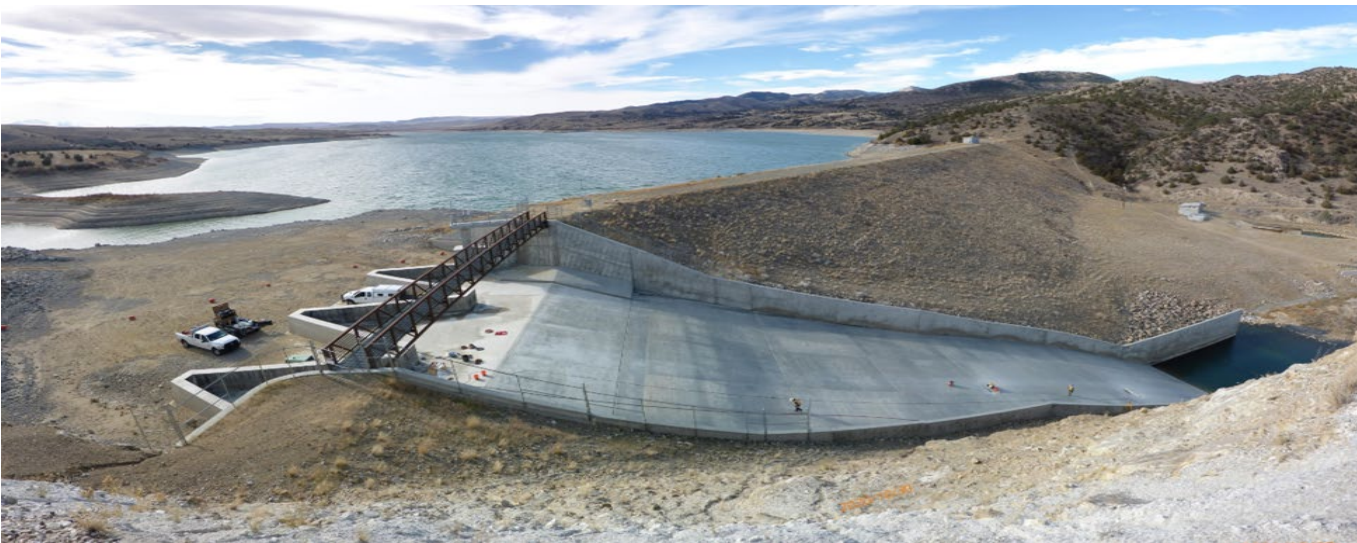
Case study – Stovepipe

- Restriction of 4 ft / 3,200 AF
- Owner + regulator
- Feasibility study underway

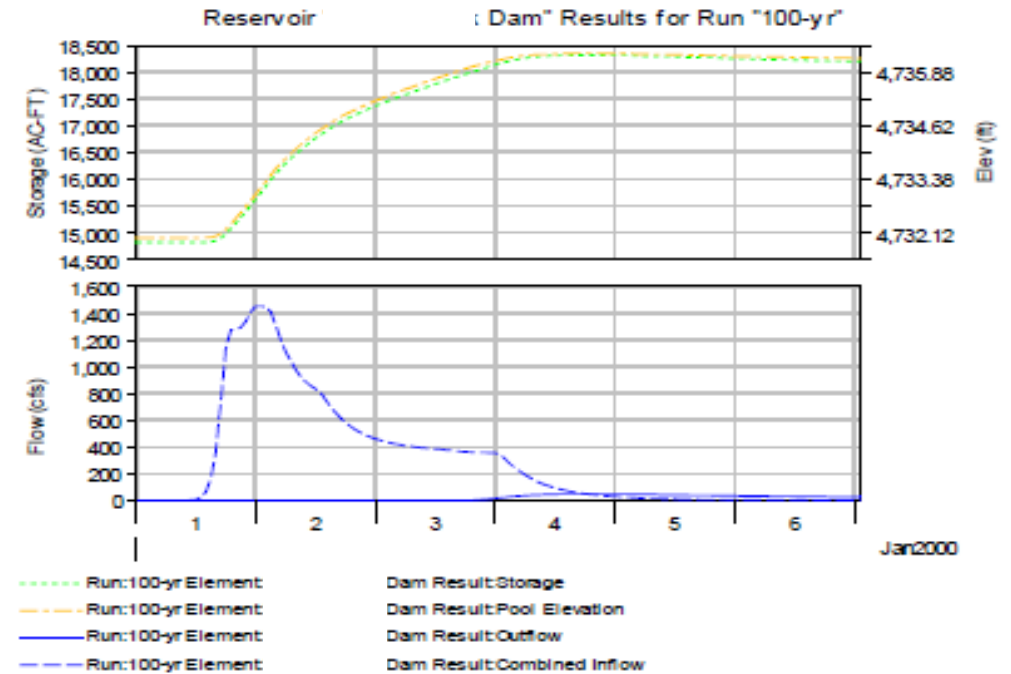
Figure B-1b 100-year inflow, Initial elev. = 4732.0

Max outflow: 47 cfs (4,736.3 ft)

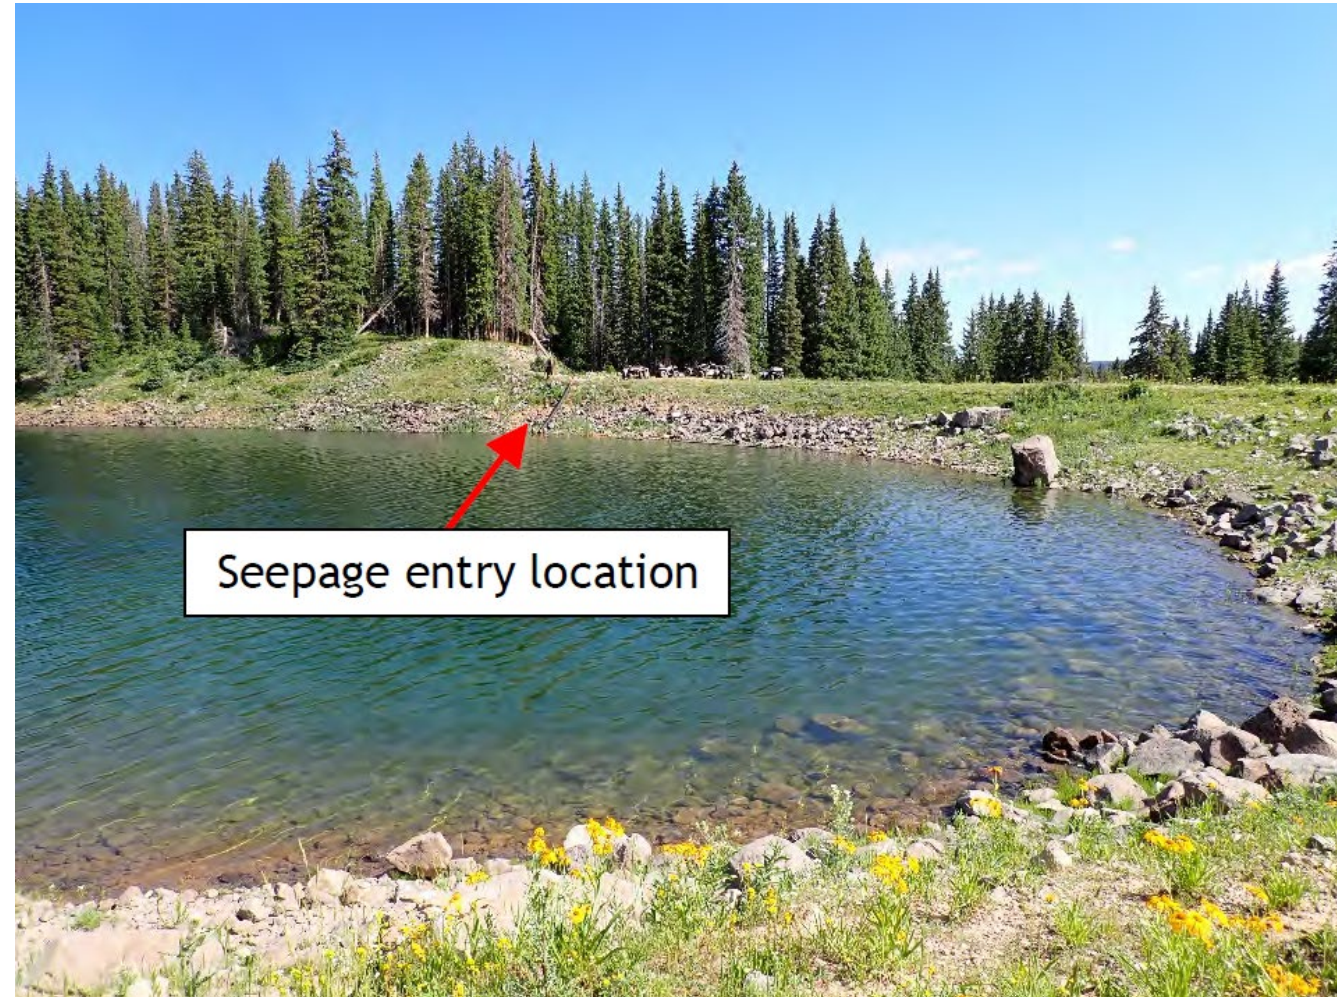
Risk-based case study – Lion Pool

- 2022 inspection revealed seepage entry point at upstream groin
- Relatively impervious embankment on pervious foundation
- PFM of concern: contact erosion of embankment fill adjacent to pervious foundation
