# Montana Association of Dam and Canal Systems

*Is your Diversion Structure a “Drowning Machine”?*

*Actions you can take to Improve Safety*

Karl Kingery, P.E., CFM

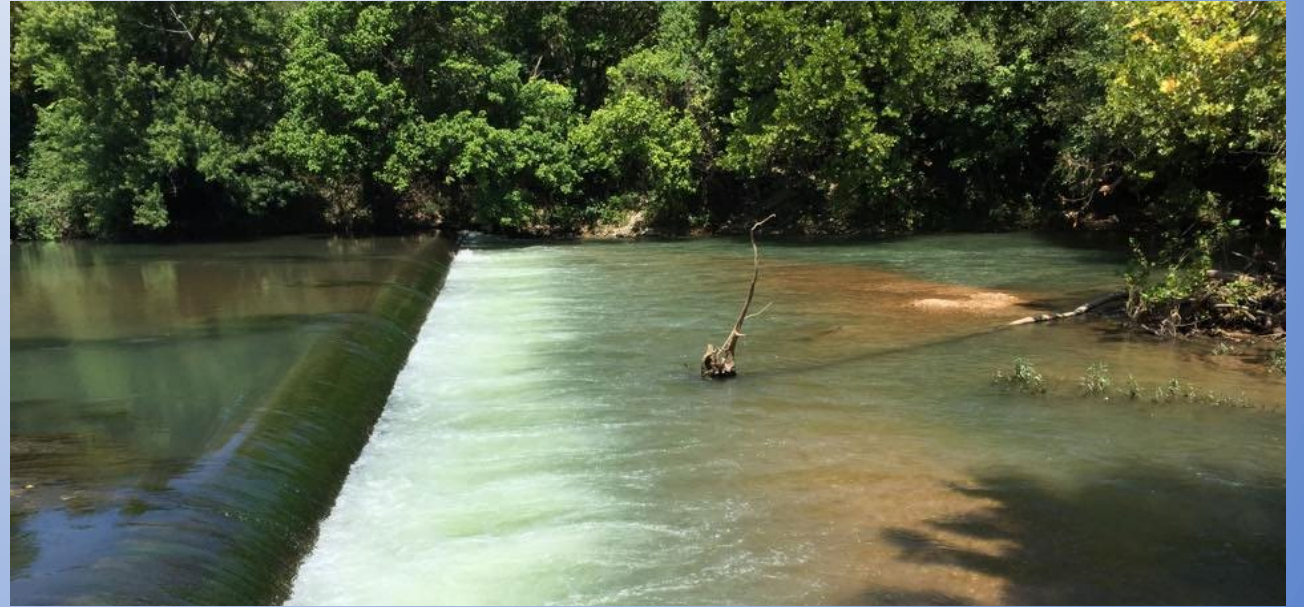
# Noticeable Features

- There is often a noticeable drop in water elevation when not “flooded out”, although this drop may only be a few inches.
- Low Head Dams often have smooth water upstream of the dam.
- There is often a noticeable “boil” downstream of the dam.
- Under some hydraulic conditions, there is an aerated zone at the bottom of the dam.

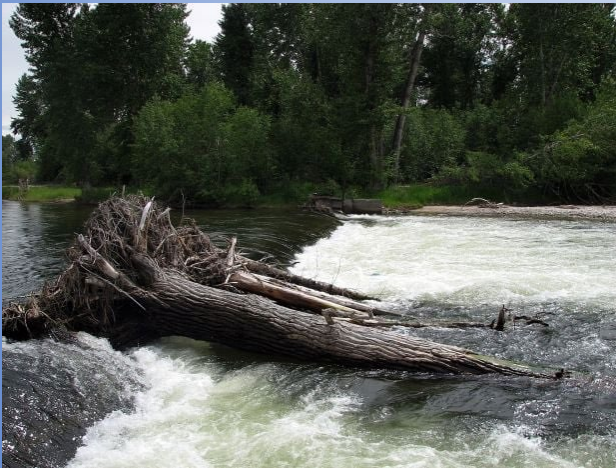
Pre-Construction (2013)

- Supply Ditch Headgate Diversion Dam on the Bitterroot River

- Supply Ditch Headgate Diversion Dam on the Bitterroot River.
  - Pre 2011 – History of accidents at low head dam and frequent calls for help from Ravalli County Search and Rescue and Fire Departments; Some signs in place;
  - 2011 - High water caused that stretch of the Bitterroot to shift, sending the main river (and more boaters) through the eastern channel;
  - **June 23, 2013 - 6-Year-Old Girl Killed after her father's boat went over the dam and capsized;**
  - 2014 – Conservation District places signs at boat put-ins upstream from dam and near dam;
  - 2017 – Conservation District spent \$500,000 to modify the structure to make it safer to boaters.
    - \$300,000 from USACE,
    - \$125,000 from DNRC RRGL Grant Program,
    - \$40,000 from Montana FWP.

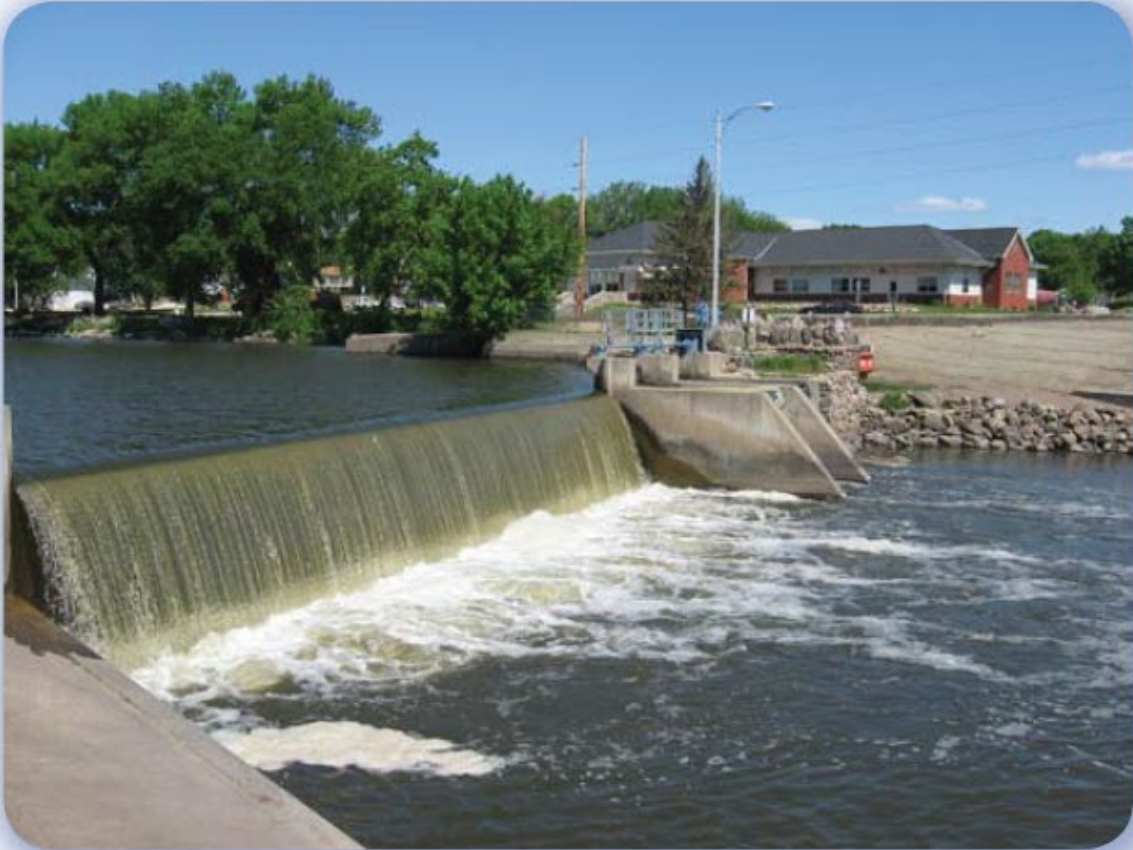
*Before*

# ROCK RAMP

Upstream view of dam from right bank

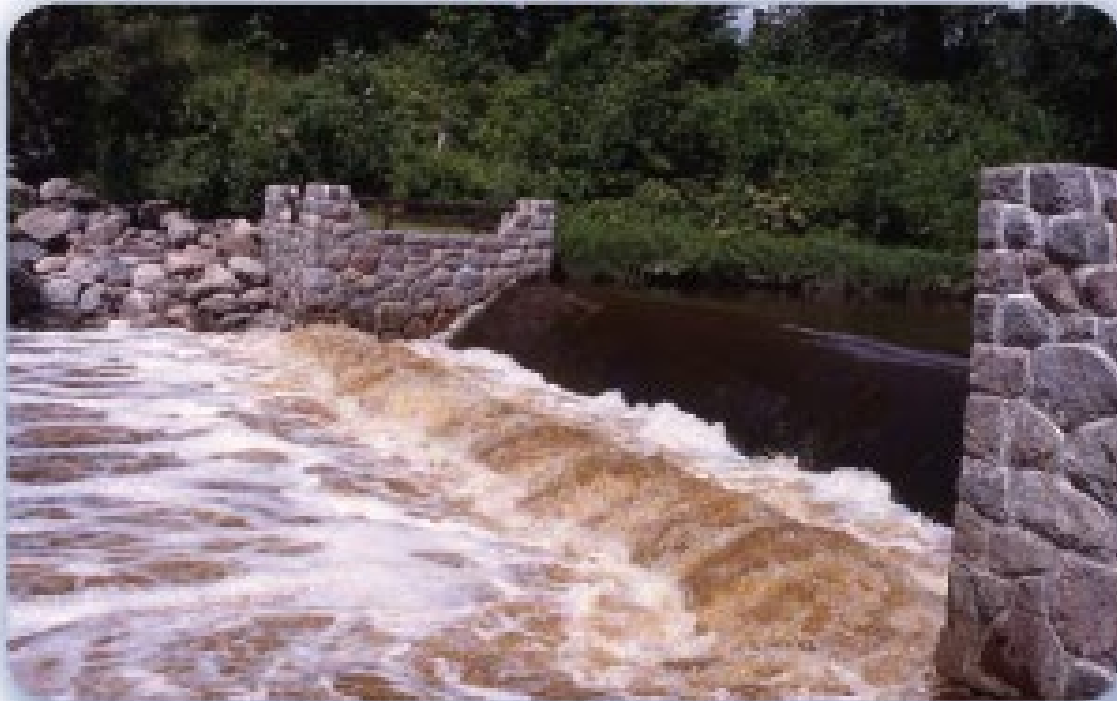
*Before*

Upstream view of dam during high flow

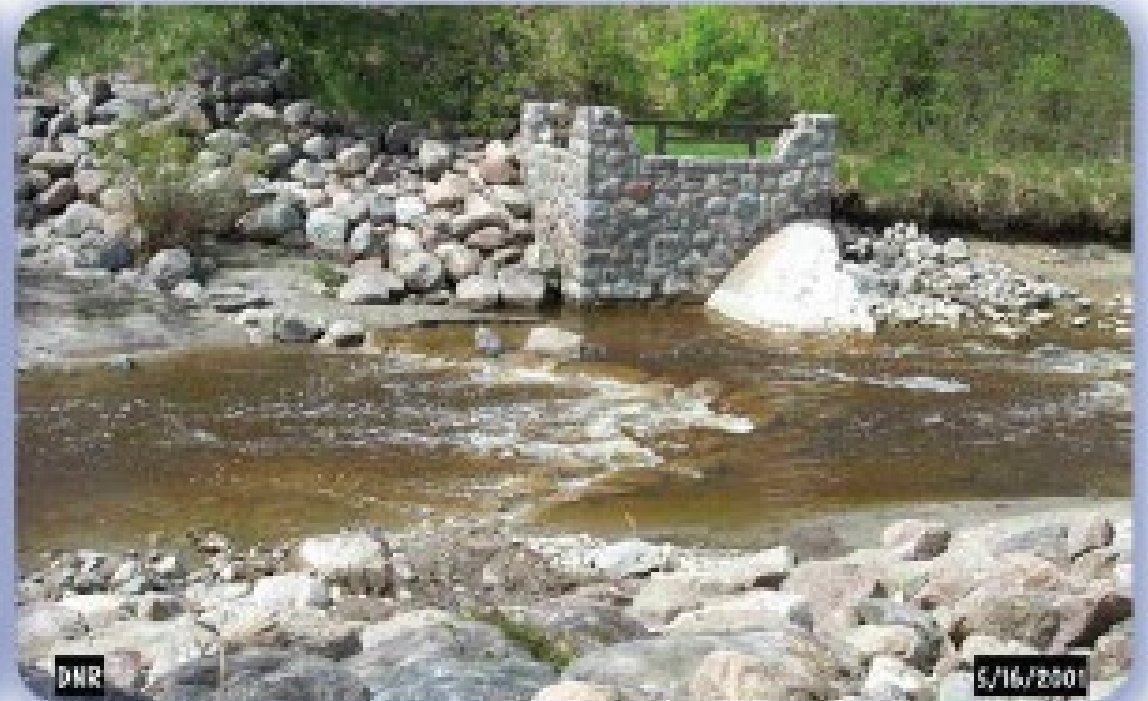
*After*

Upstream view of removed dam and constructed boulder weir
