MADCS Conference 2025

Low Level Outlet Forum

Montana Association of Dams and Canal Systems

What is a low-level outlet?

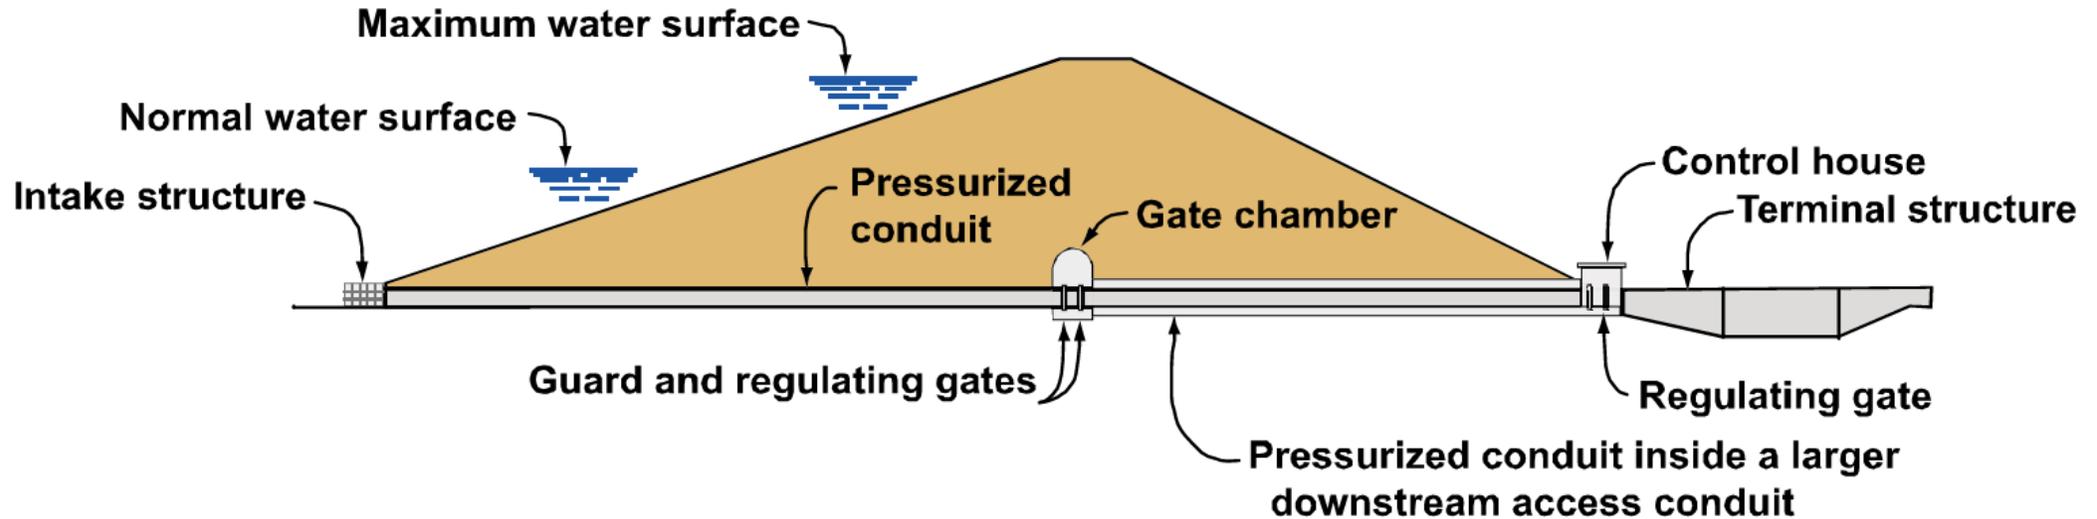
1 – Intermediate Control, downstream access

- Internal and external access for inspection of downstream portion
- Redundant and emergency closure provided by guard gate
- Pressurized conduit mitigated by hydrostatic pressure and access conduit

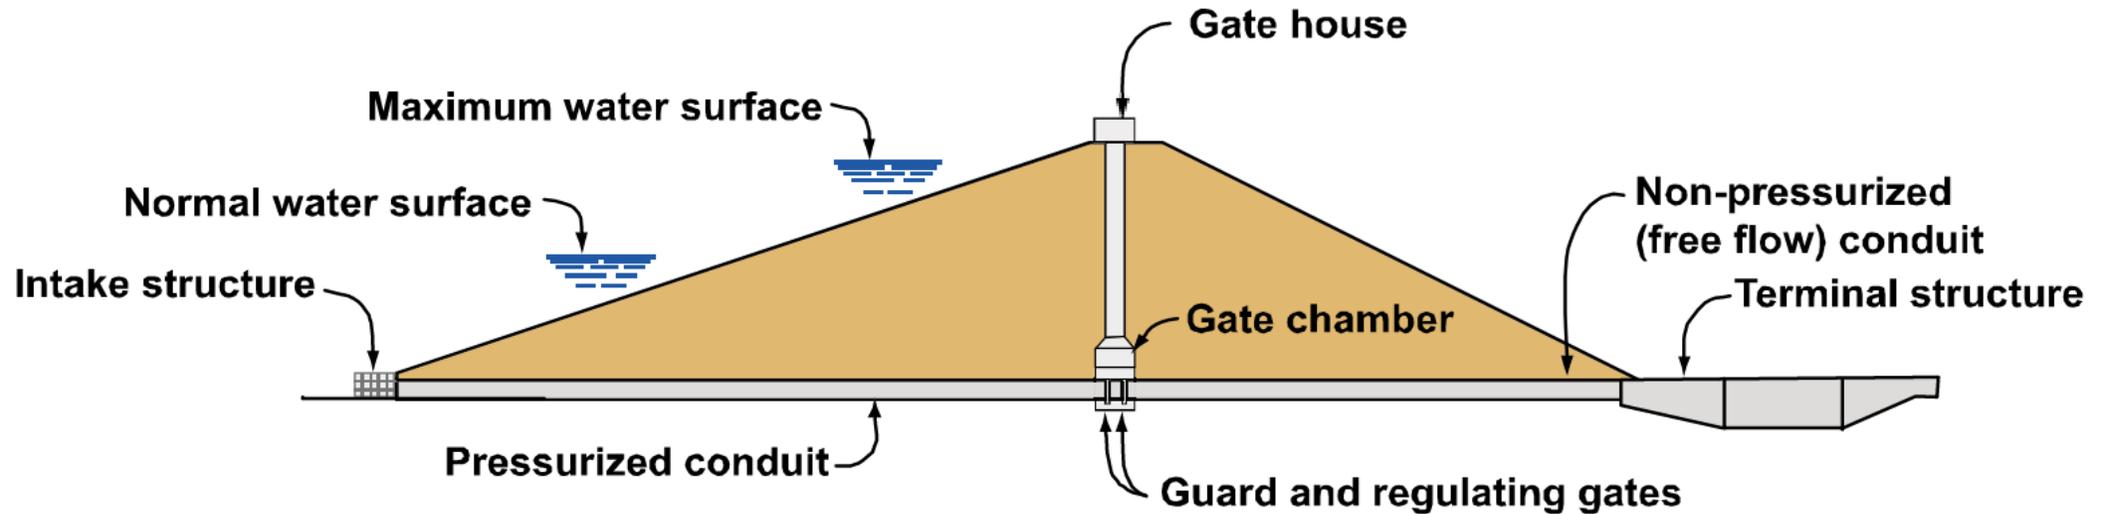
2 – Intermediate Control

- Internal access to downstream half of conduit only
- Redundant and emergency closure provided by guard gate
- Pressurized conduit mitigated by hydrostatic in upstream embankment, non-pressurized in downstream embankment

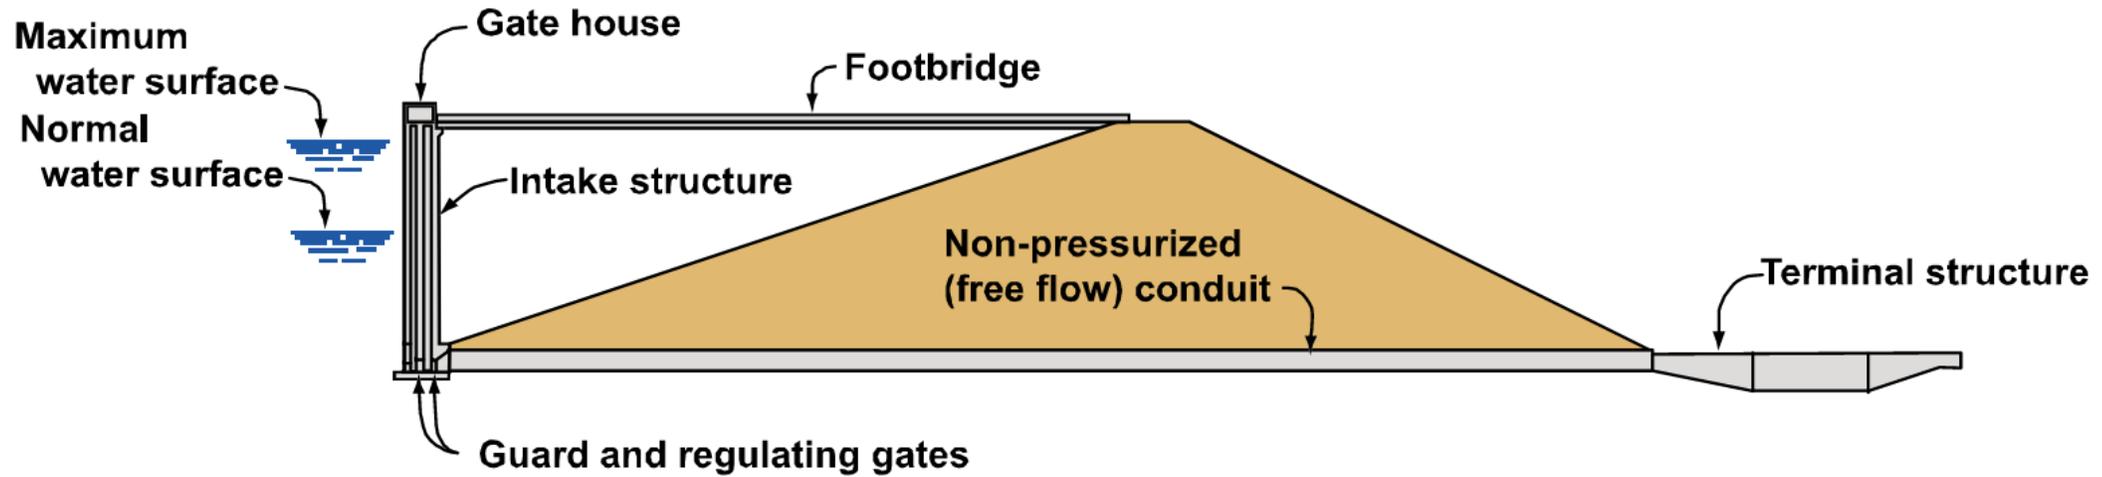
3 – Upstream Control

- Internal access to entire length of conduit
- Redundant and emergency closure provided by guard gate
- Non-pressurized conduit for entire length

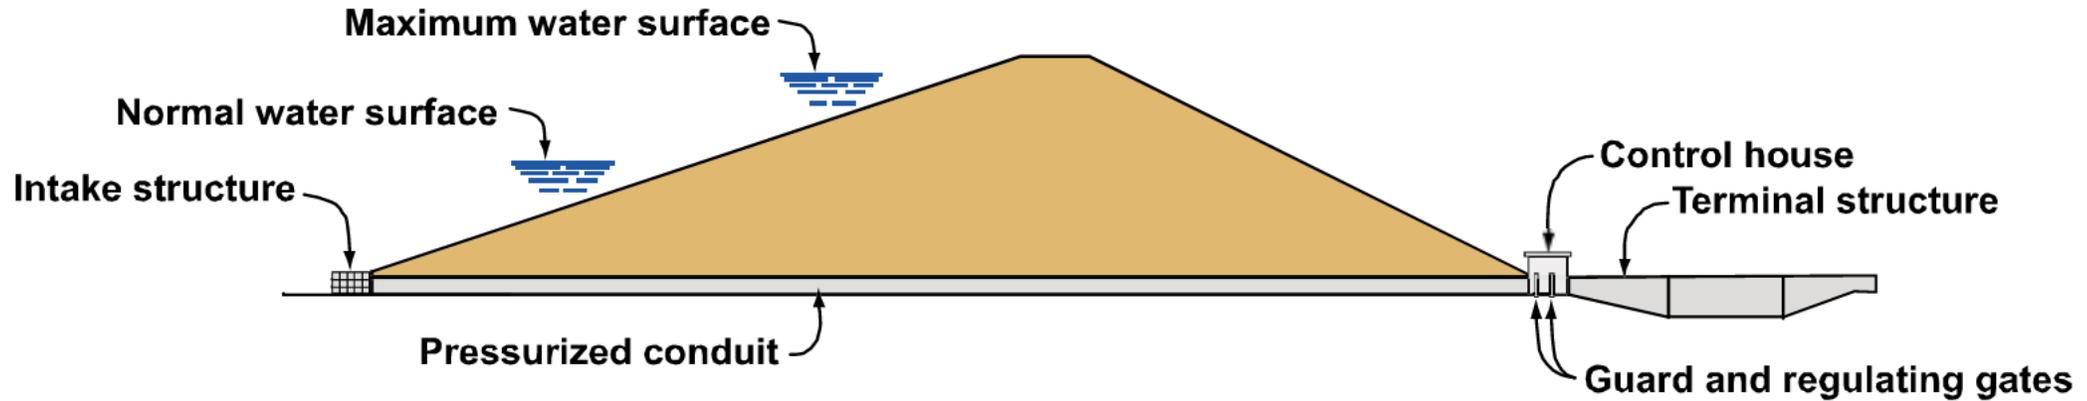
4 – Downstream Control

- No access to conduit
- No emergency closure or conduit dewatering possible
- Pressurized conduit for entire length

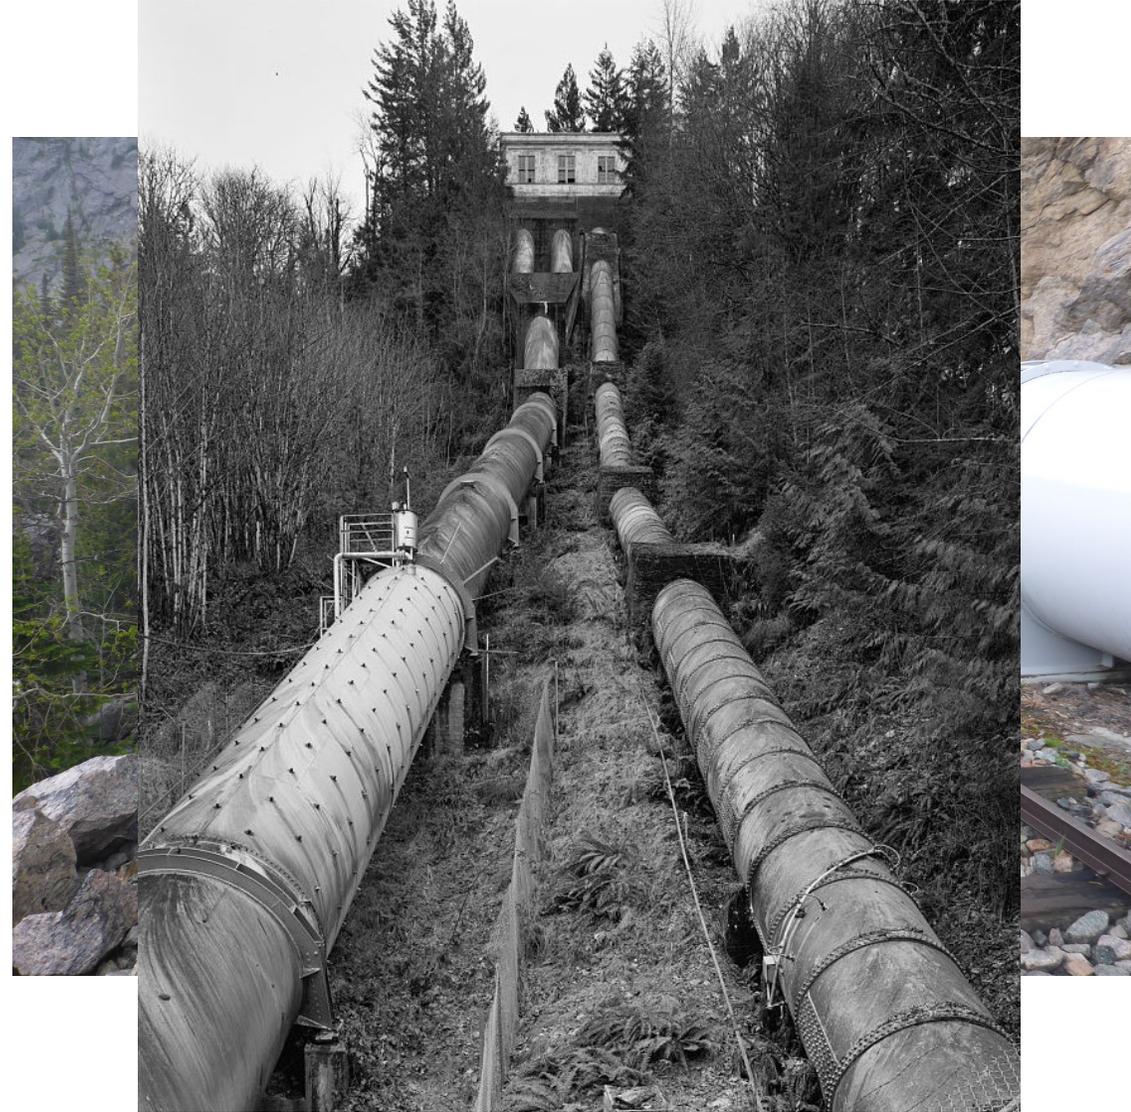
Conduit Materials - Steel

The old guard. Widely use for more than a century for all sizes and configurations of outlets. Alloys and methodologies have evolved from rivets to robot-welded. High pressure capability for penstocks.

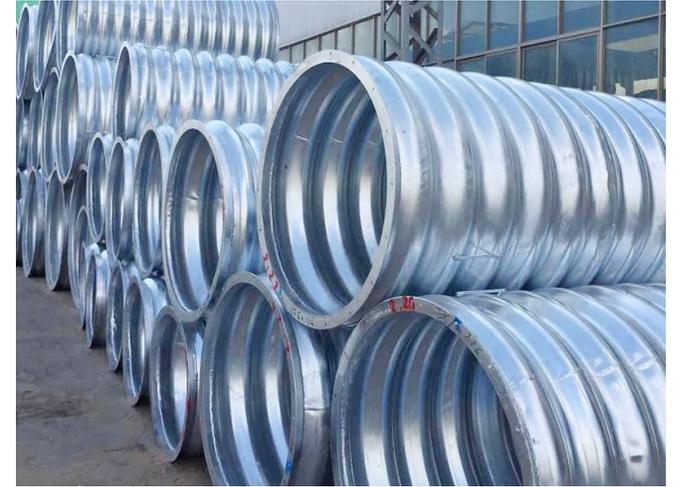
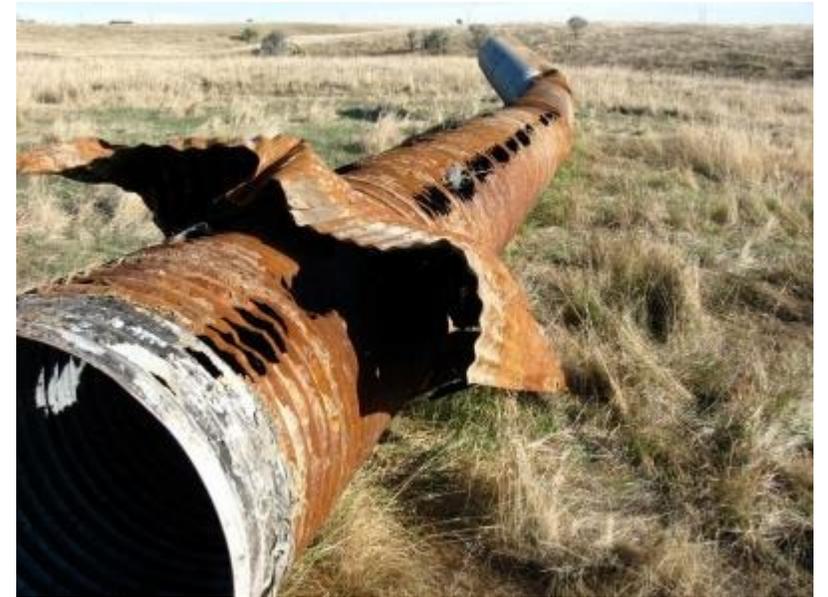
Conduit Materials – CMP

Very common in low-hazard dams due to low cost and simple installation. Only really suitable for storm drainage culverts under low-traffic roads. NOT suitable for high-hazard dams.

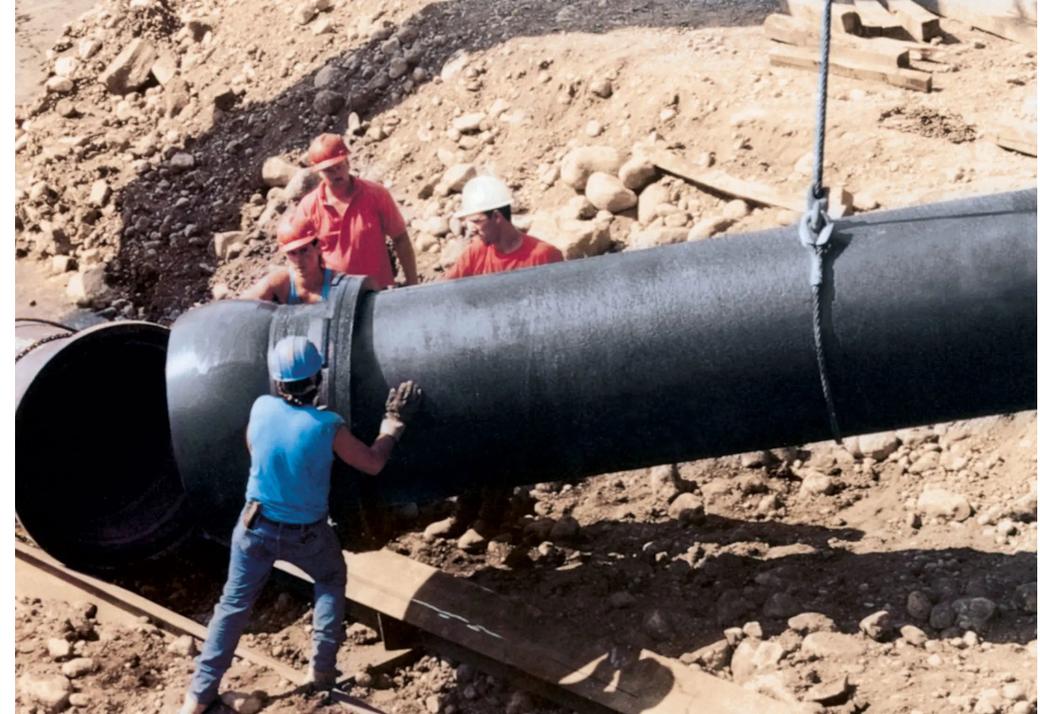
Conduit Materials – Ductile Iron

Not common in dams and irrigation but still in use for municipal utilities.

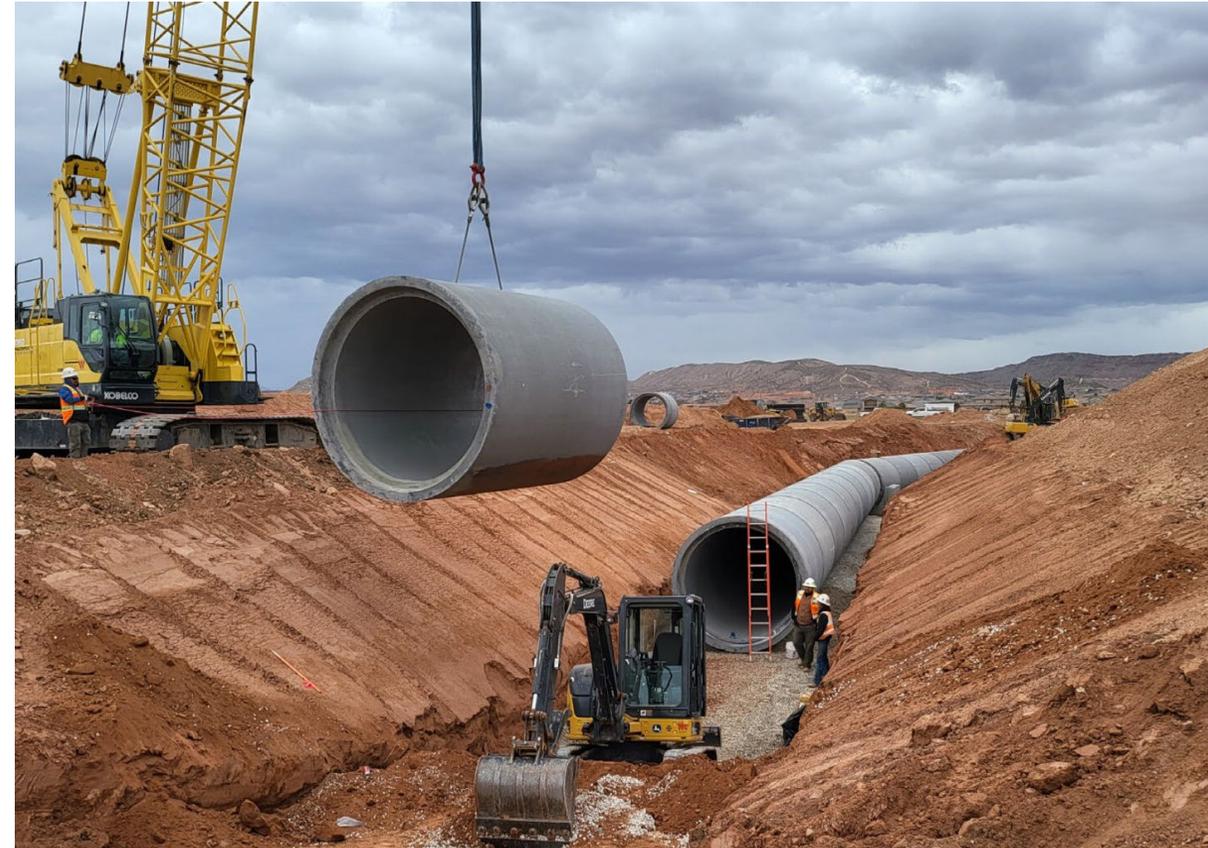
Conduit Materials – Precast Concrete

More common in storm drainage applications but in smaller sizes or with appropriate engineering and design considerations can be good solution for outlets.

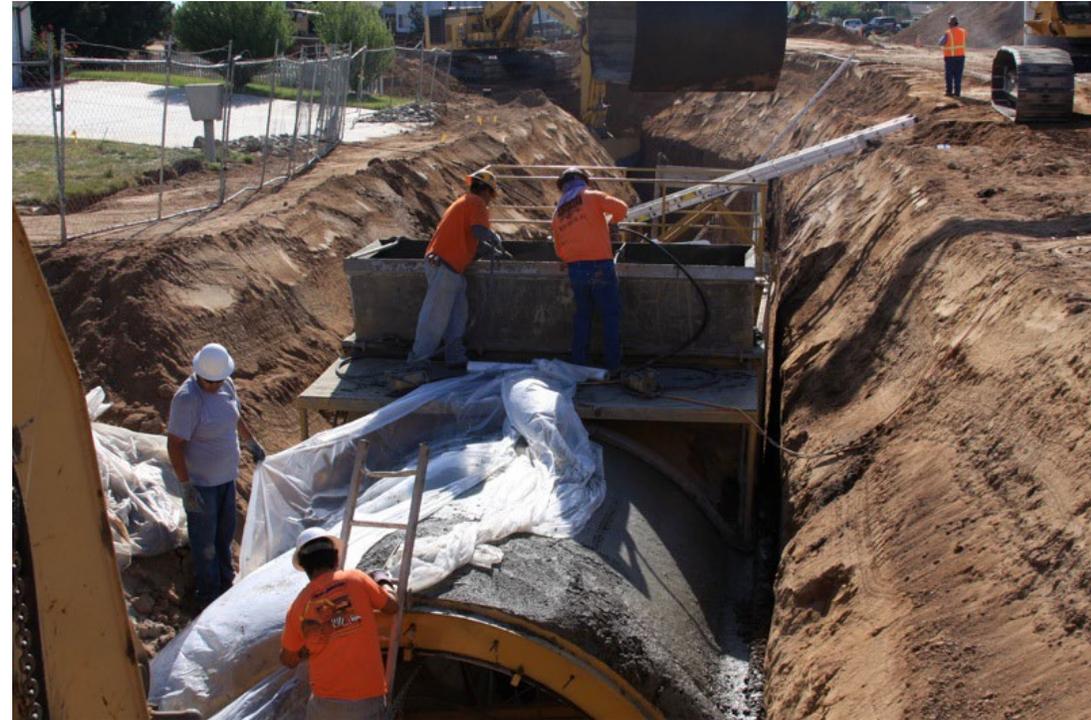
Conduit Materials – Cast-in-place Concrete

Infinitely customizable but requiring structural design and specialized construction. More common for very large outlets with linings

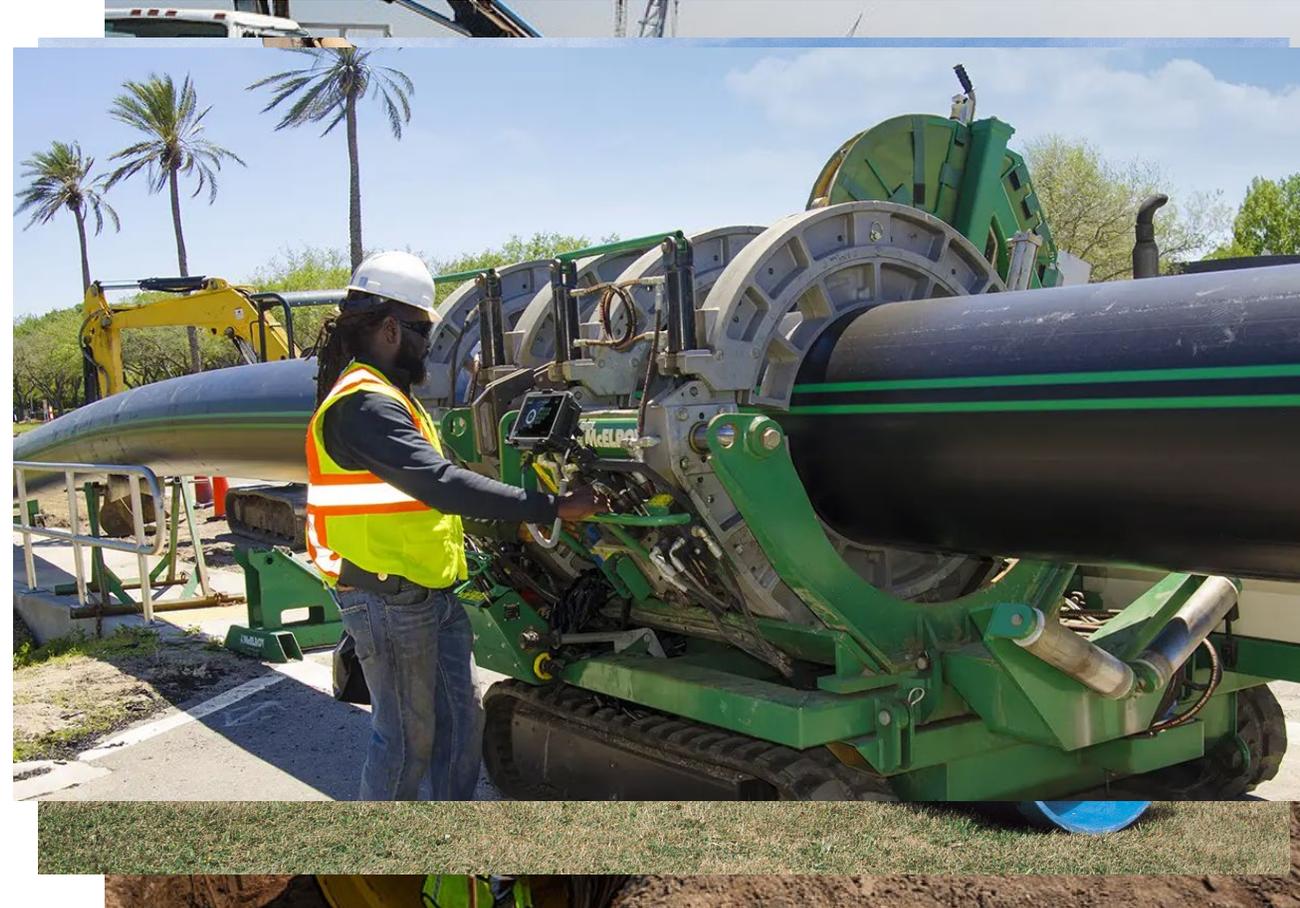
Conduit Materials – Plastic

For good or ill lasts forever. Big advances in recent decades in materials, sizes, jointing, installation. High hazard applications require addl. considerations

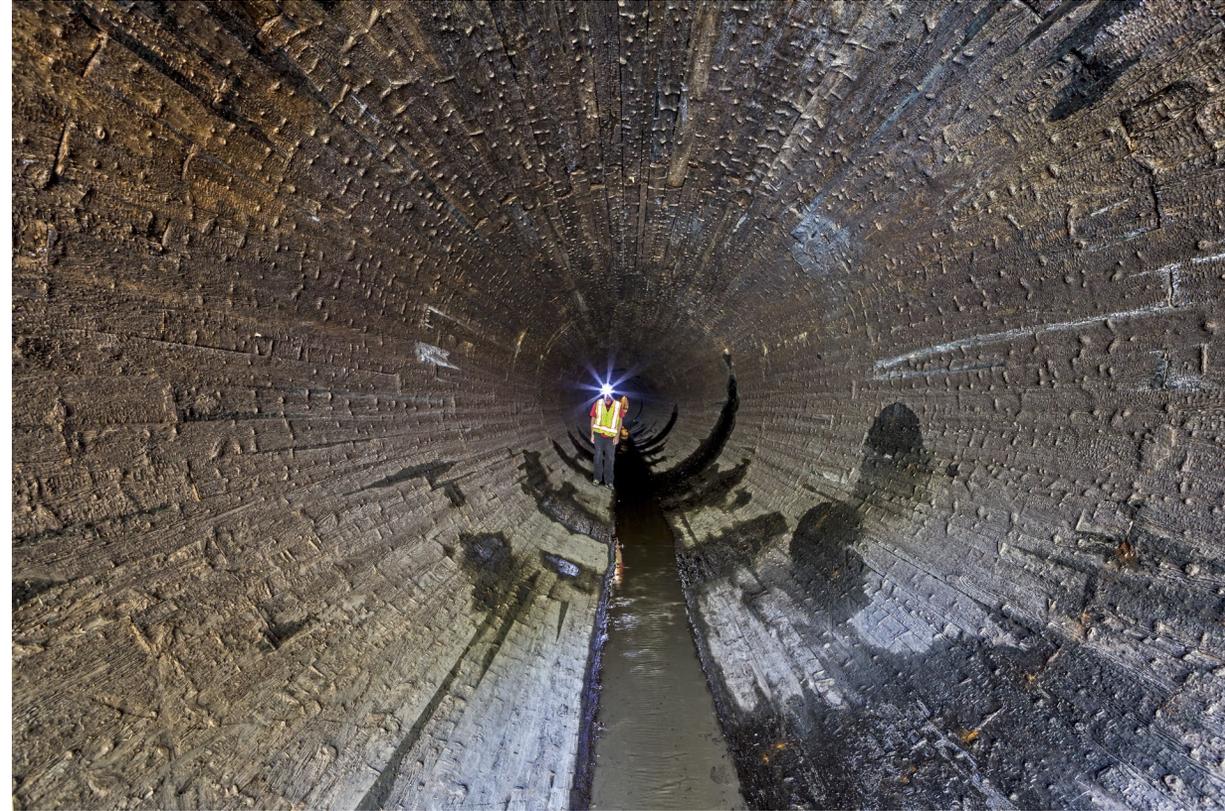
Conduit Materials – Wood Stave

Natural materials and widely adaptable.
Common a century ago but obsolete now.

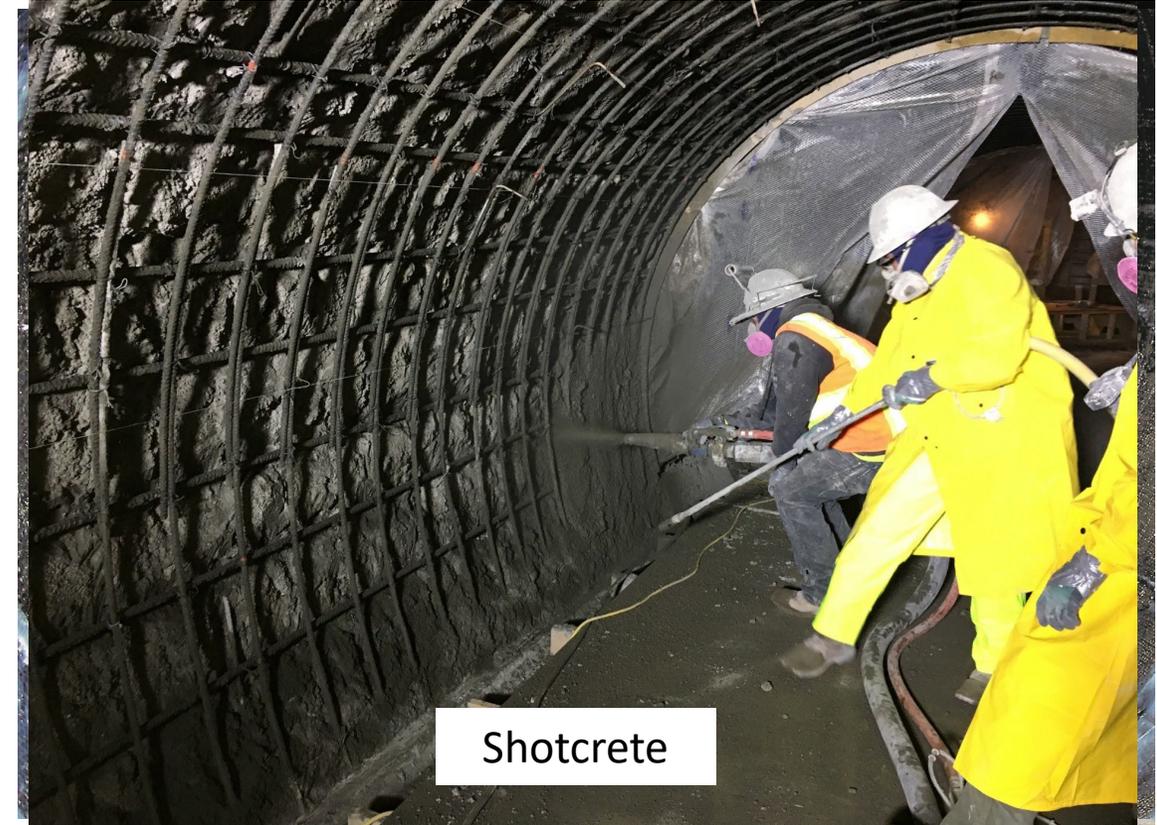
Conduit Materials – Linings / Rehabilitation

Various materials and methodology to extend the life of existing in-place conduit.

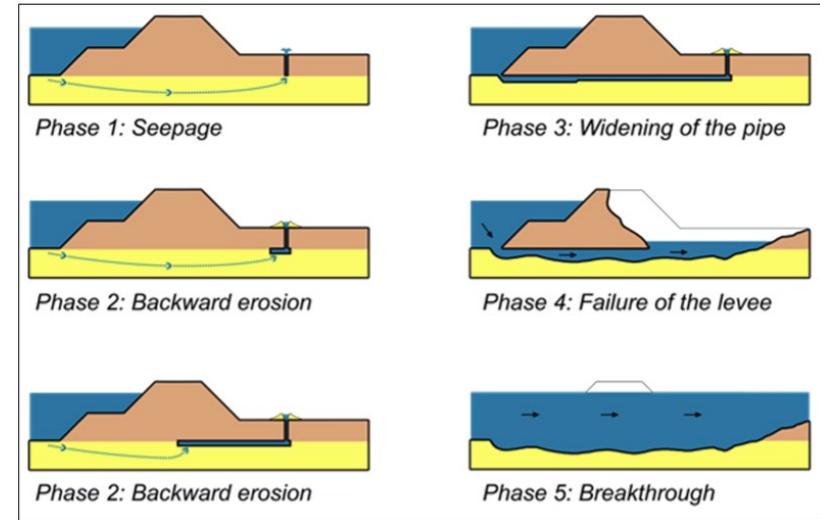
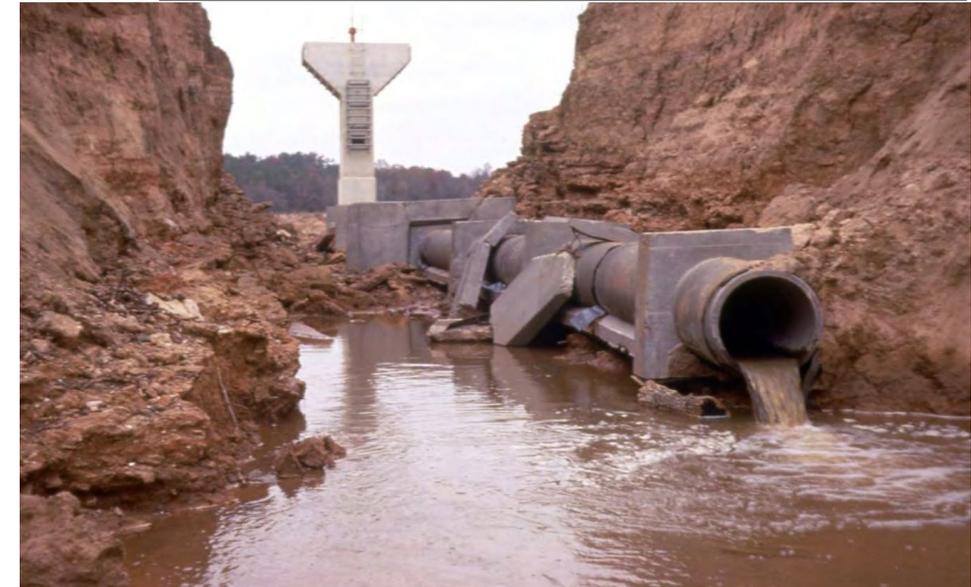
Embankment Considerations - Internal Erosion

- Cracks / defect / penetration (conduit?) / high gradient in embankment creates leak.
 - Leakage and gradient erodes finer-grained materials first
 - Erosion progresses in upstream direction
 - Forms a “pipe”
 - Progresses to failure
-
- Seepage collars are bad news
 - Make compaction more difficult
 - Don't address the source of the problem
 - Many instances of failure

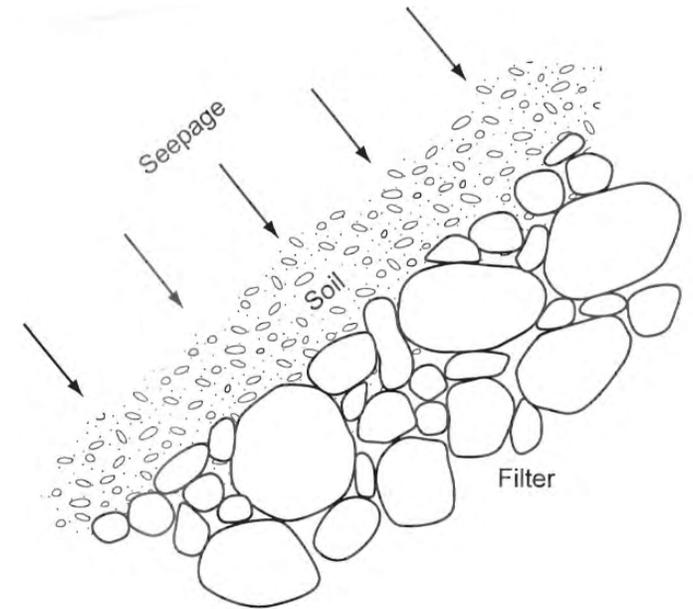
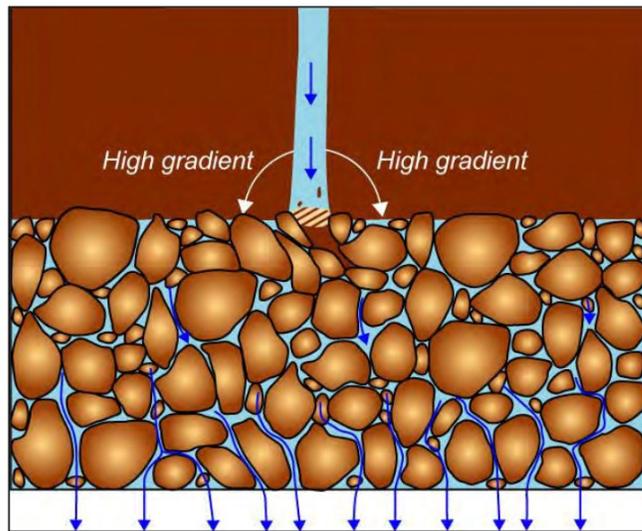
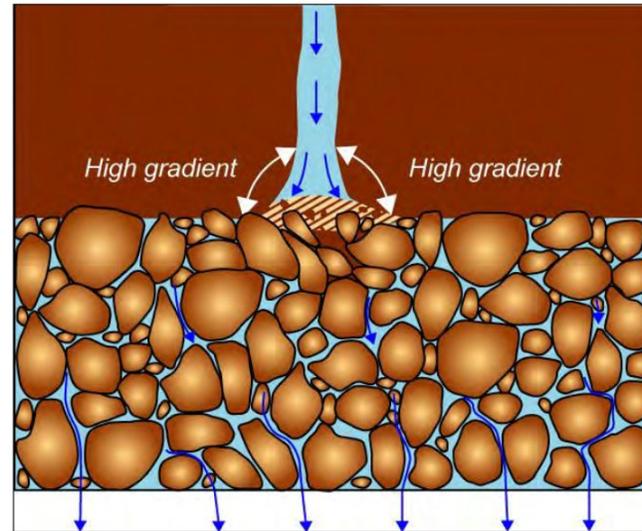
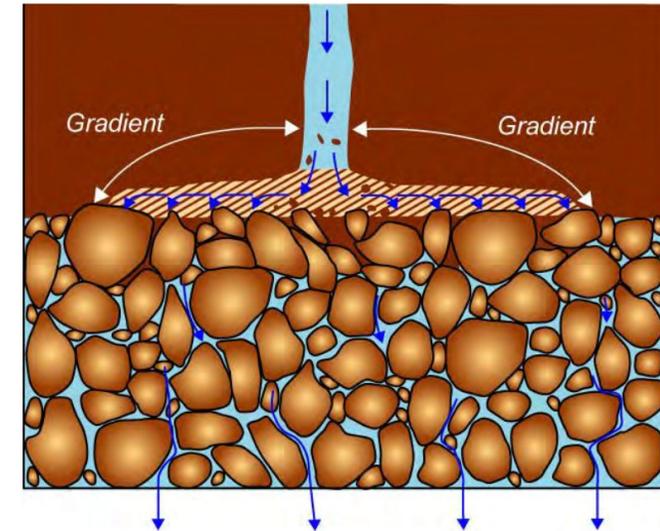
Embankment Considerations - Filters

Sand layer expressly designed to pass inevitable seepage but stop internal erosion of fine-grained soils.

- Couple with downstream drainage to reduce gradient
- Seepage monitoring provides early detection
- Vastly superior to filter fabric for high gradients

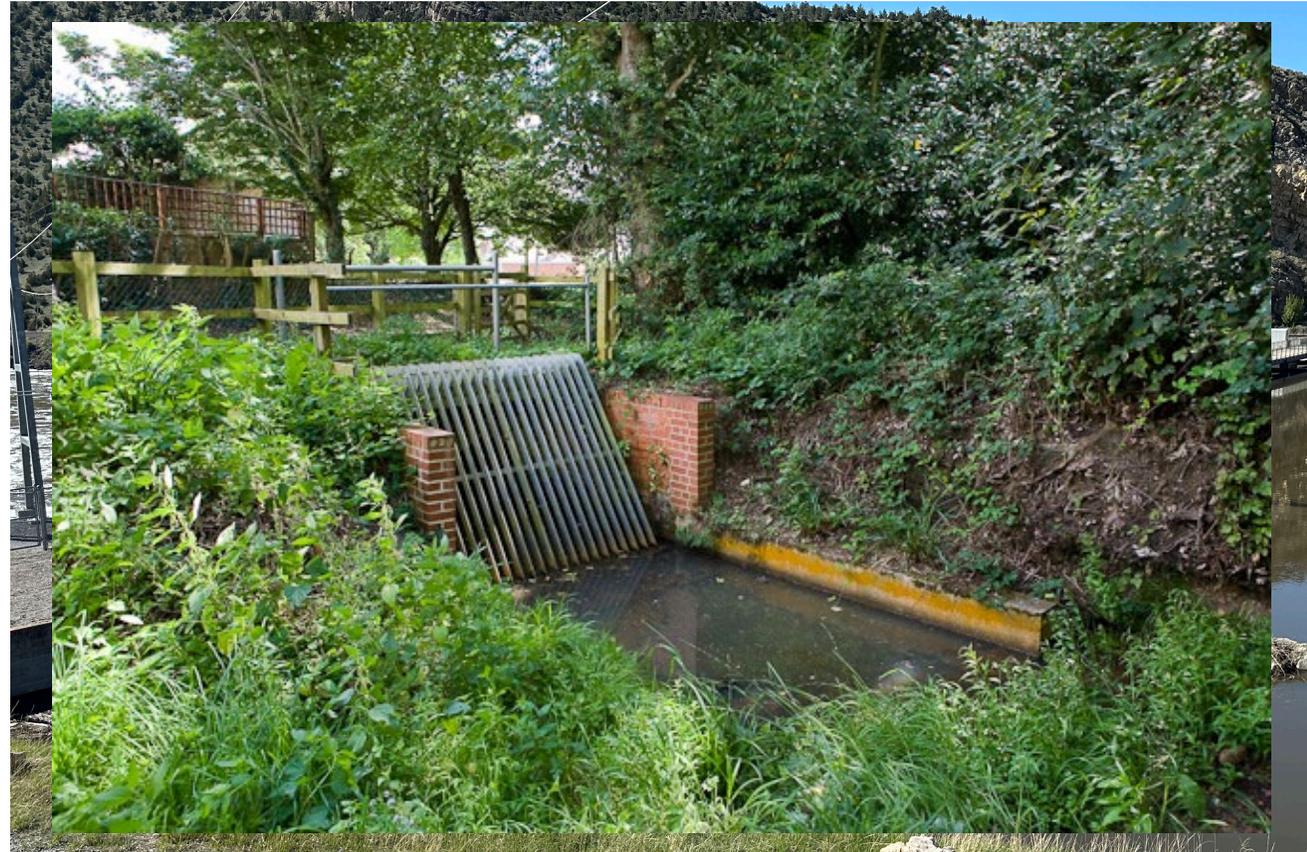
Intake Structures

- Controlled water intake
- Prevent erosion to embankment / foundation
- House gates
- Protect conduit and gates from debris
 - Grate
 - Trash screen
 - Trash rake
- Depth considerations
 - Head
 - Debris (type, size, floats/sinks)
 - Temperature
 - Dissolved O₂

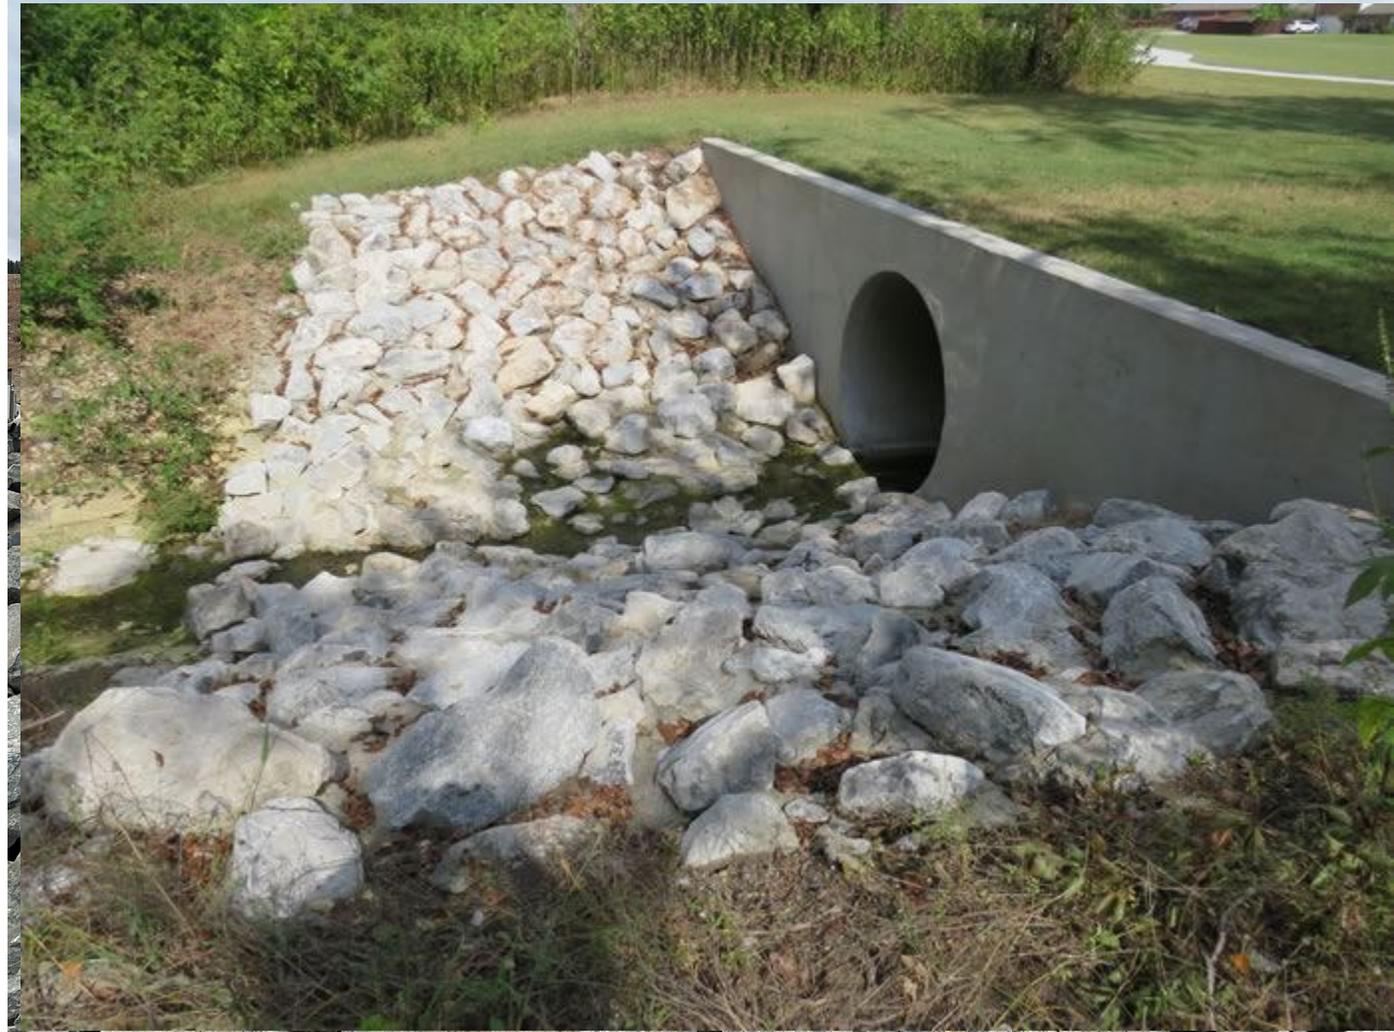
Outlet Structures

- Dissipate Energy
 - Prevent erosion at toe of dam
 - House gates / bulkheads (pressurized conduit)
-
- Design Considerations
 - Avoid cavitation velocities
 - Consider tailwater / potential submergence effects on hydraulics
 - Erosion will happen, plan for it
 - Consider scour / sidecutting /undercutting

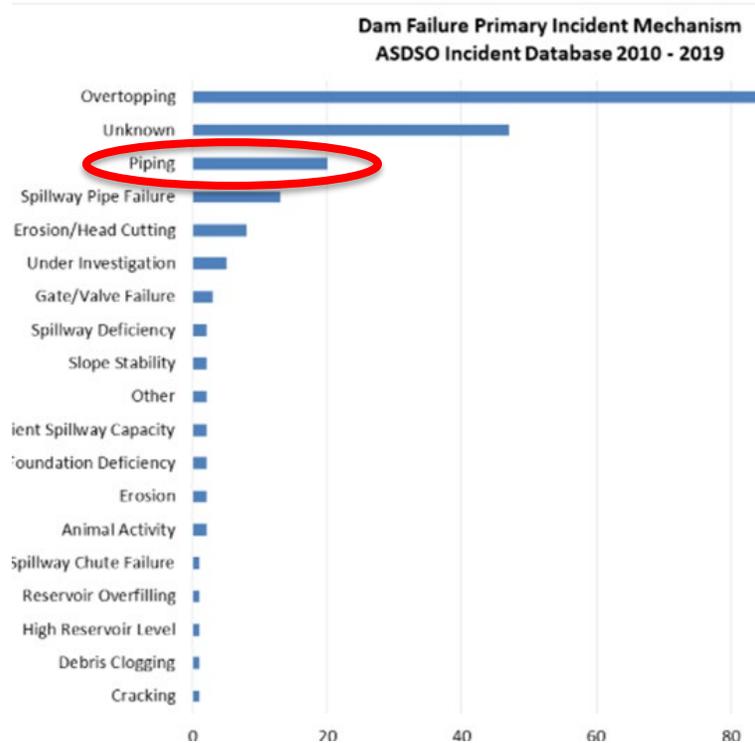
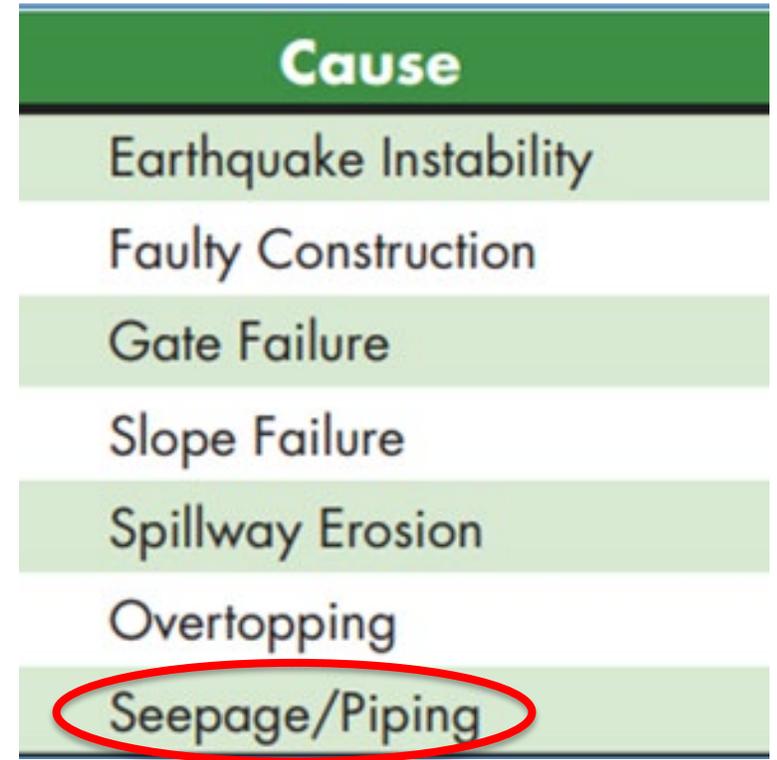
Potential Failure Mode (PFM): Internal Erosion (Piping)

Historically internal erosion (piping) is one of the primary causes of dam failures

Identified four primary Potential Failure Modes (PFM) associated with internal erosion

Chain of events

- Initiation – Conditions that trigger erosion (e.g. hydraulic gradient, soil erodibility)
- Progression – Erosion channels enlarge, forming pipes or tunnels
- Breach – Structural failure

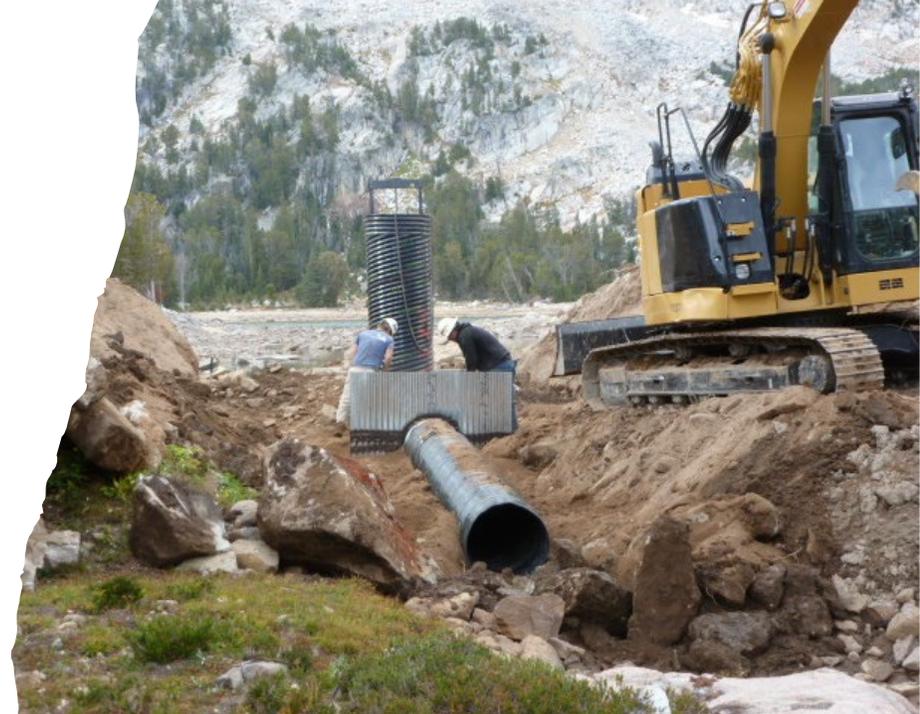
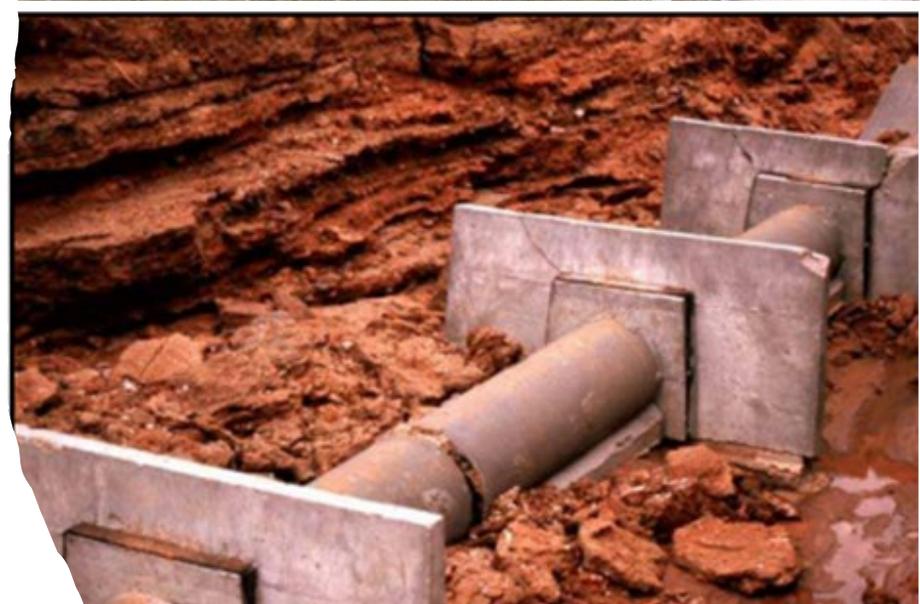
Anti-Seep Collars

- Impermeable diaphragm constructed at intervals along the conduit that passes through an embankment dam.
- Theory: forcing water to take a longer flow path along the conduit would dissipate hydraulic forces and prevent piping at the downstream toe.
- Lessons Learned:
 - Impeded proper compaction.
 - Low density zones => increased risk of hydraulic fracture and piping.
 - Root cause for many piping failures.
- State of Practice: use filter instead of anti-seep collars.

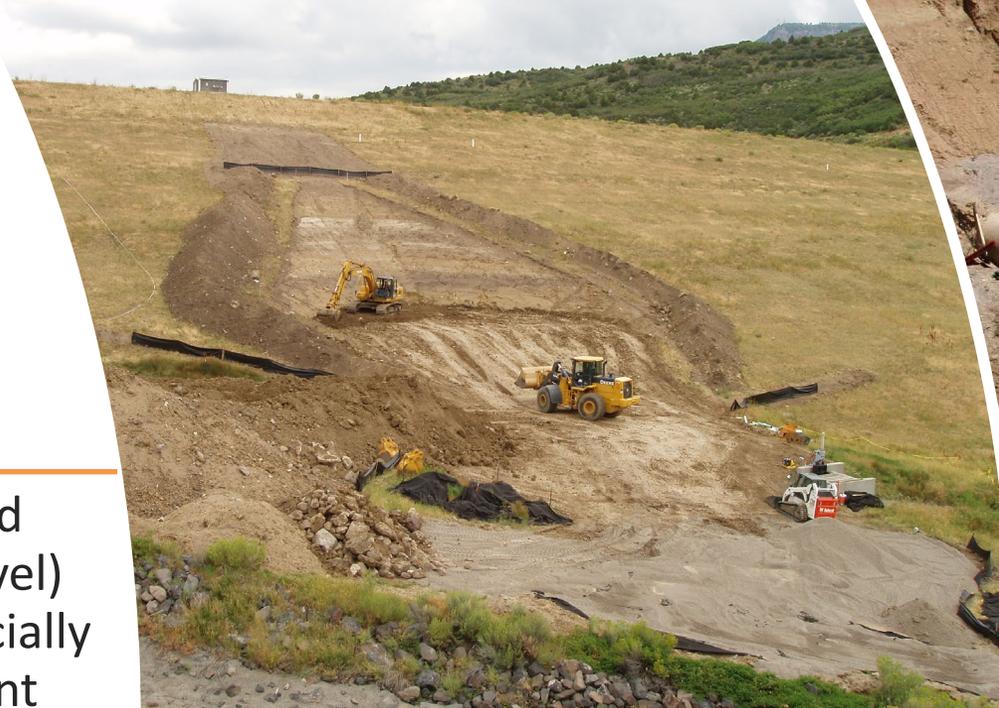
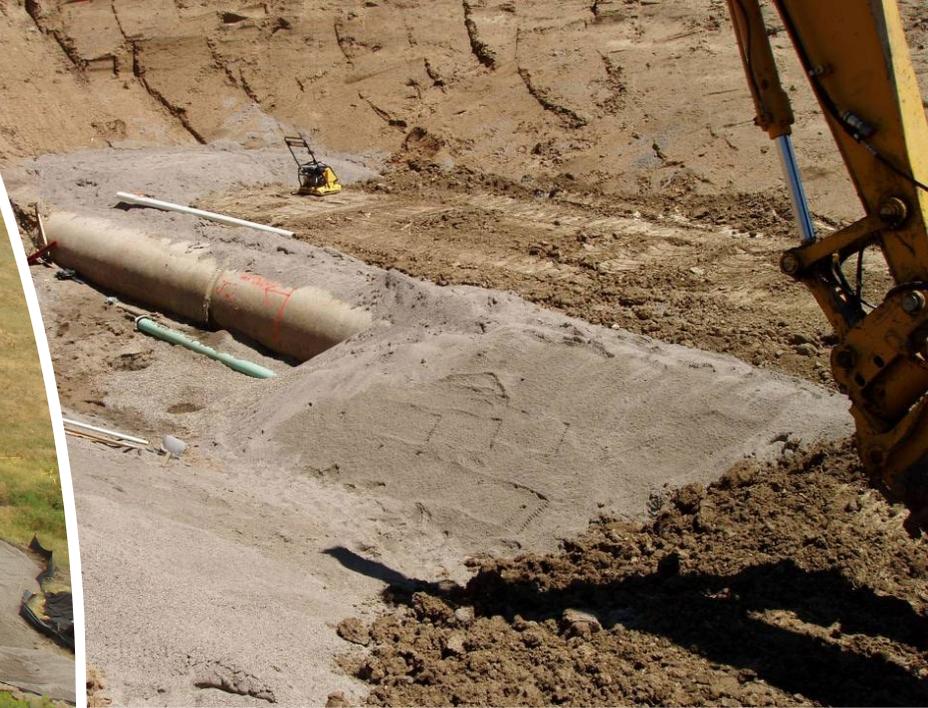
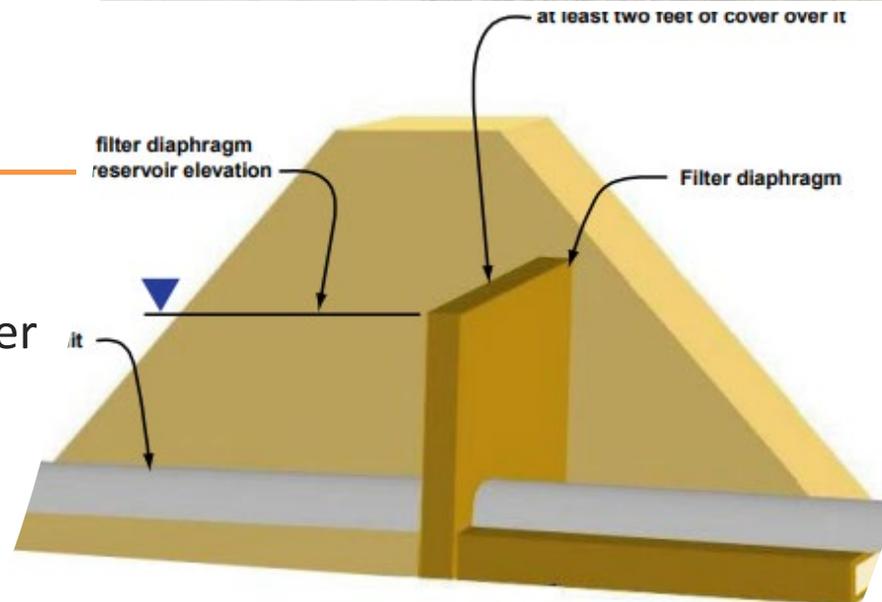
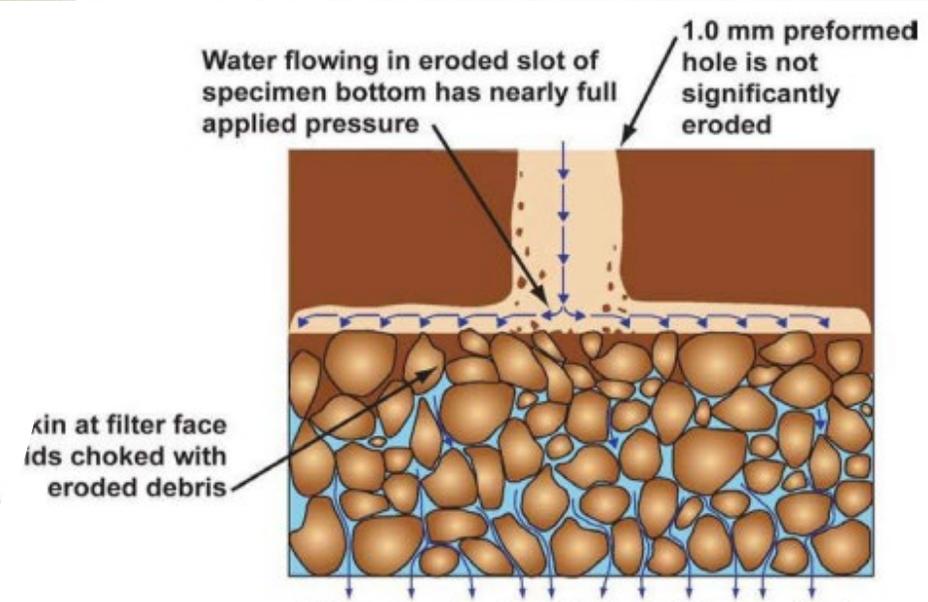
Filters in Embankment Dams

Zones of specially designed material (sand and/or gravel) placed within dams, especially around conduits, to prevent soil erosion caused by uncontrolled seepage.

Function is to intercept and block the movement of soil particles while allowing water to pass through, thus preventing internal erosion (piping) and embankment failure.
