MADCS Conference 2025

Low Level Outlet Forum

Montana Association of Dams and Canal Systems

What is a low-level outlet?

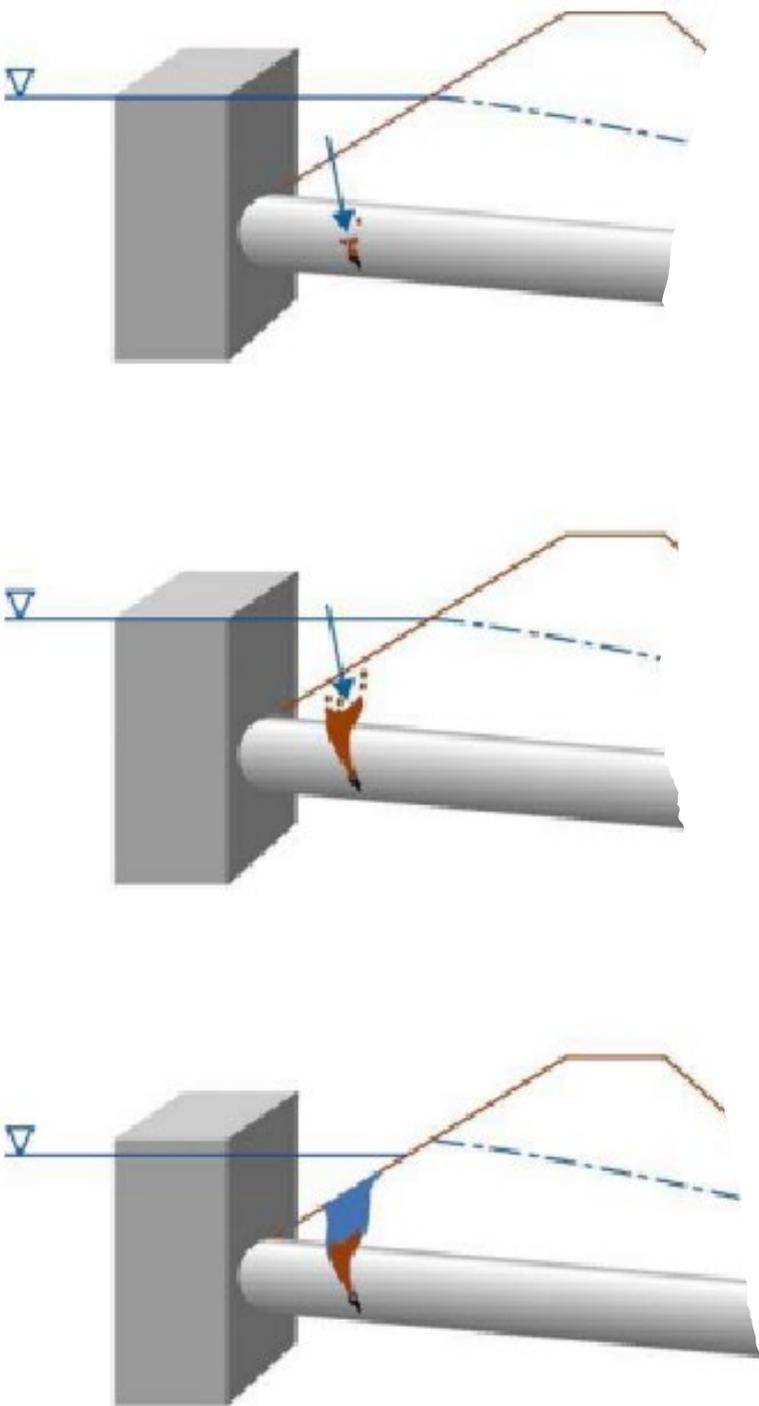
PFM 1: Internal Erosion of Soils into a Nonpressurized Conduit

Mechanism:

- Soil particles are eroded into the conduit through joints, cracks, or defects when the conduit is not under pressure.
- Progressive erosion can lead to voids, settlement, and ultimately dam failure.

Risk Factors:

- Poor joint sealing
- Lack of filters
- Inadequate compaction around the conduit.
- Conduit Corrosion

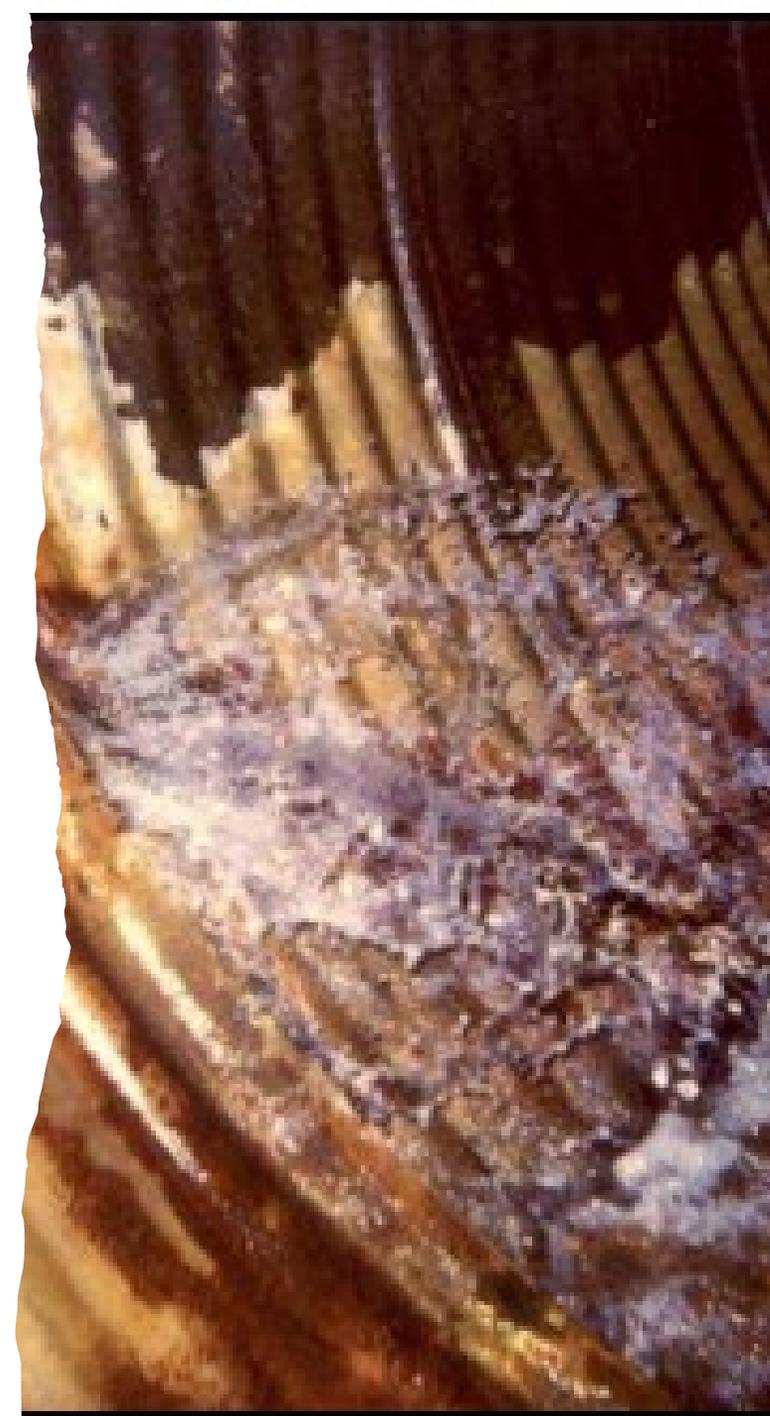
PFM 2: Backward Erosion from a Pressurized Conduit

Mechanism:

- Pressurized water escapes through a conduit defect into the embankment
- Seepage forces can detach soil particles
- Backward erosion piping can occur, forming a tunnel
- Can lead to a breach of the embankment dam

- Cracked or leaking pressurized pipes, especially in older or poorly maintained systems
- No filters

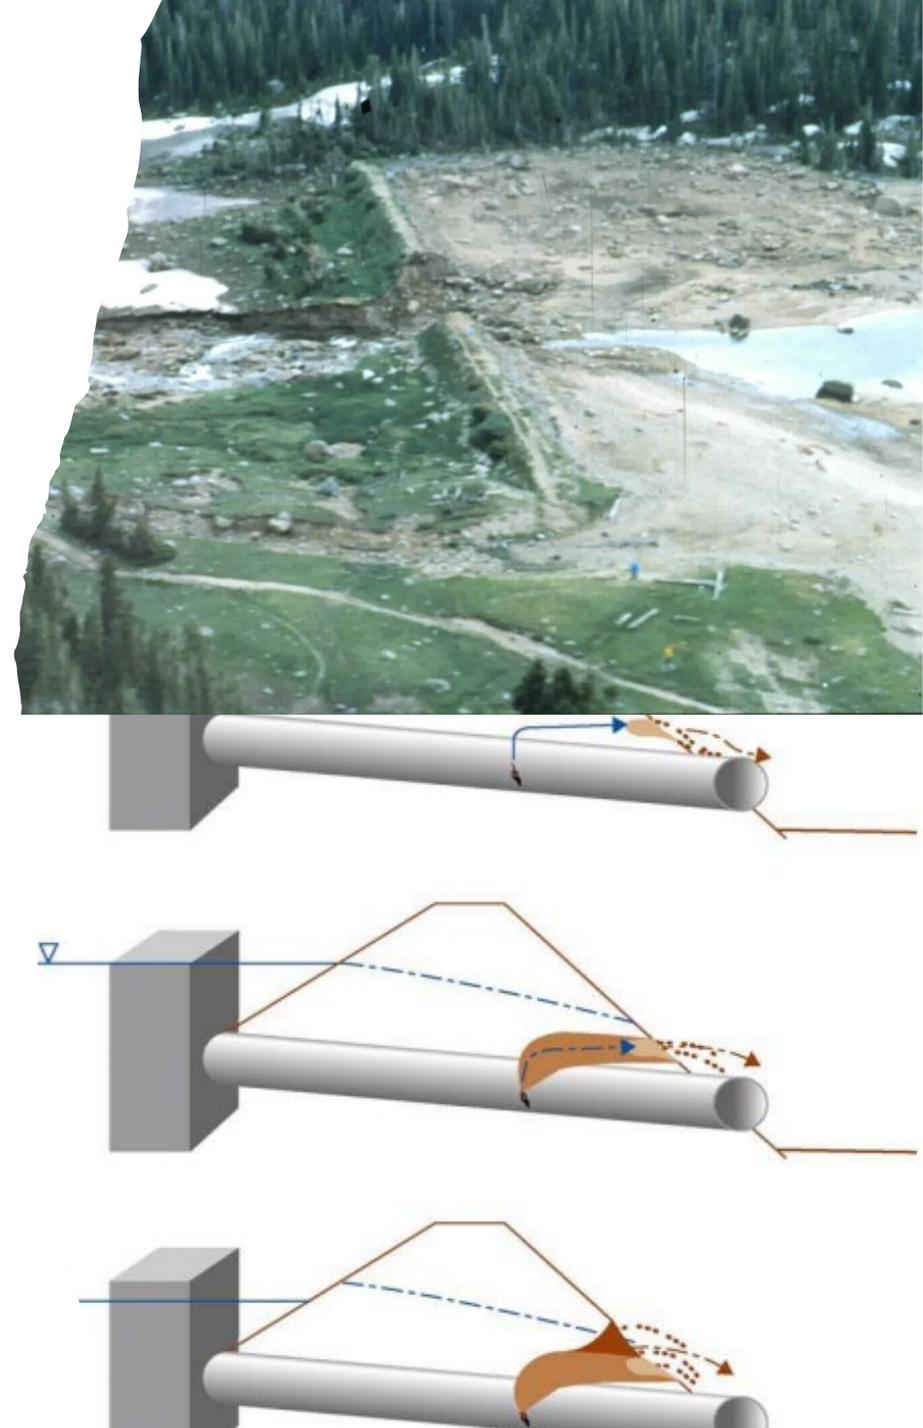
Lawn Lake Dam Failure, CO, 1982

“... the failure occurred due to leakage under high pressure from the leaded connection of the outlet pipe and valve, causing progressive piping of the dam embankment in the vicinity of the outlet pipe during periods of high reservoir levels and gate closure and sudden collapse of the embankment allowing rapid evacuation of the reservoir.”

Photo Credit ASDSO website

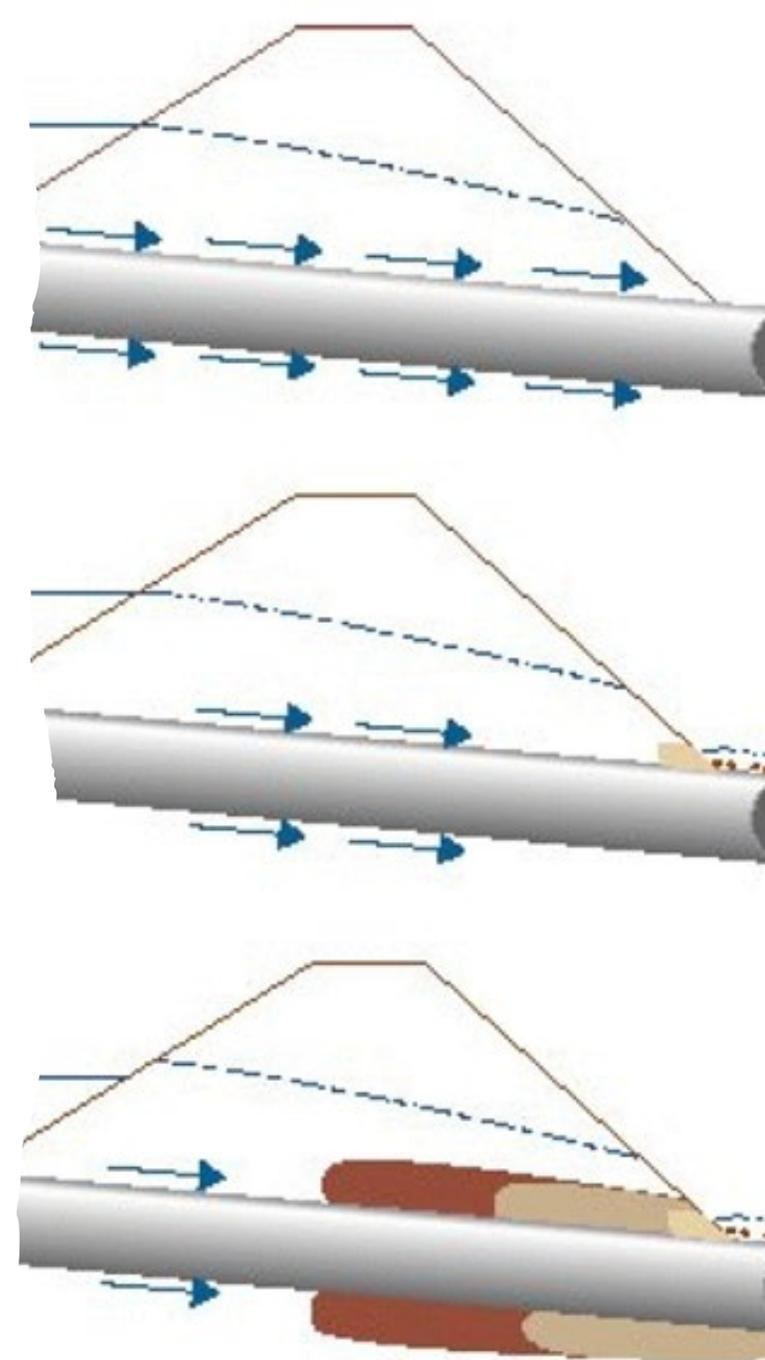
Anita Dam Failure, MT, 1997

PFM 3: Erosion Along the Outside of the Conduit

Mechanism:

- Water seeps along the conduit's exterior, especially if the conduit is not well bonded to surrounding fill.
- Preferential flow paths result in backward erosion piping.
- Breaching failure

- Hydraulic fracturing & poor compaction around the conduit & anti-seep collars.
- Dispersive lean clay
- Flowable backfill instead of concrete cradle
- Lack of filter and drain systems
- Frozen lenses in the backfill which thawed and allowed concentrated leakage.

Photo Credit ASDSO website

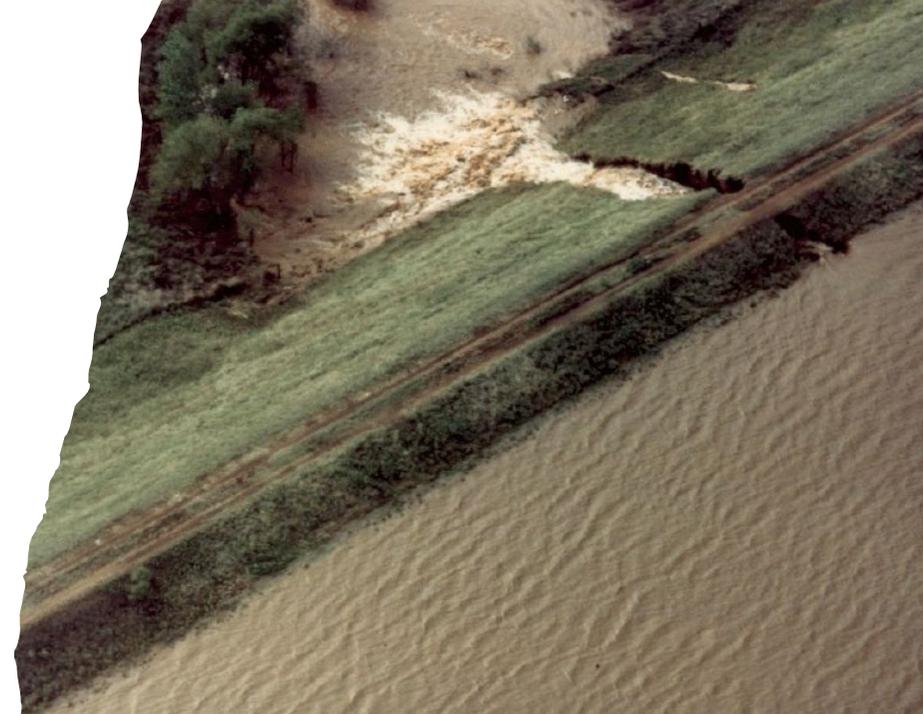
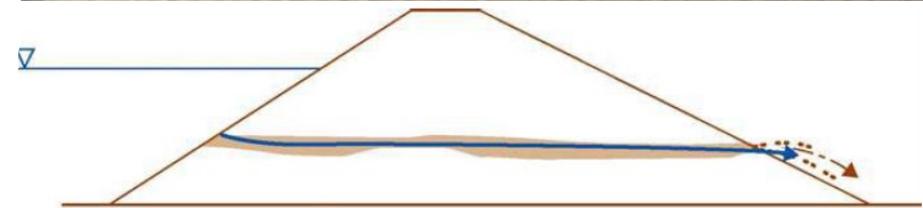
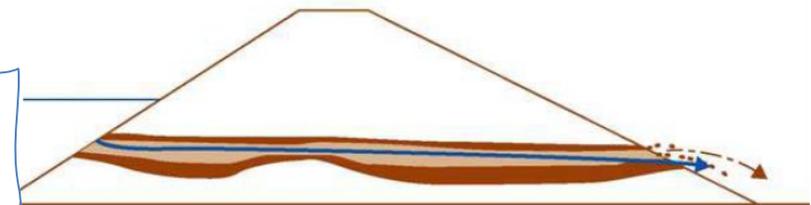
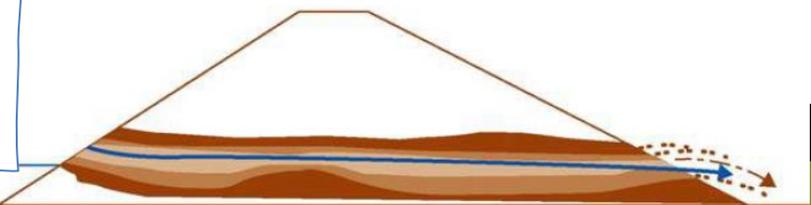
PFM 4: Hydraulic Fracture Cracks in the Earthfill Above, Below, or Adjacent to the Conduit

Mechanism:

- Cracks form in the embankment due to hydraulic fracturing, and water flow enlarges these cracks by eroding the soil.
- Backward erosion occurs. Water discharging at downstream face of embankment is muddy and vortex may form at entry point.
- Erosion tunnel enlarges, reservoir empties/breaches.

Risk Factors:

- Most frequent during first filling
- Dispersive clay
- No filter diaphragms or collars
- Low compaction
- Excess pore pressure

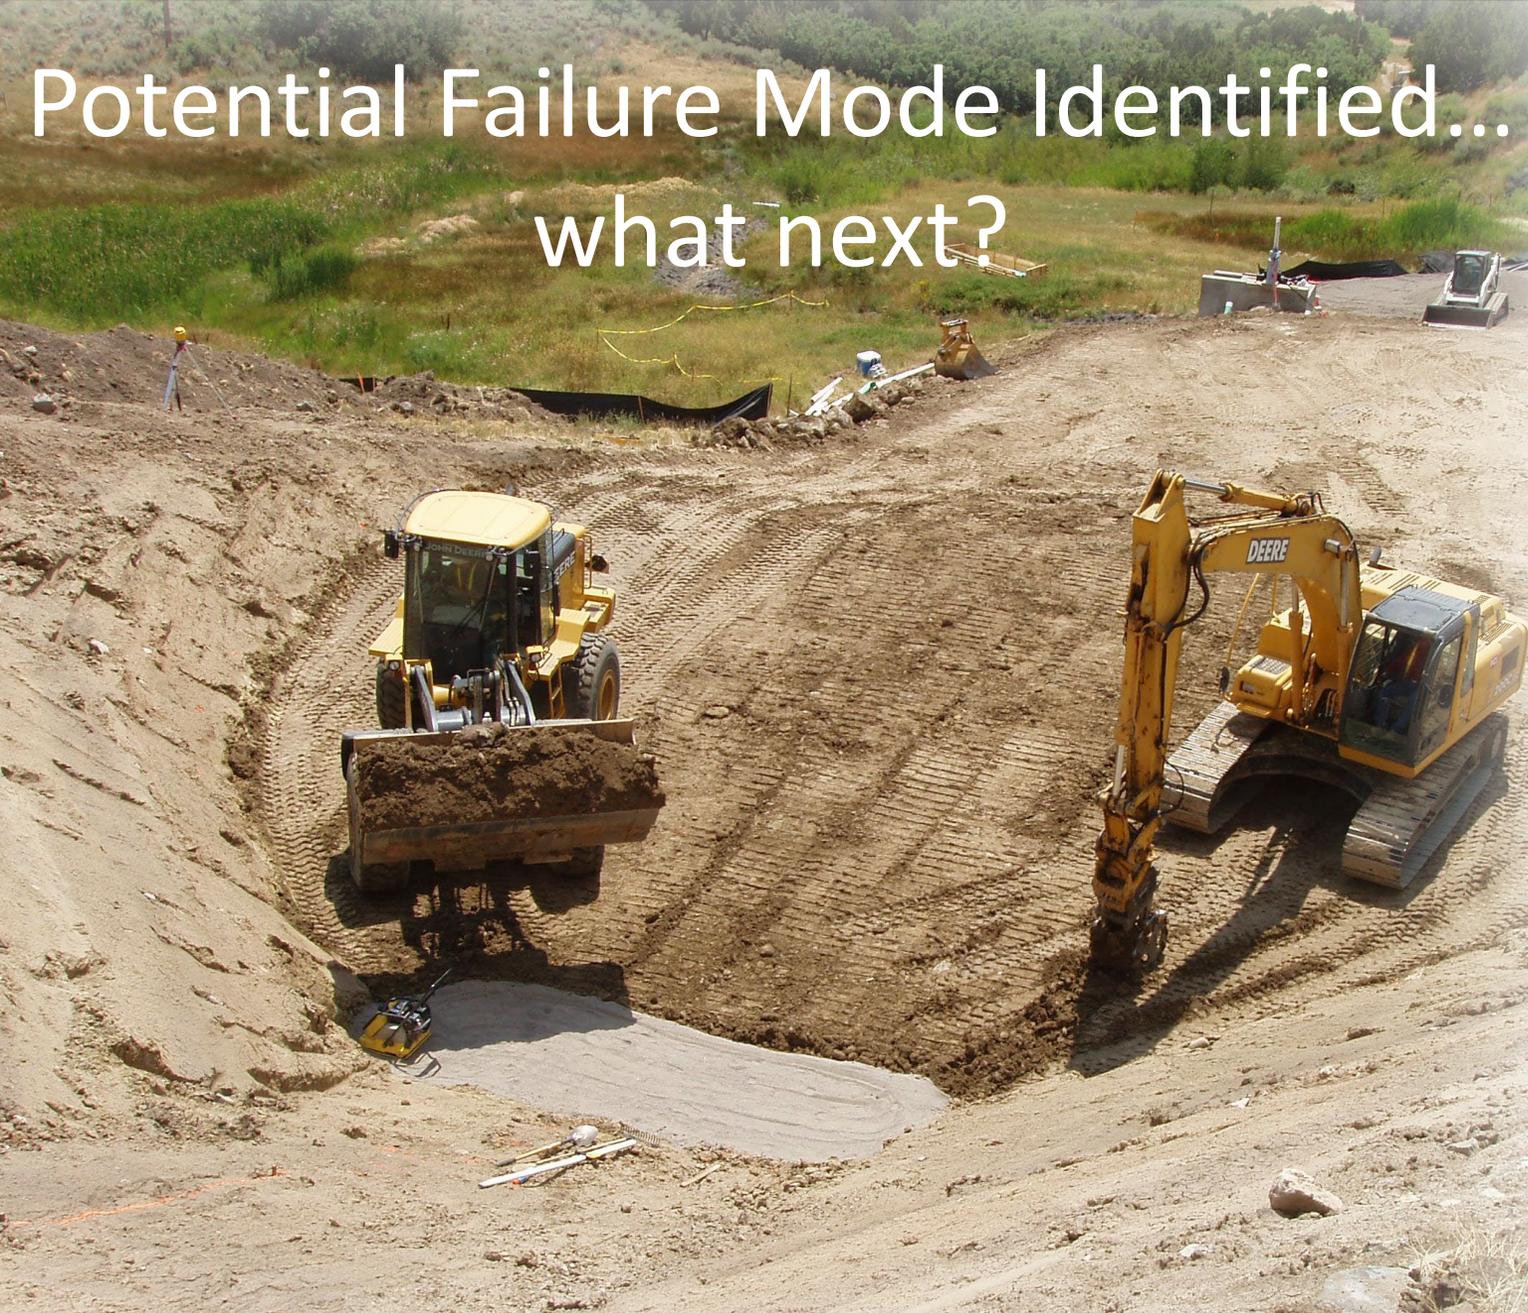
Filter Diaphragms

Context: Embankment dams equipped with properly designed filter diaphragms around conduits have successfully prevented internal erosion.

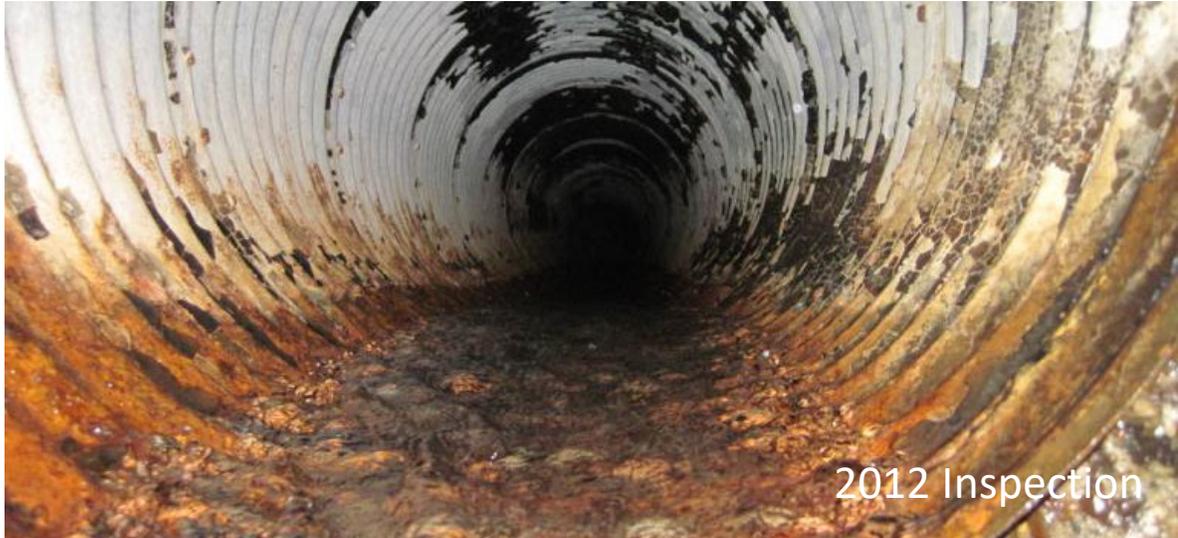
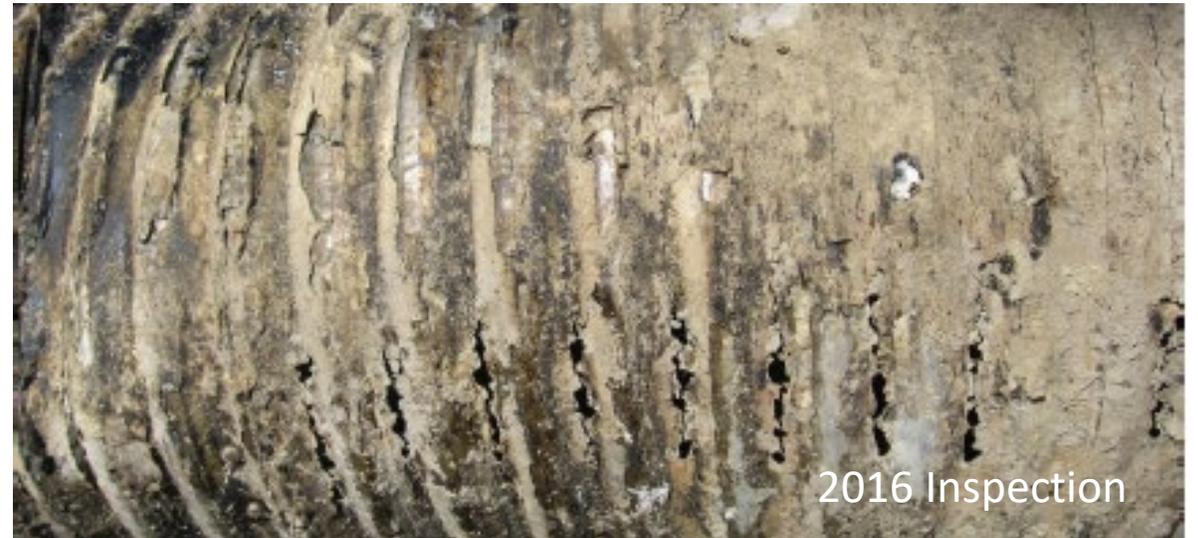
Outlet Deterioration

Photos curtesy of DNRC Dam Safety

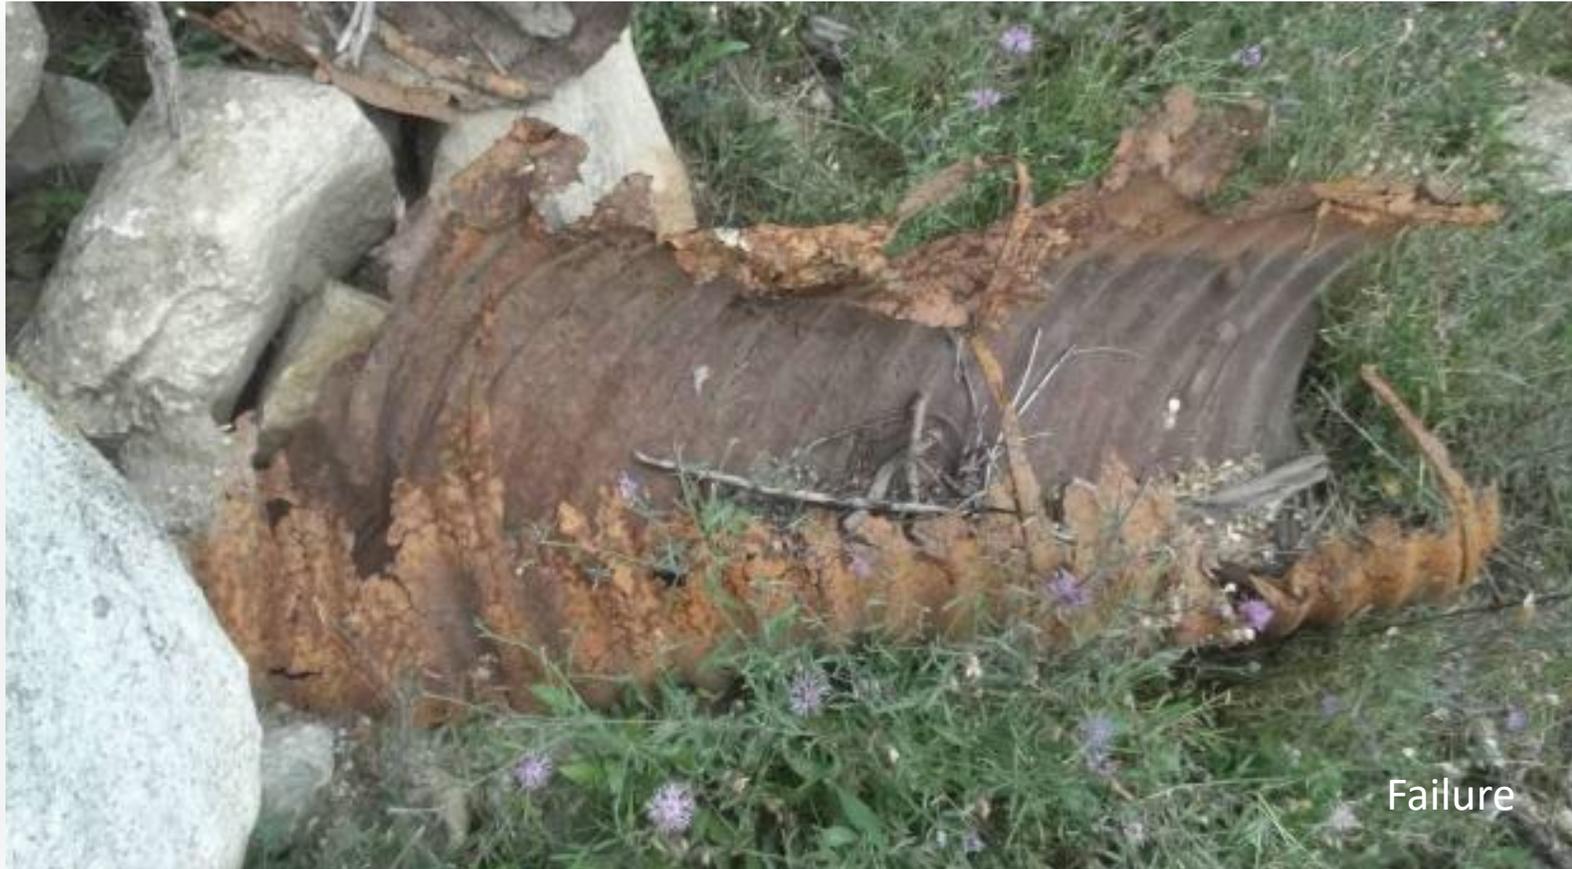
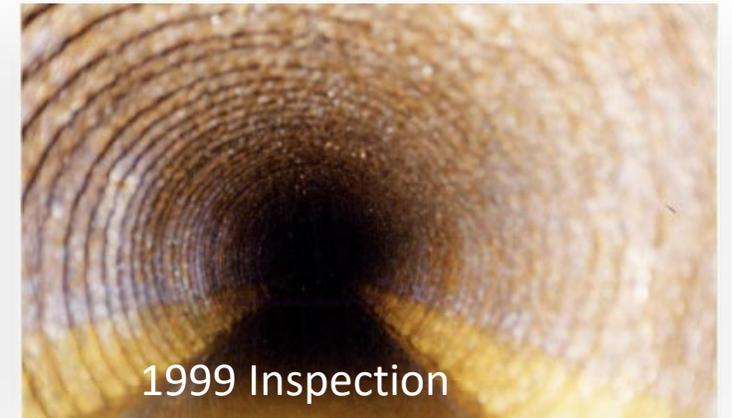
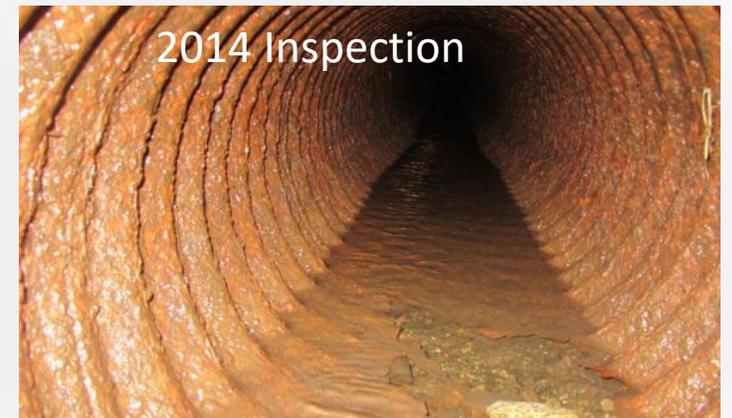
Outlet Deterioration

Photos curtesy of DNRC Dam Safety

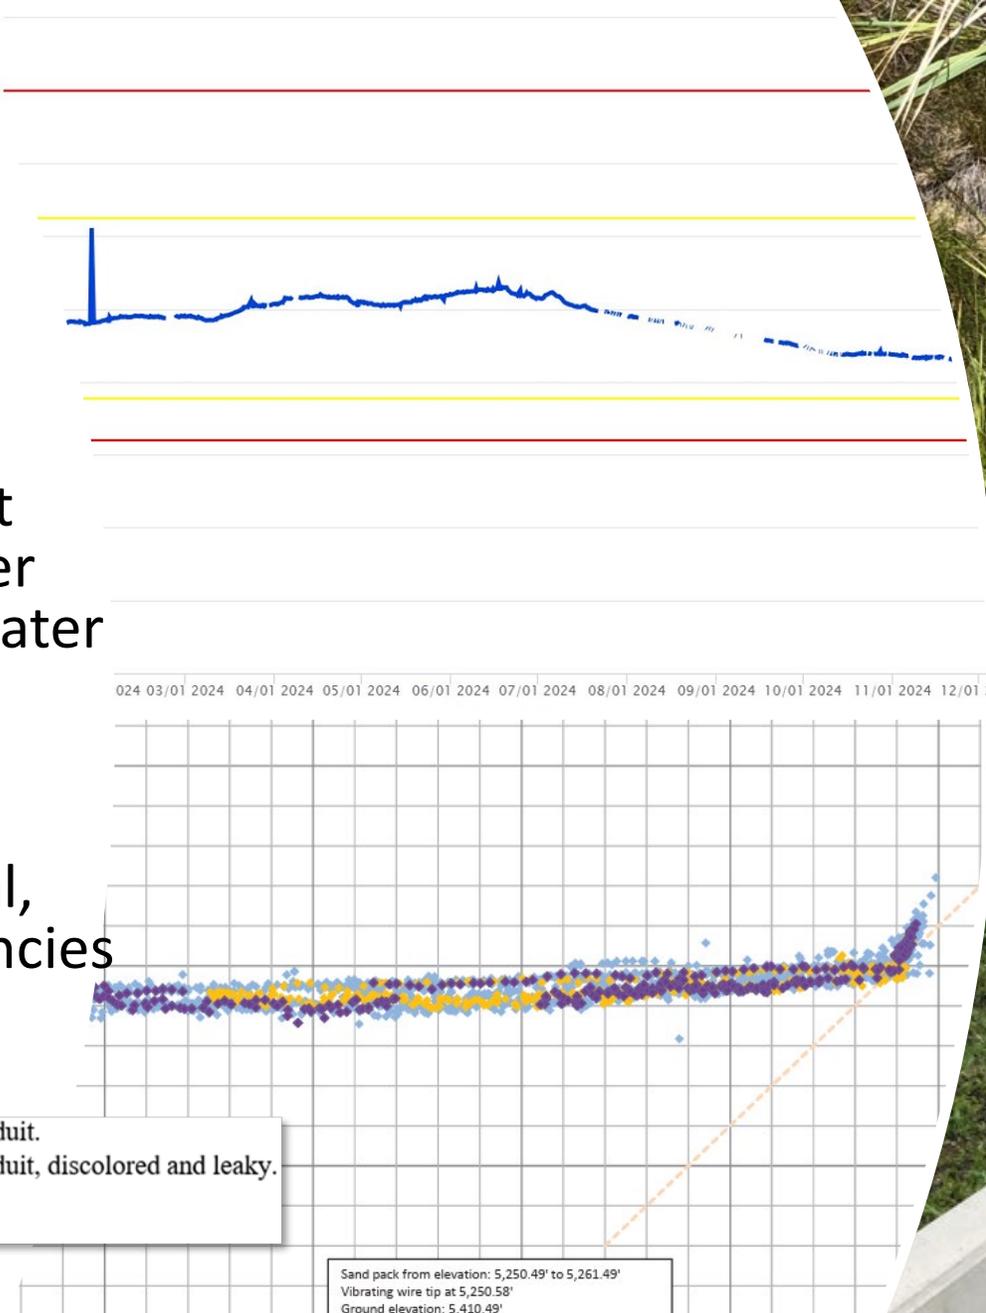
65-feet: Large crack on the North side of the conduit.
 80-feet: Large crack on the North side of the conduit, discolored and leaky.
 97.5-feet: Leaky joint.
 110-feet: Leaky joint.

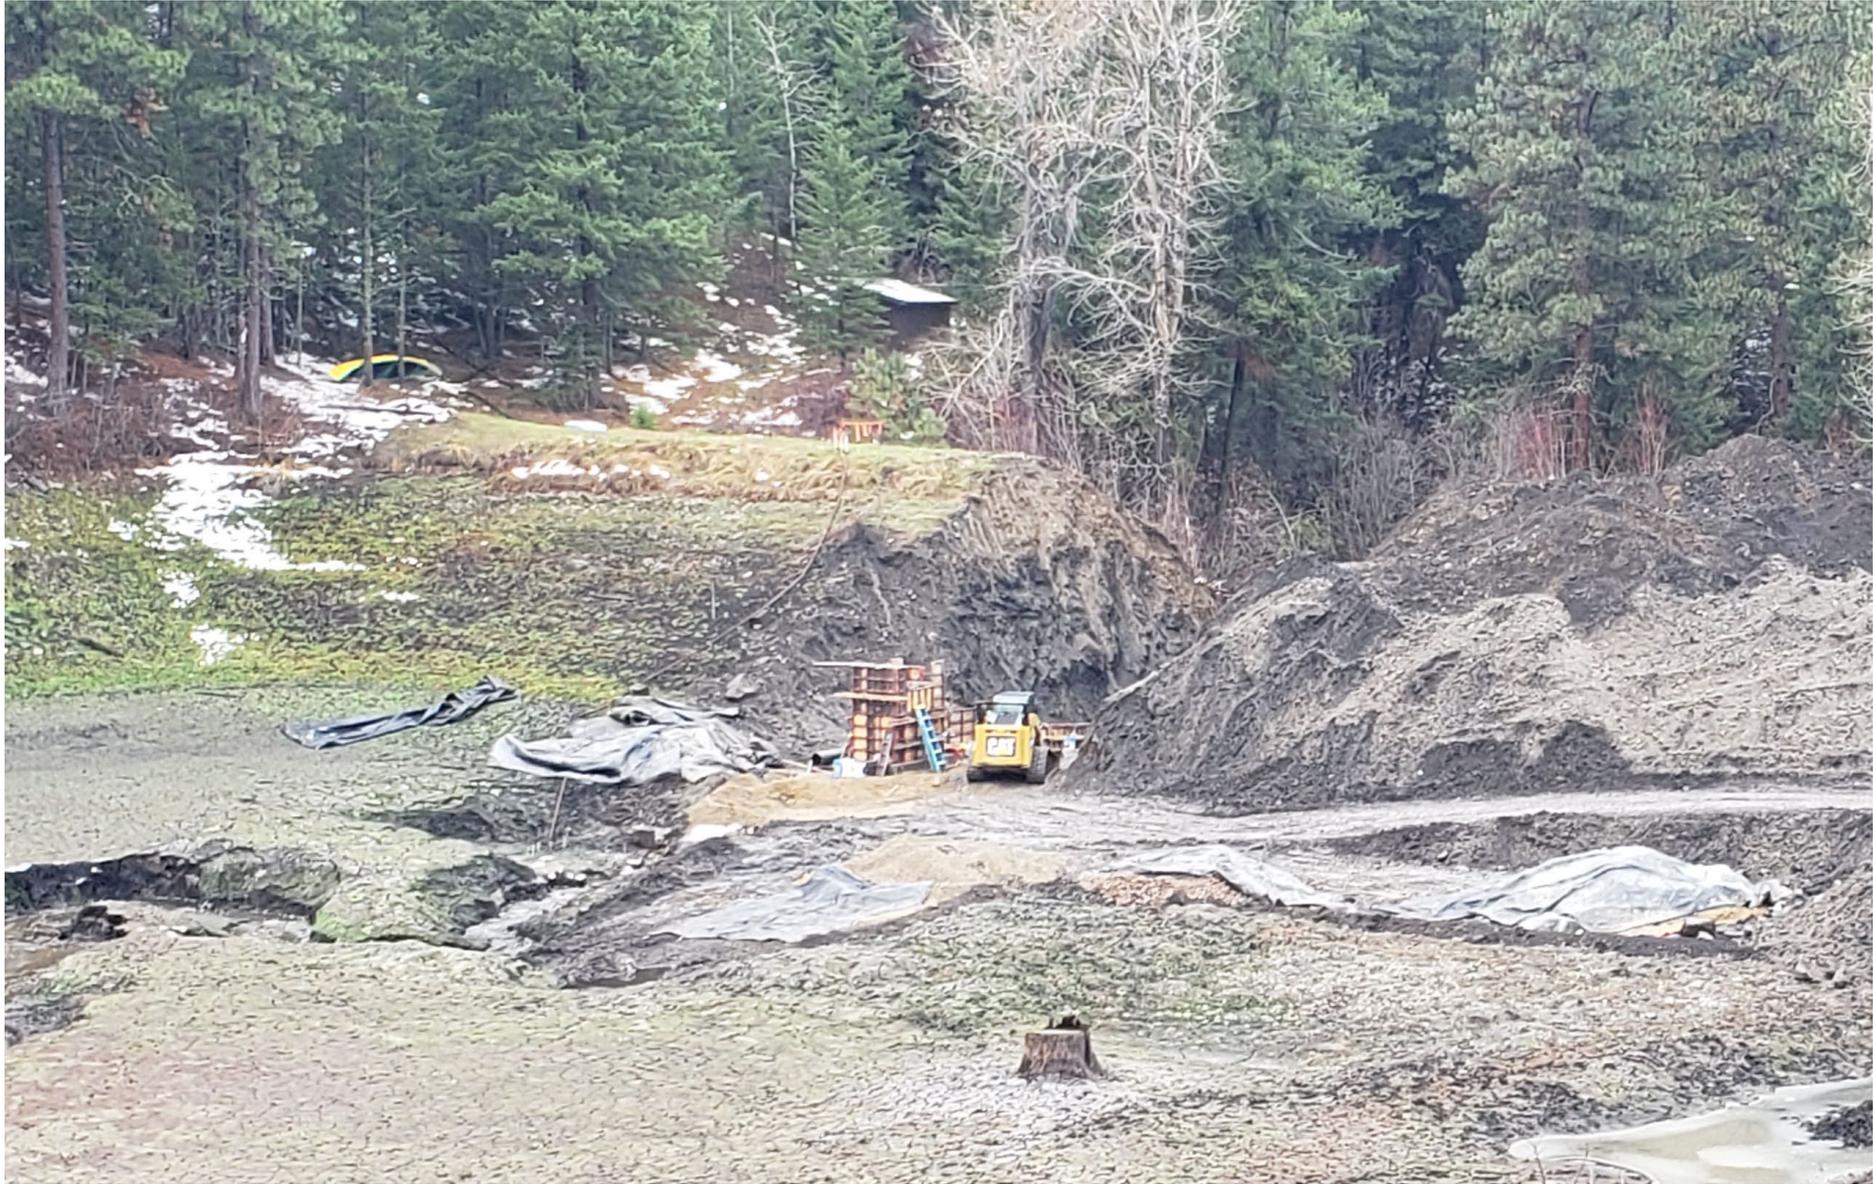
1. 14" HDPE Pipe encased in lean concrete.
2. Slip-lining not preferred
- ~~3. Excavate and replace the existing conduit.~~
4. Change order: Abandon the existing conduit in-place and construct over the top of it. (Reduced the amount and cost of excavating the original pipe.)
4. Inlet structure with vertical drop keeps the inlet pipe clear of the sediment and other bottom debris.

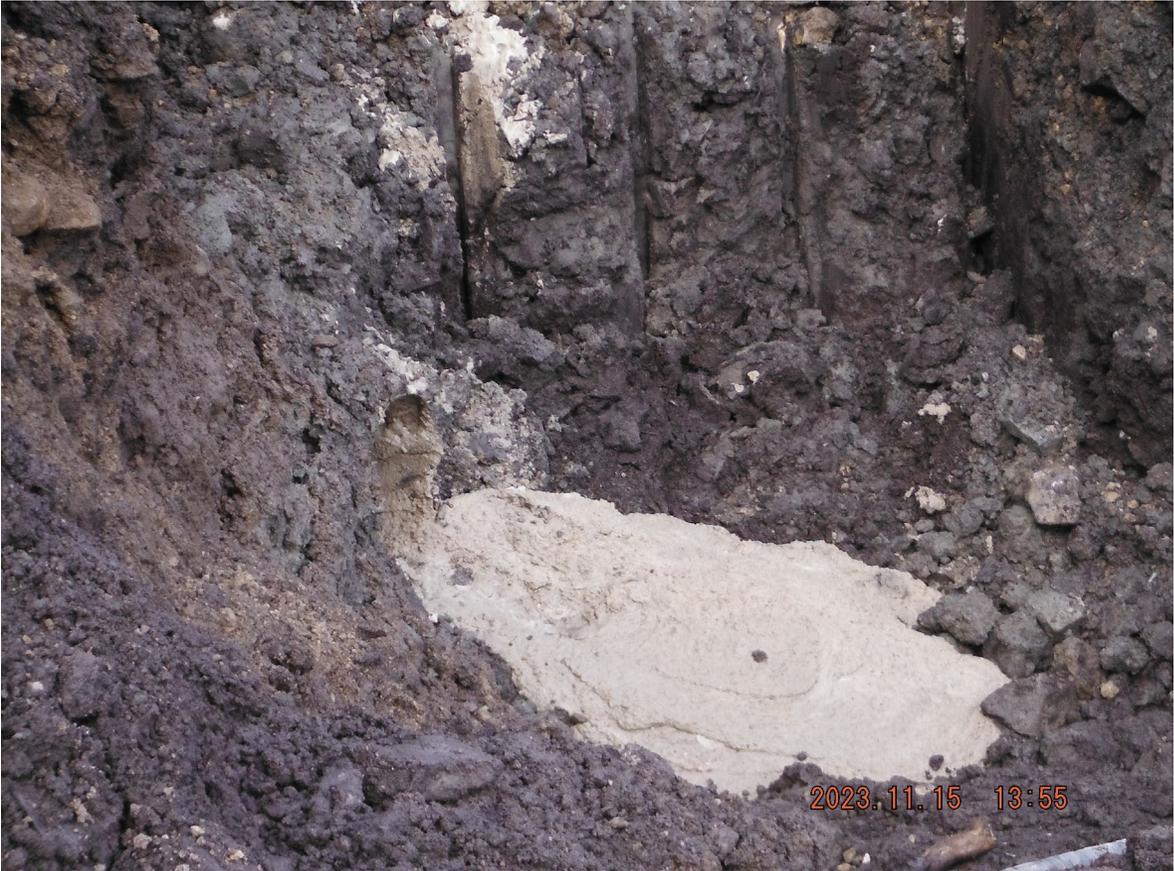
Flowable fill emerging at the downstream end.

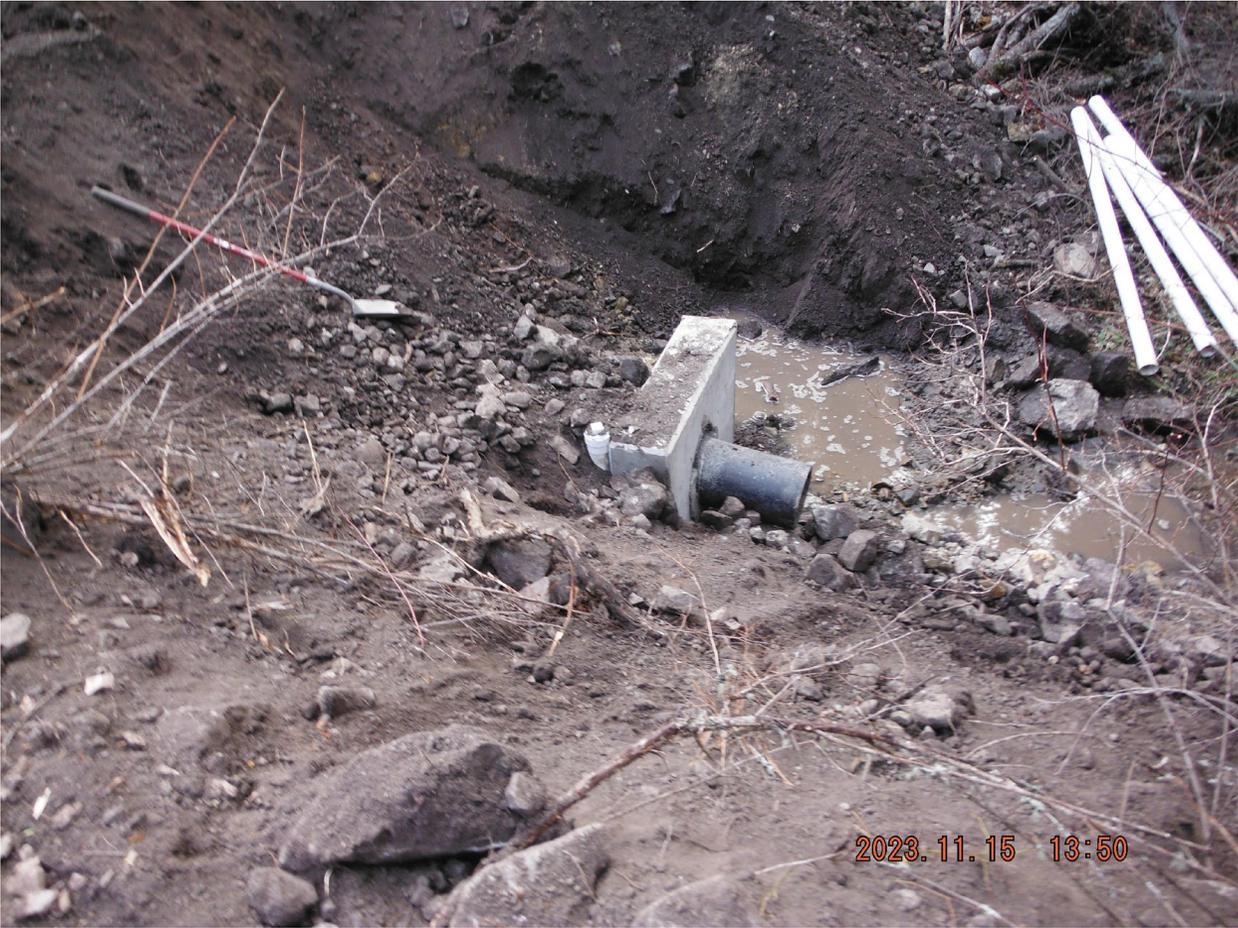
Removed 30-ft of the downstream end of original conduit.

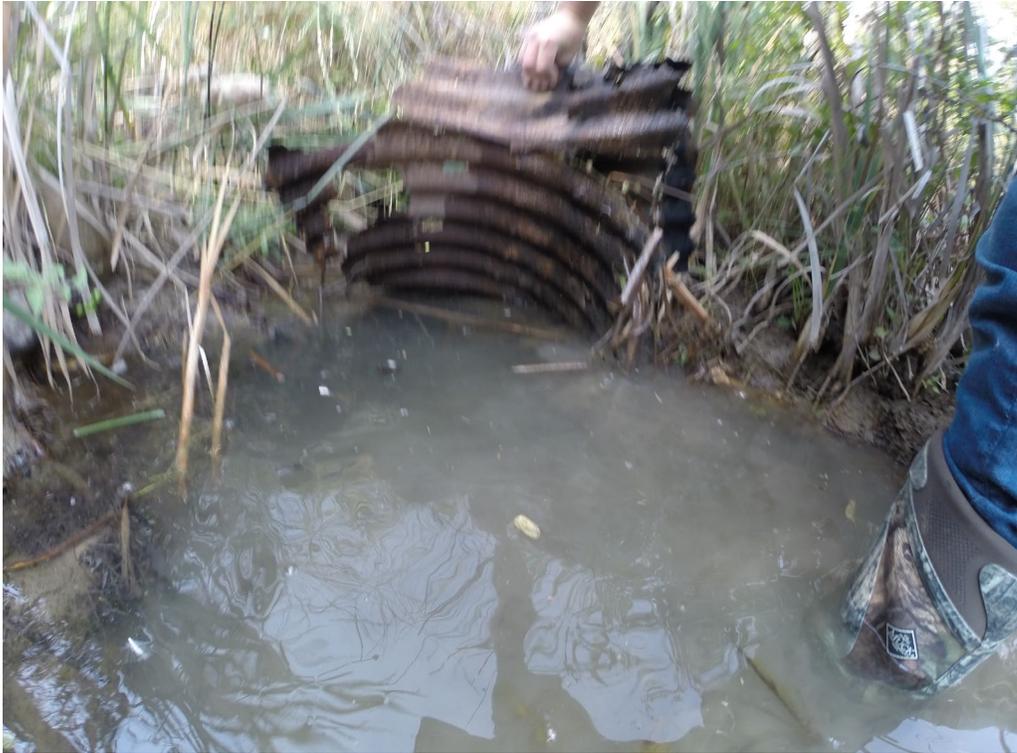
Outlet end of the conduit had completely failed.

Coating is gone and joints are in terrible corroded condition. Conduit appears to show ovality.

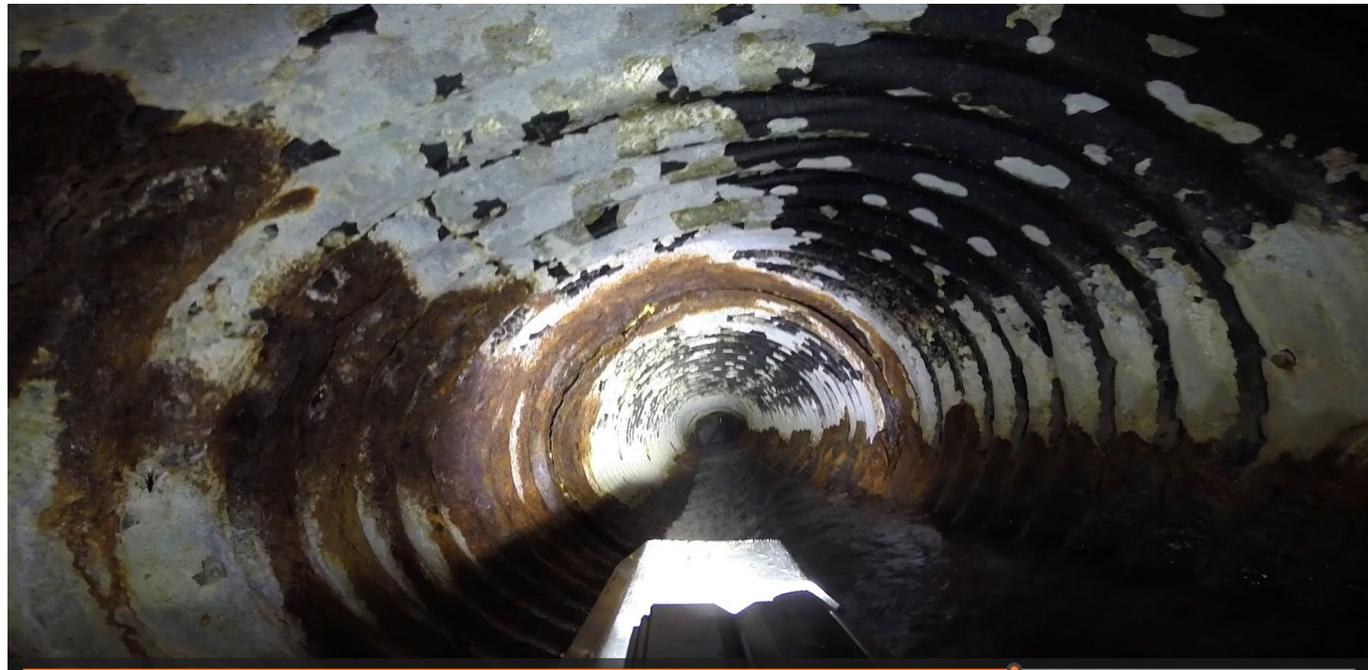
1. Abandon the existing conduit in-place, using flowable fill.
2. High-level weir & drop-inlet structure for reservoir elevation control.
3. High-level inlet structure includes a slide gate at the bottom of the structure for emergency drawdown.
 - ~ capable of 5-feet of drawdown
 - ~ provides enough drawdown until irrigation and additional pumps can assist further, if necessary.
4. New conduit was positioned over the old to reduce excavation costs.

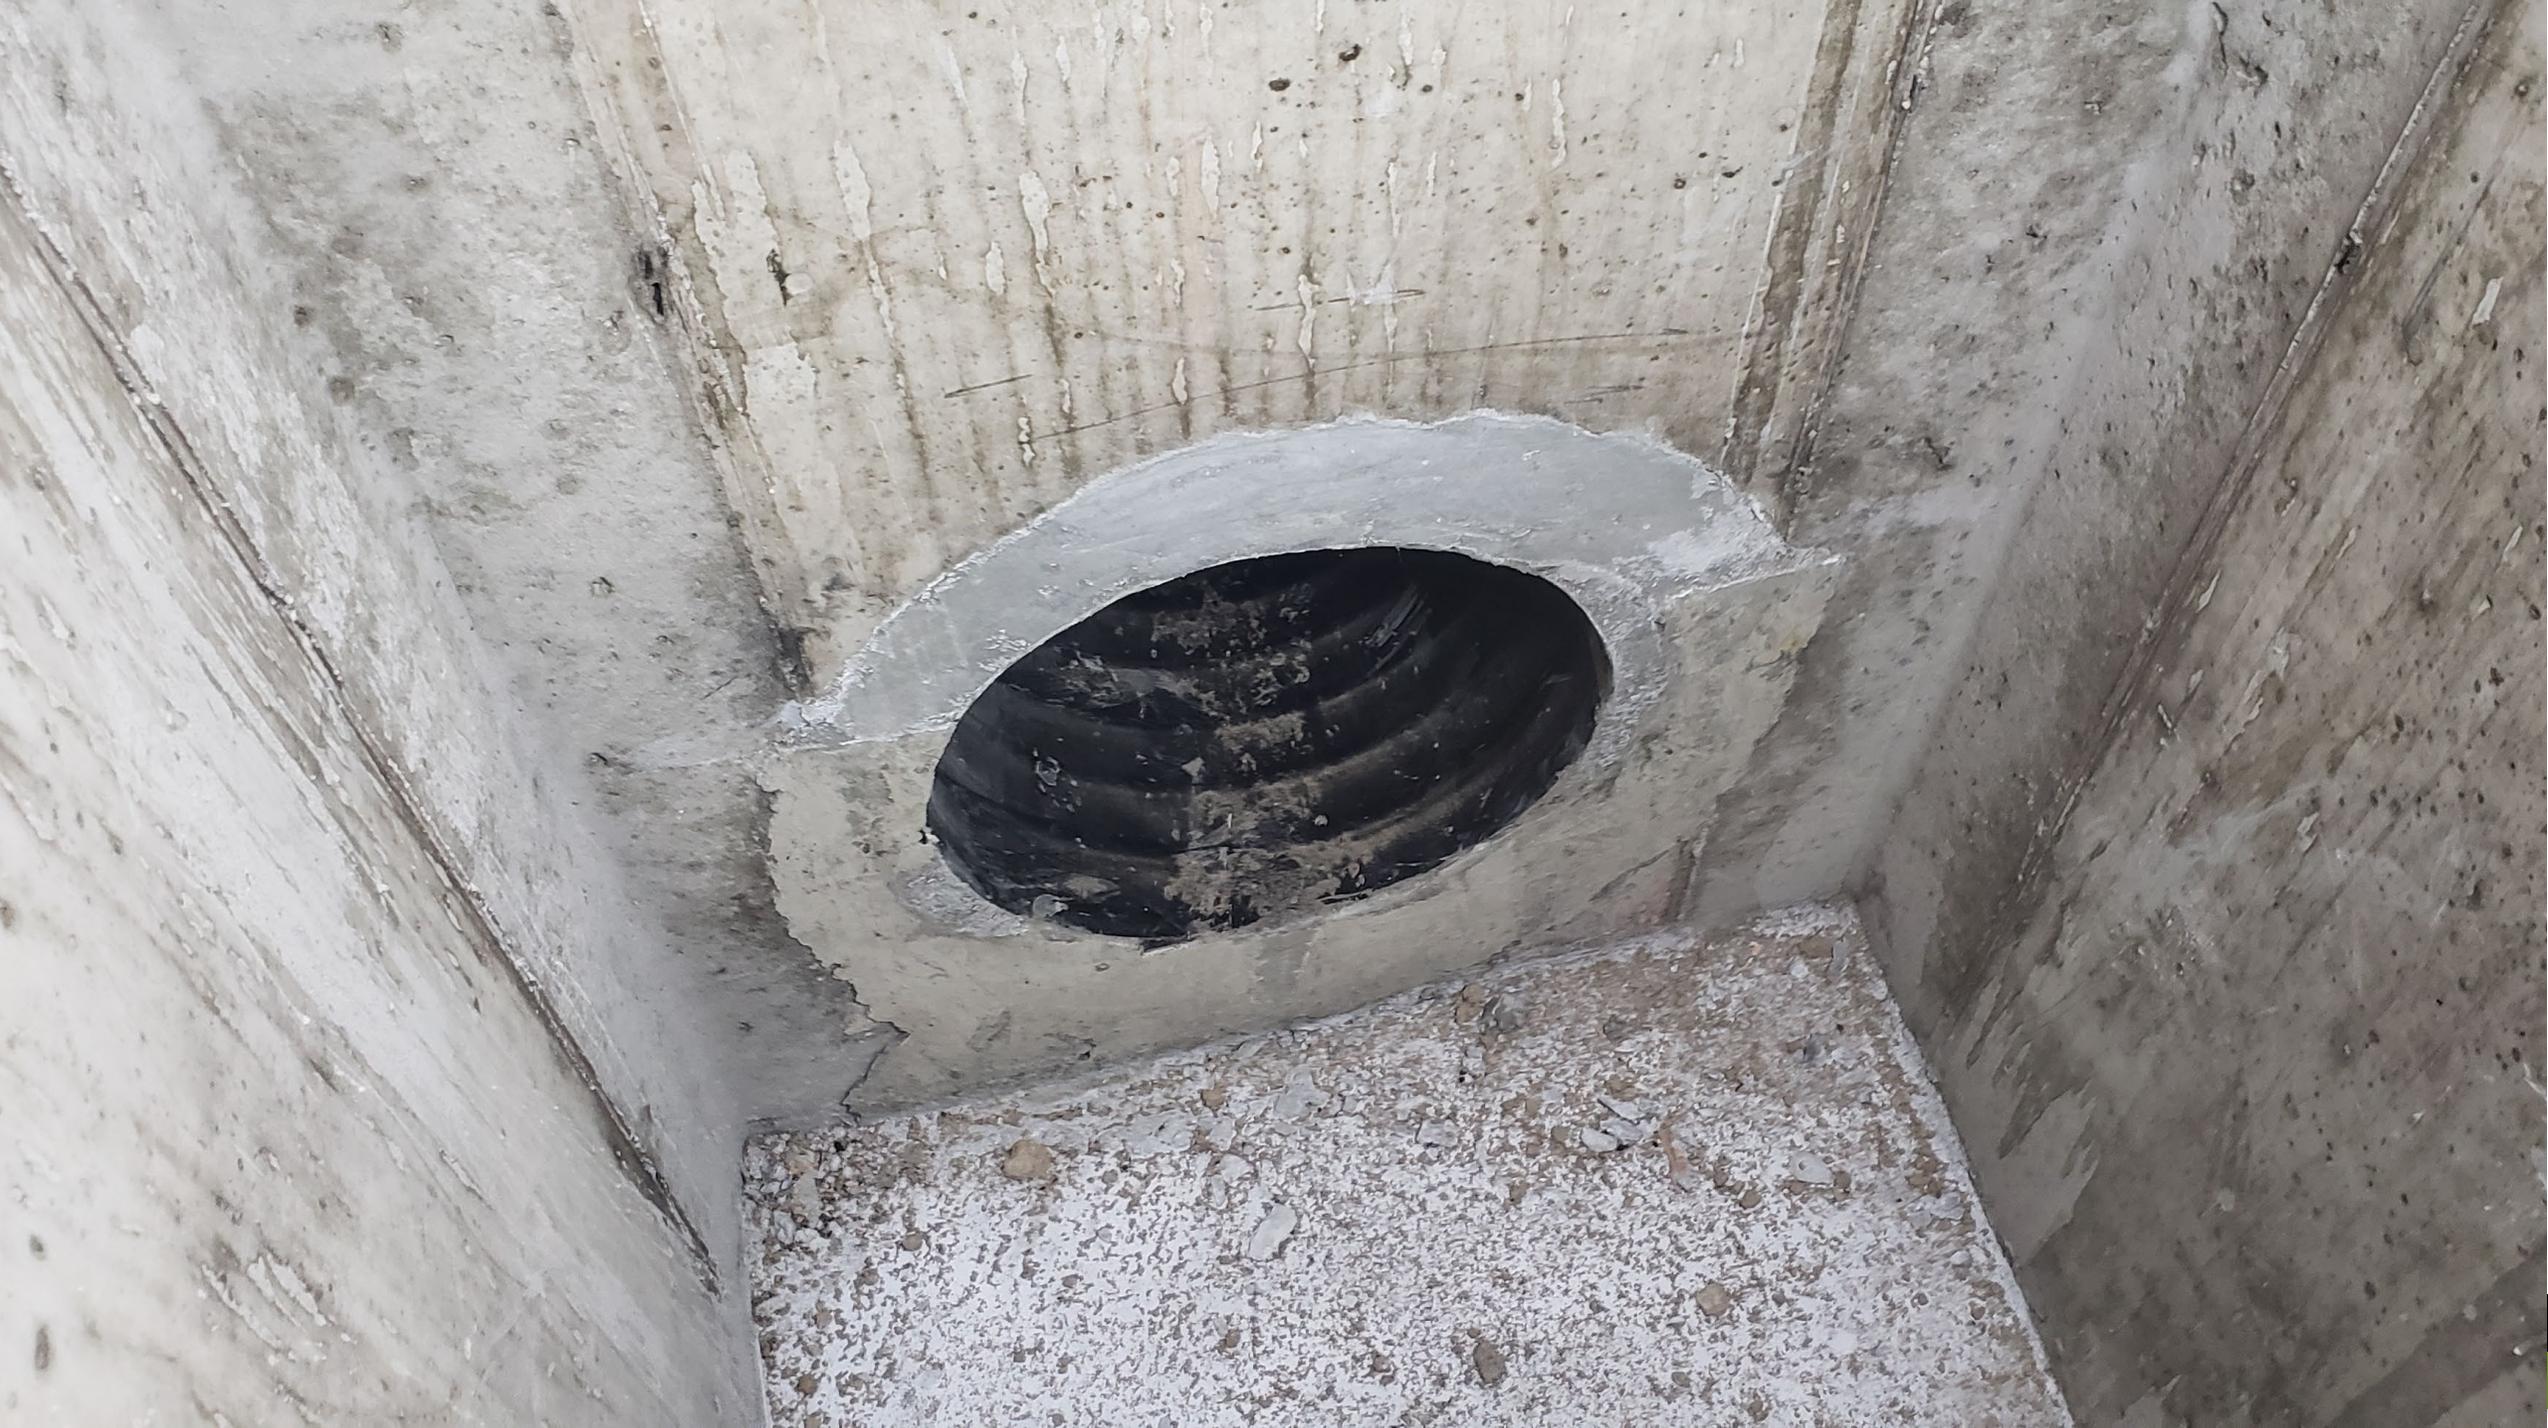
Outlet conduit to be buried minimally under the embankment slope.

Ready to be encased in CLSM.
