MADCS Conference 2025

Low Level Outlet Forum

Montana Association of Dams and Canal Systems

What is a low-level outlet?

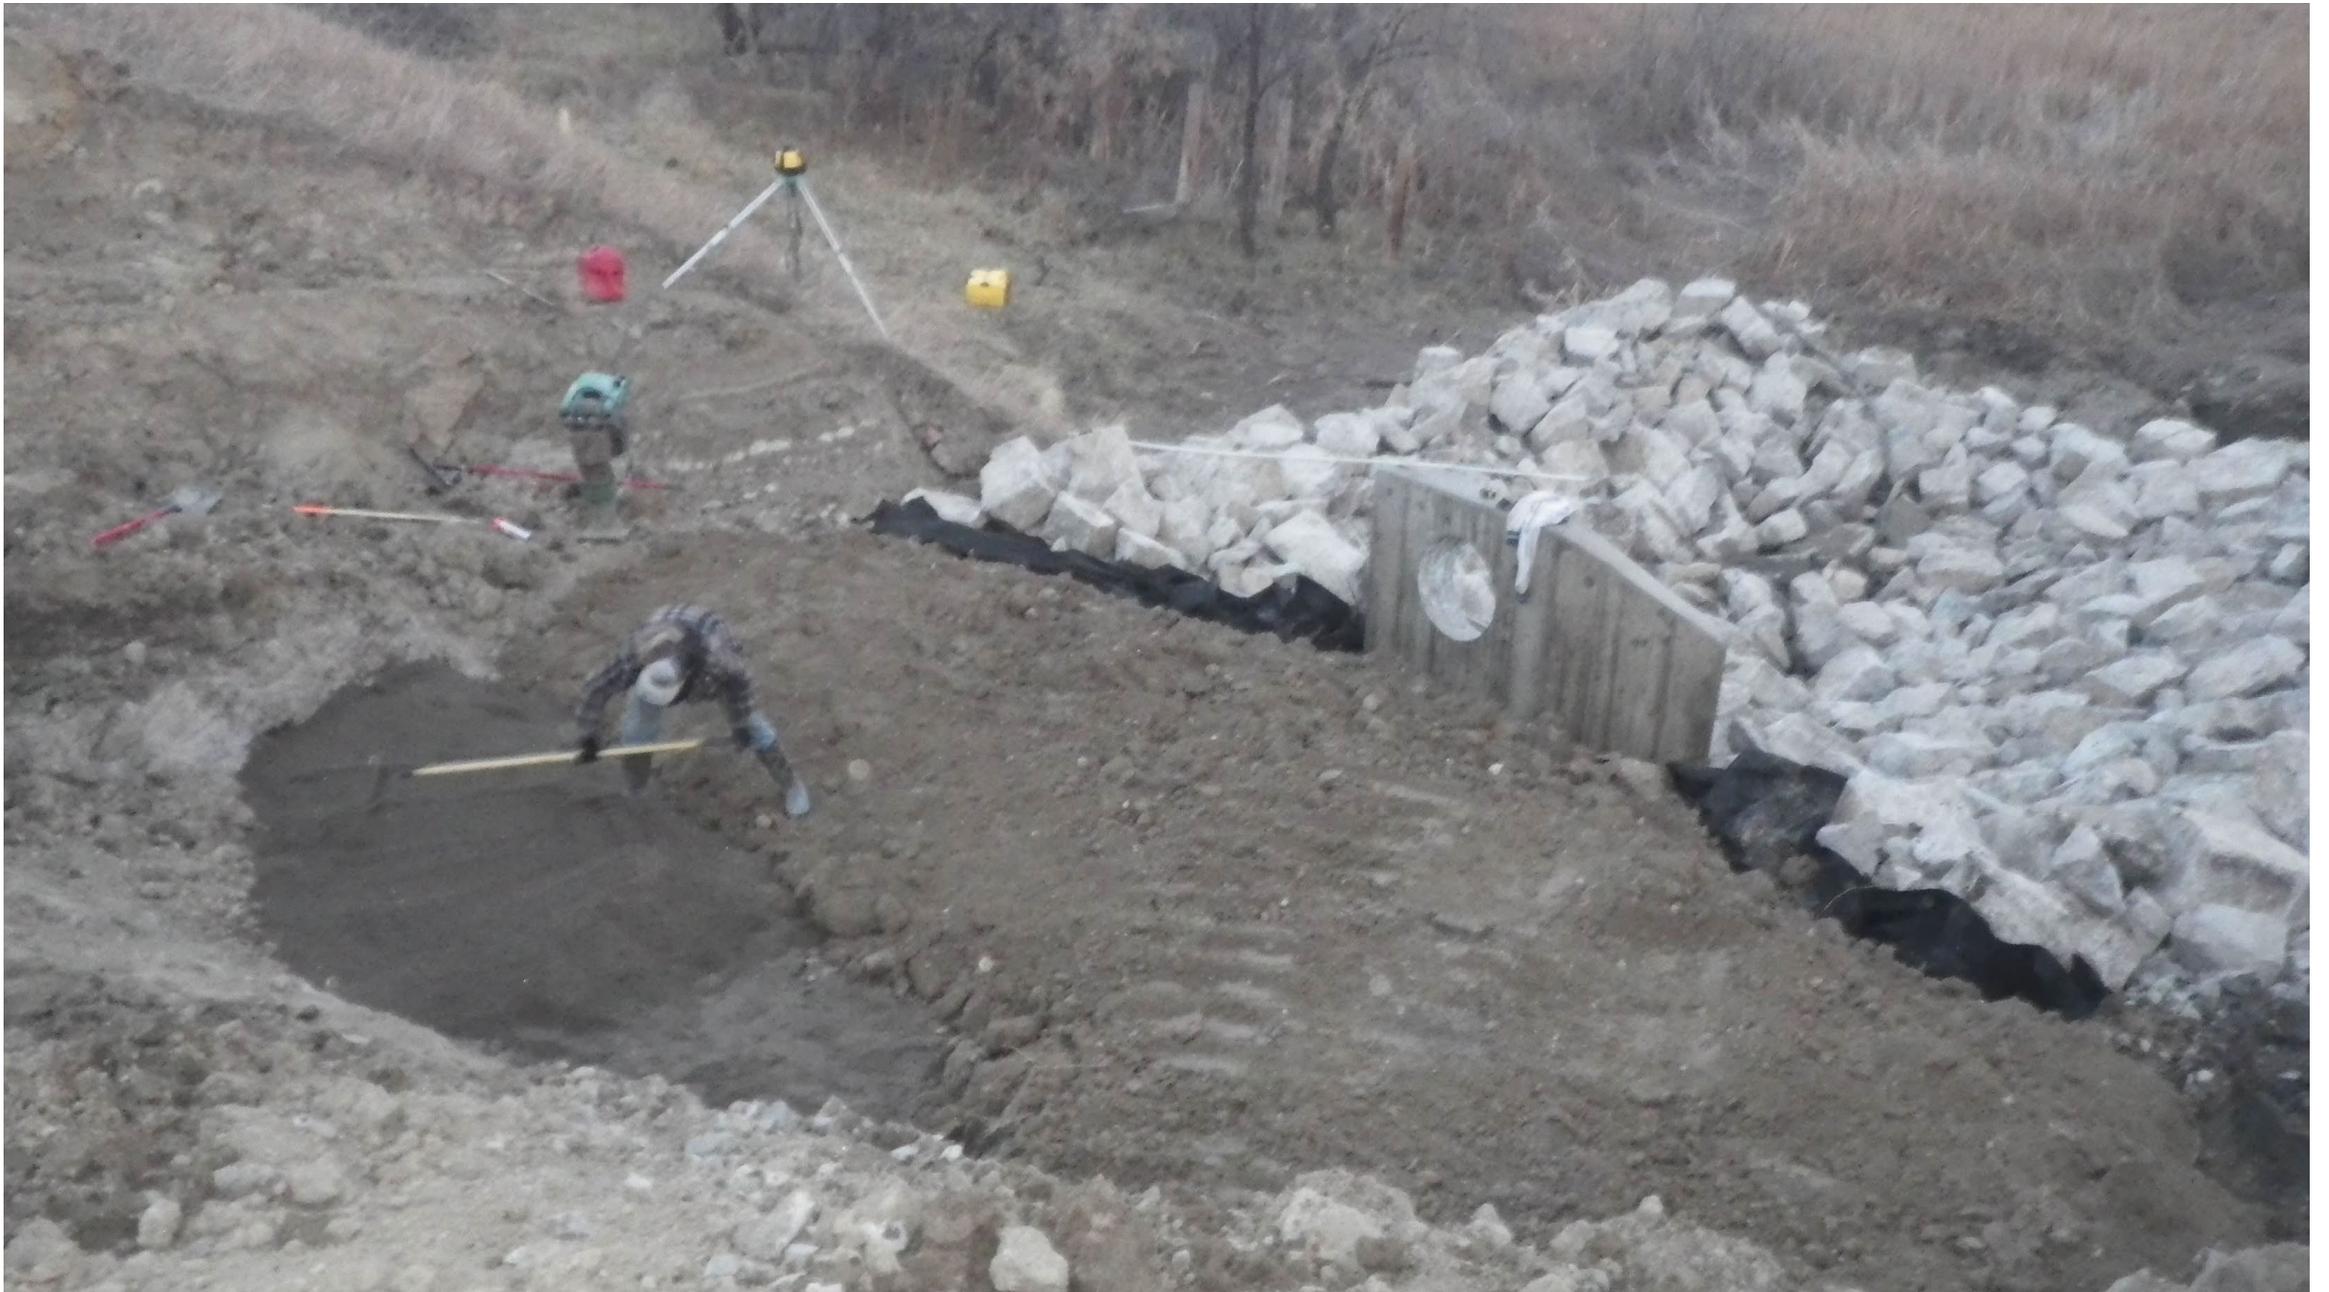
Filter diaphragm with embankment fill constructed in simultaneous lifts to prevent contaminating the filter with embankment materials.

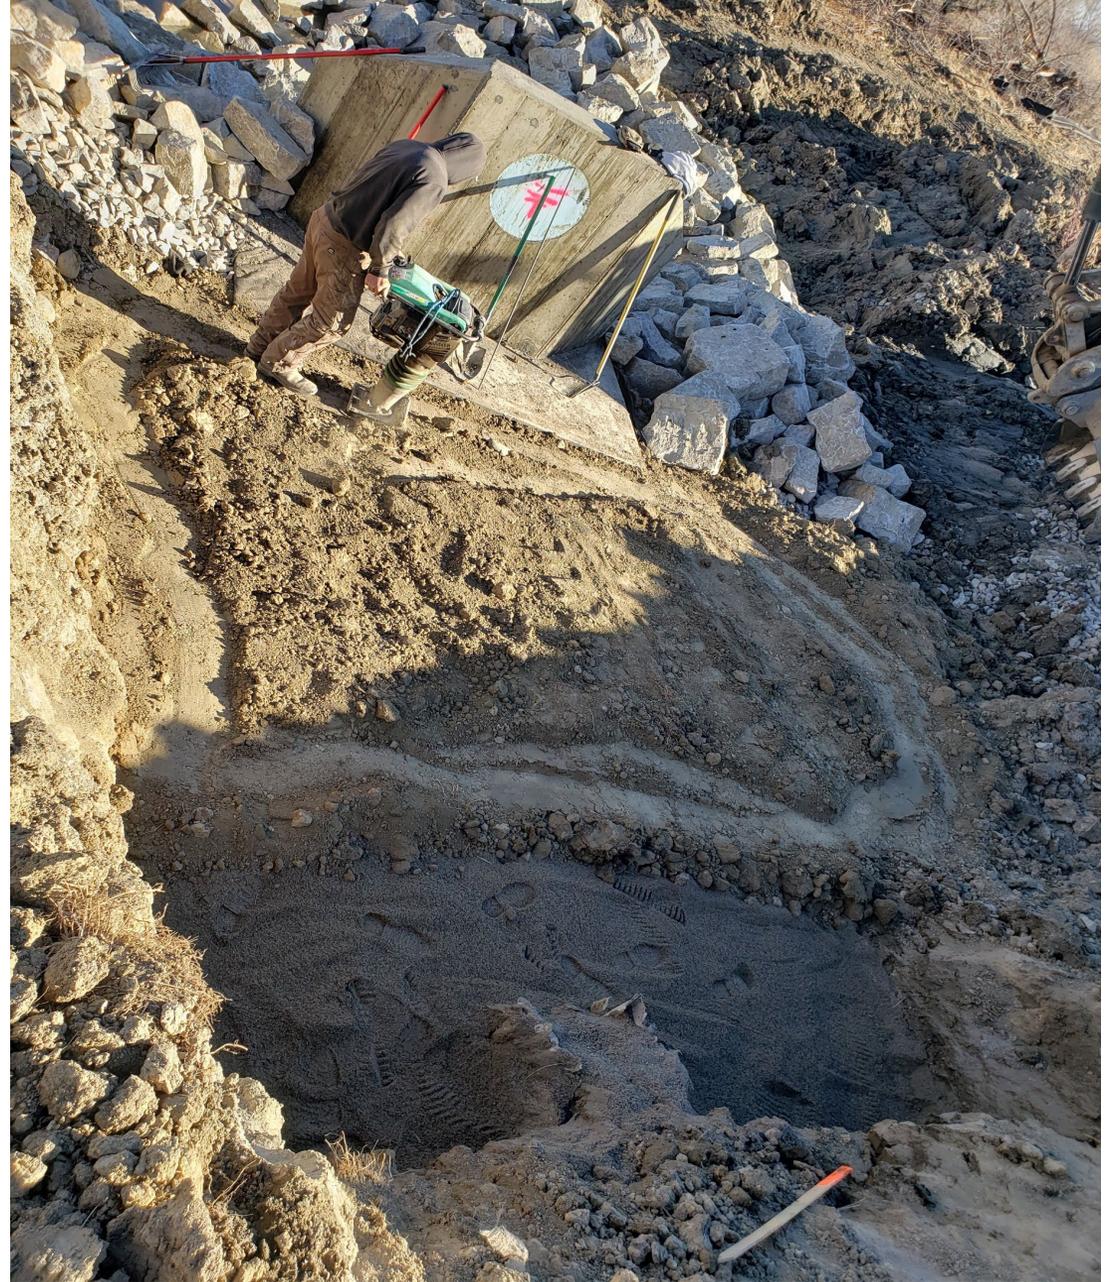
Outlet structure with conduit knockout for the conduit.
