Teton Dam Failure

failure, damage, lessons

Teton Dam

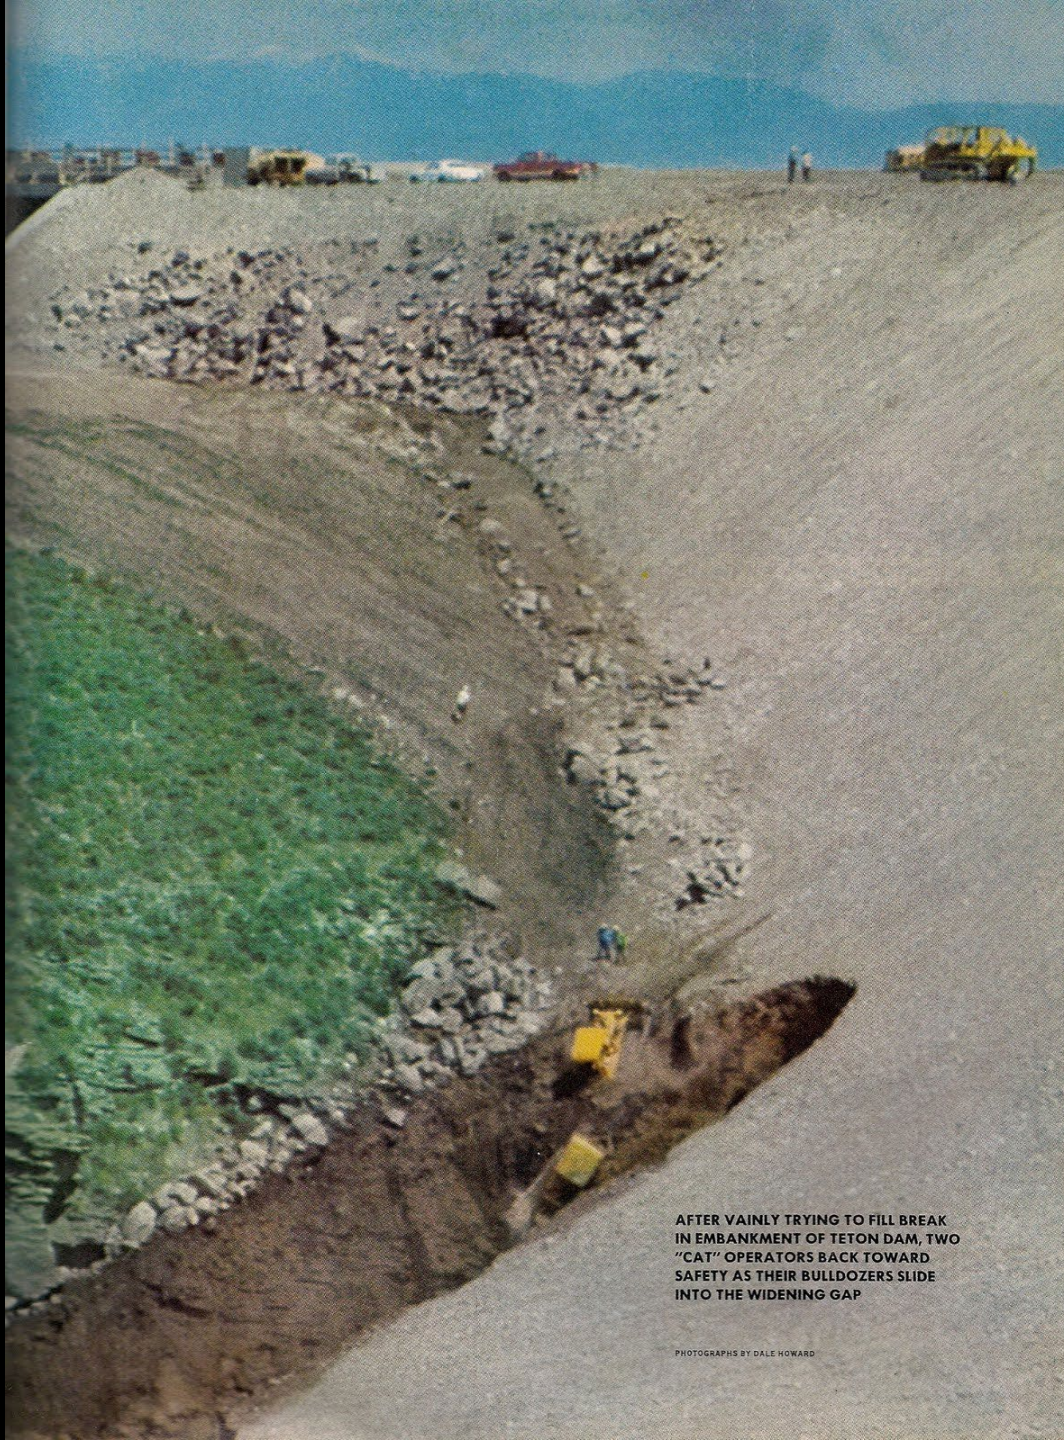
AFTER VAINLY TRYING TO FILL BREAK
IN EMBANKMENT OF TETON DAM, TWO
"CAT" OPERATORS BACK TOWARD
SAFETY AS THEIR BULLDOZERS SLIDE
INTO THE WIDENING GAP

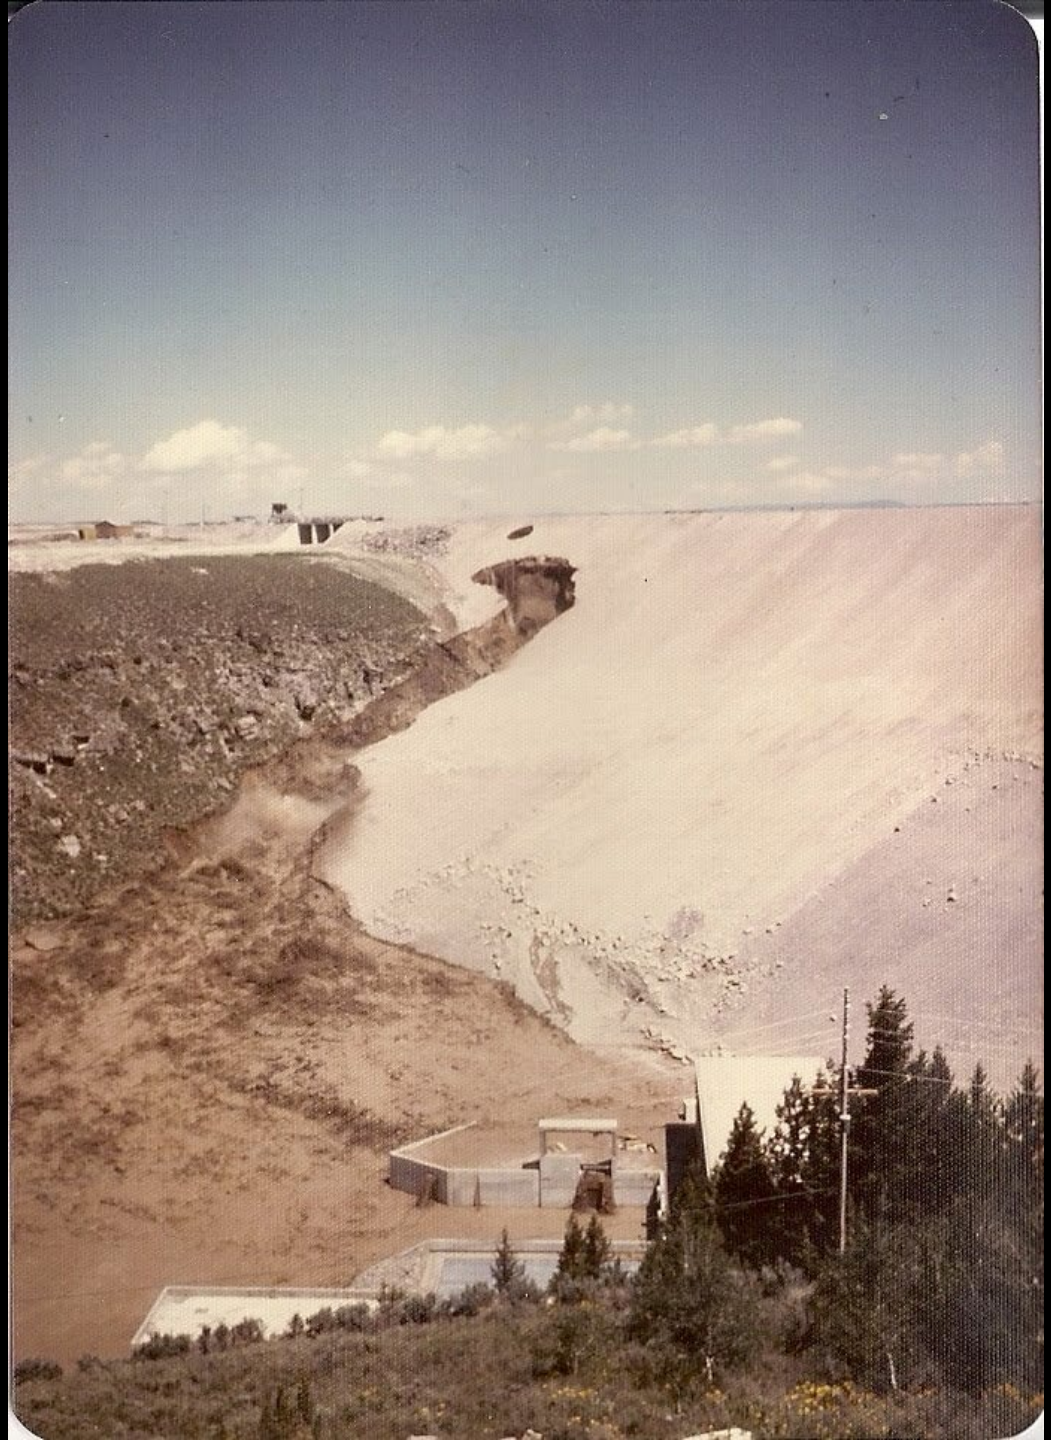
11:45AM

- Sinkhole forms on embankment near crest
- Dozers attempting to fill whirlpool removed and personnel flee dam
