Visual Inspections of Outlet and Drain Conduits on a 5-year Cycle

Chadrick Hill – Civil Engineering Specialist,
The Montana Department of Natural Resources and Conservation,
Water Resources Division

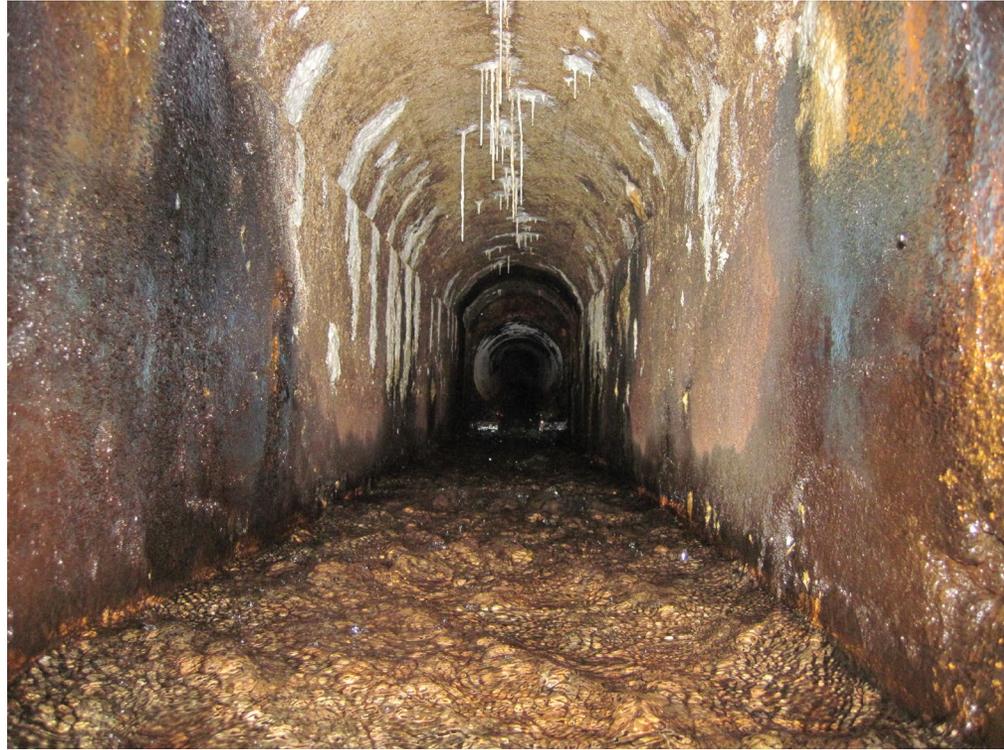
2012

Case Study #1 Dam in Beaverhead County

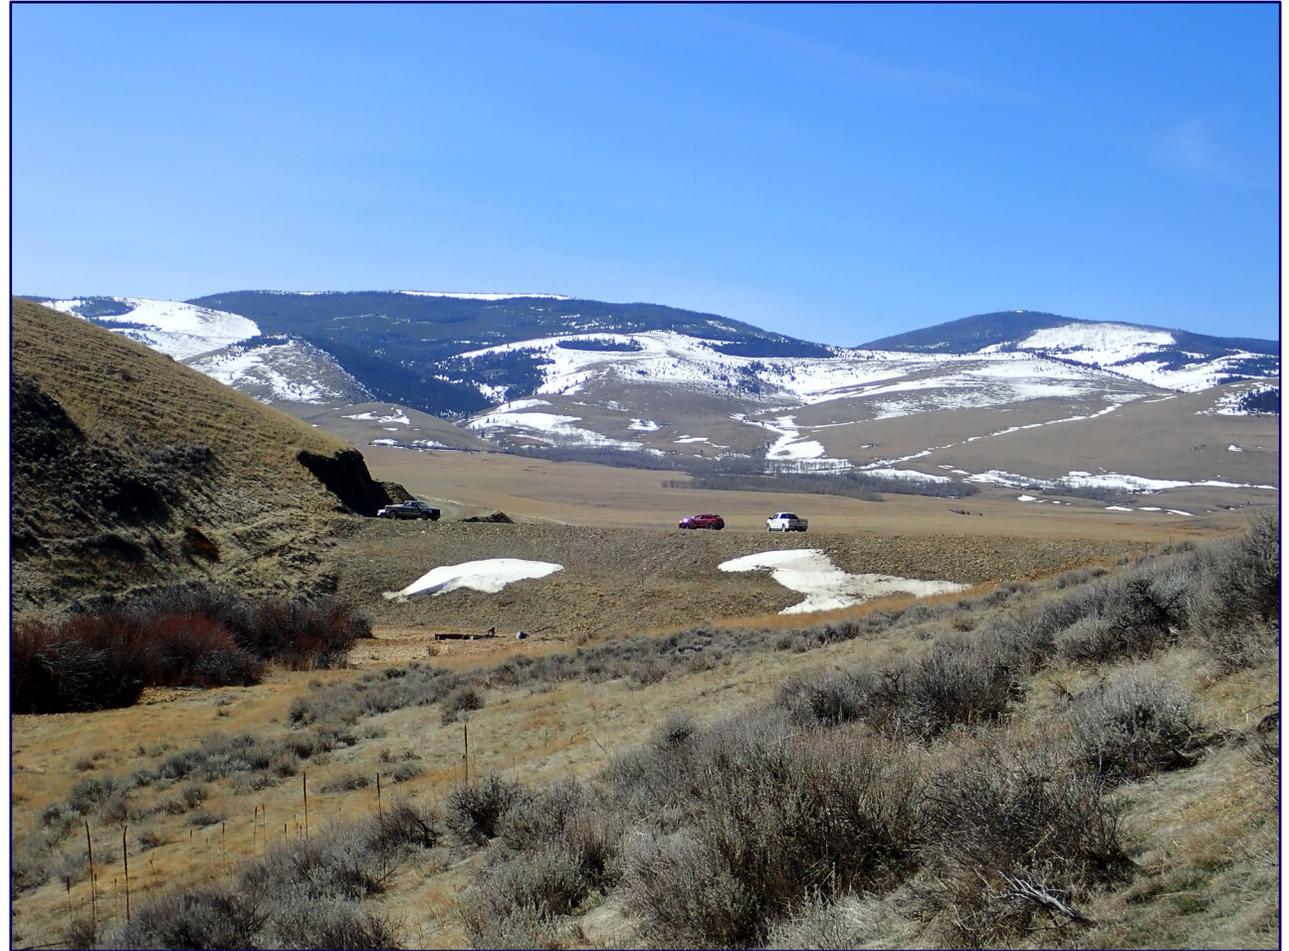
- Originally built in 1936

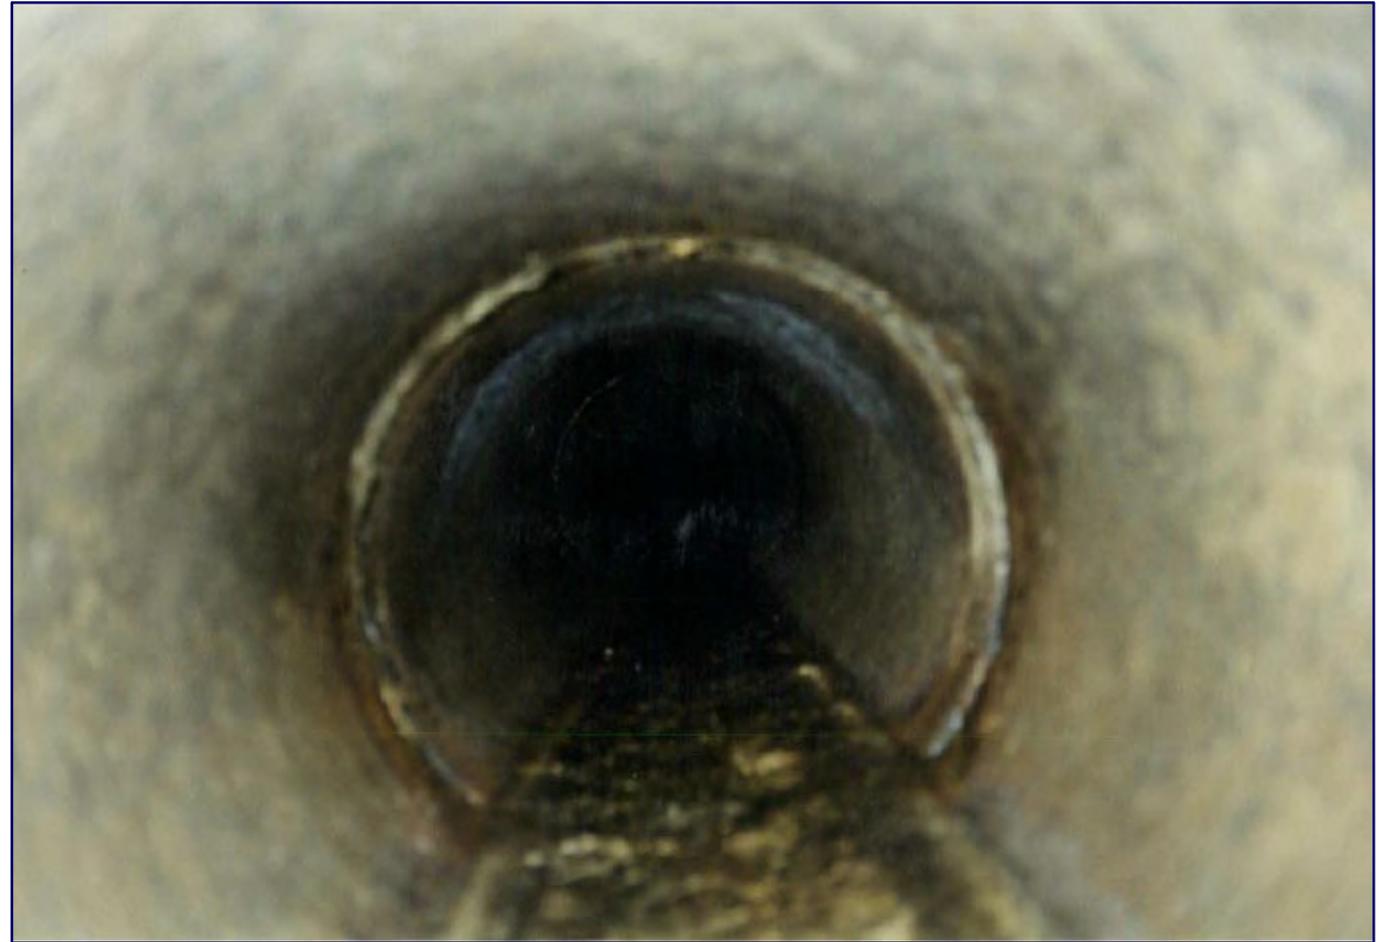
- Originally built in 1936
- **Original outlet conduit is a 12" precast concrete pipe**

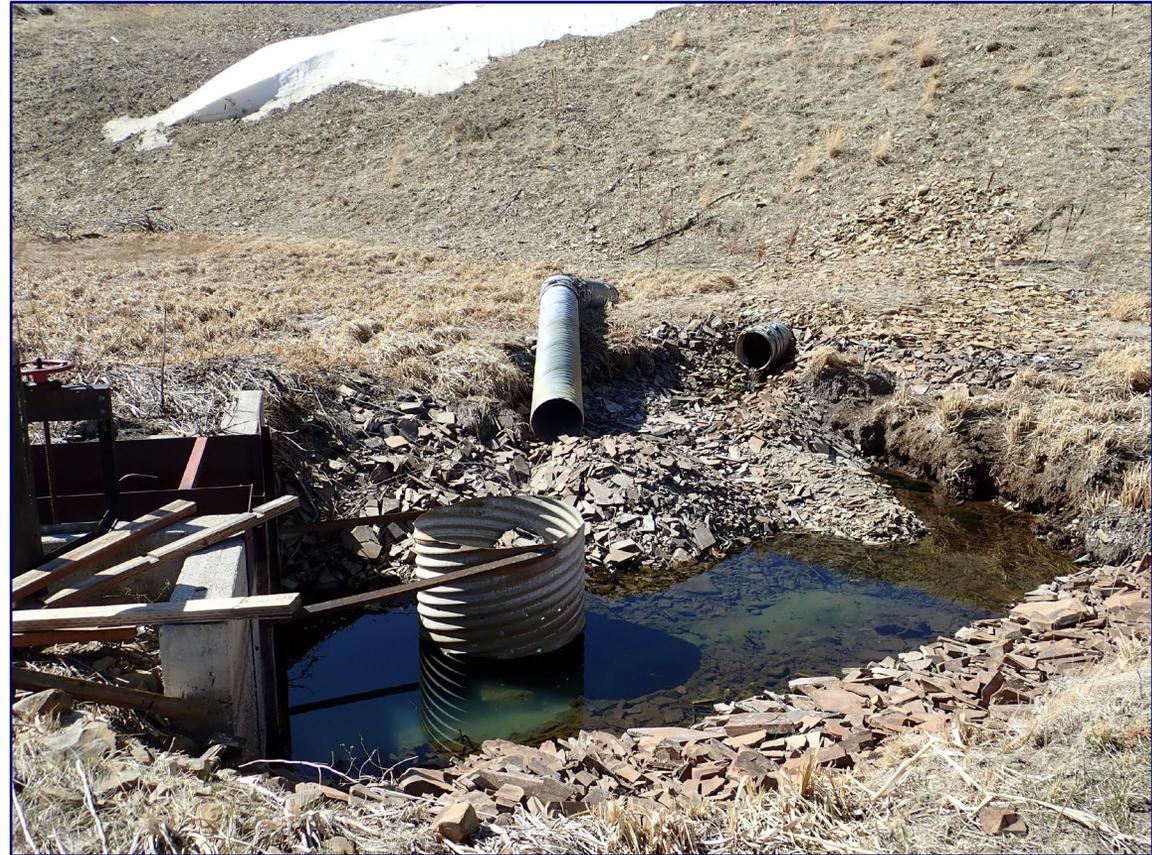
- Originally built in 1936
- Original outlet conduit is a 12” precast concrete pipe
- **Extensions to the outlet conduit consists of 15” CMP**

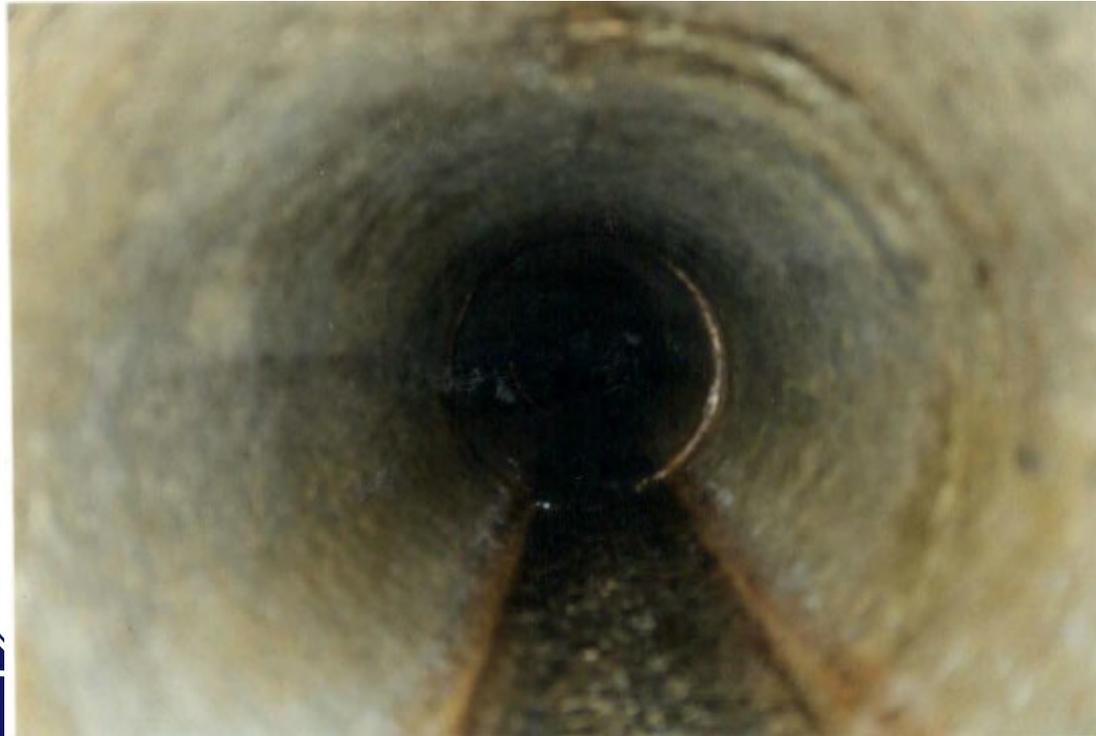
1995

84 Feet

Case Study #2

Dam in Meagher County

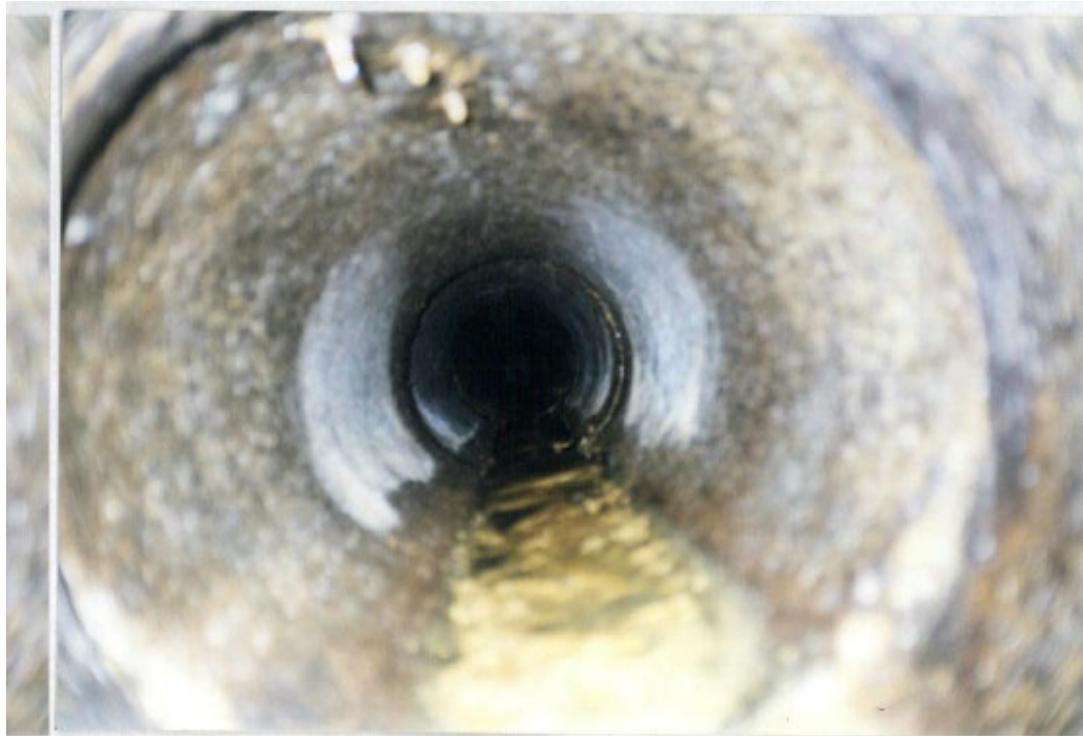
2000

84 Feet

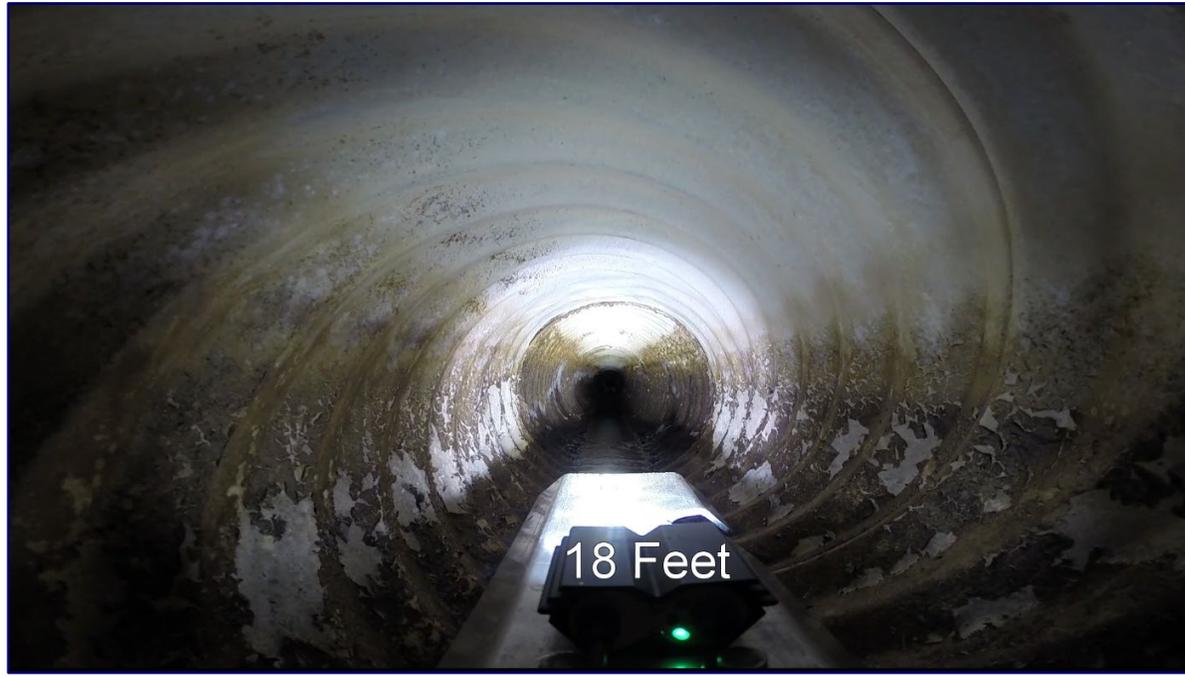
2016

Case Study #2

Dam in Meagher County

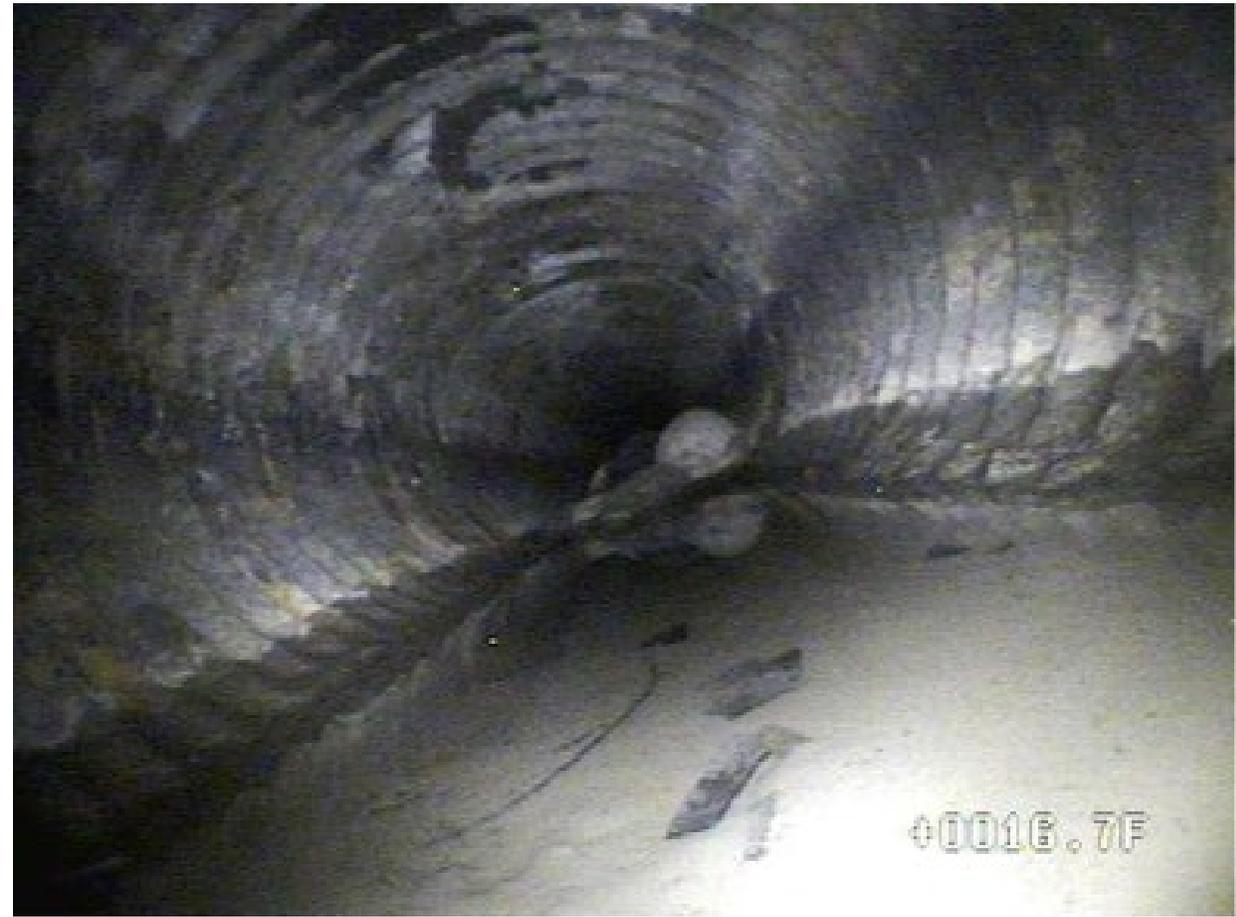
- Built in the 1960s
- **Outlet is an 18" CMP**

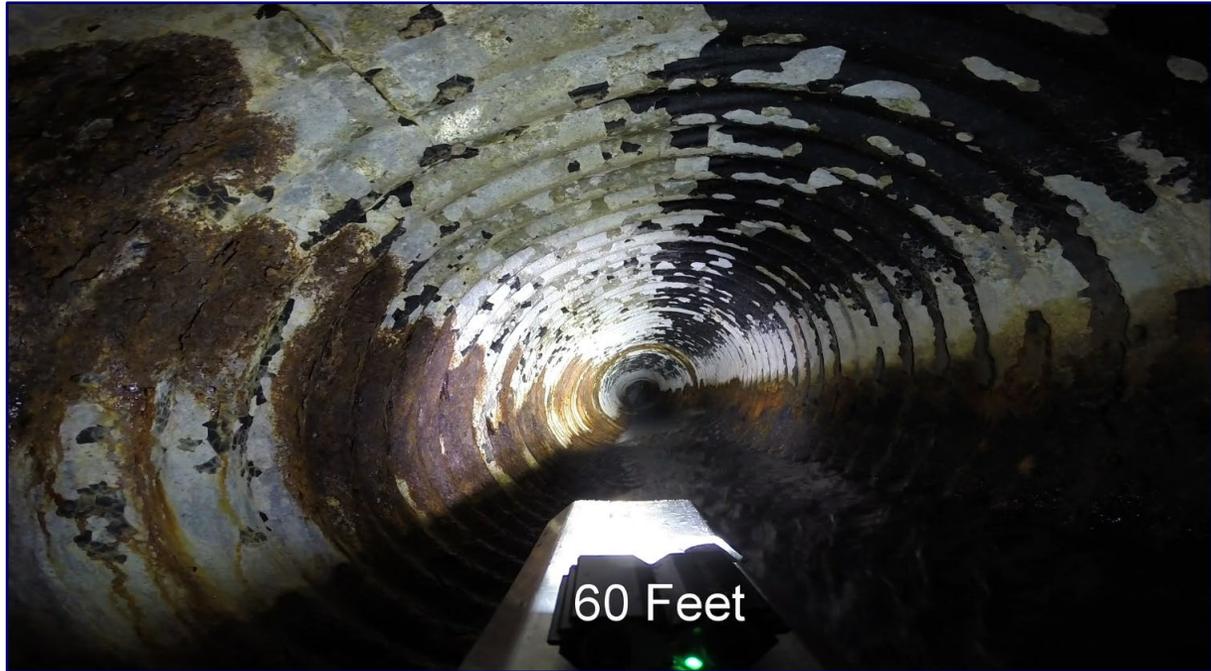
2015

Case Study #4 Dam in Yellowstone County

- The outlet pipe was abandoned with flowable fill
- An 18" HDPE high-level outlet conduit was built in early 2021

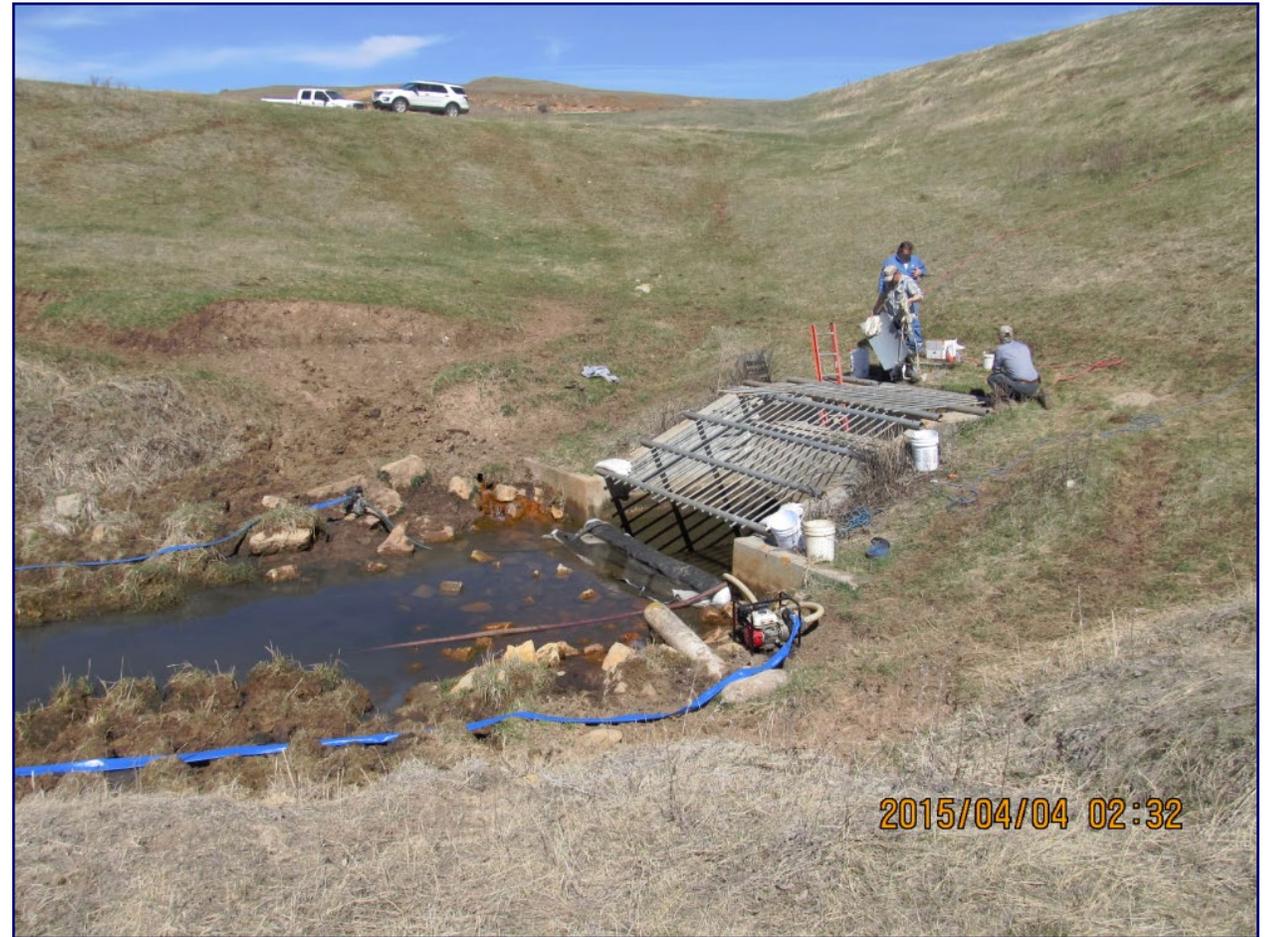
- Inspection conducted in 2015

- **During the inspection, a hole was found in the concrete exposing the steel cylinder**

- During the inspection, a hole was found in the concrete exposing the steel cylinder
- **It was located about 133' from the downstream end of the outlet**

- NRCS put in a temporary patch

- NRCS put in a temporary patch
- **Later placed an expander as a permanent solution**
